MNMM Fatal 2012-13

- Fall of Person Accident
- September 22, 2012 (Arizona)
- Copper Operation
- Contract Laborer
- 34 years old
- 6 days of experience

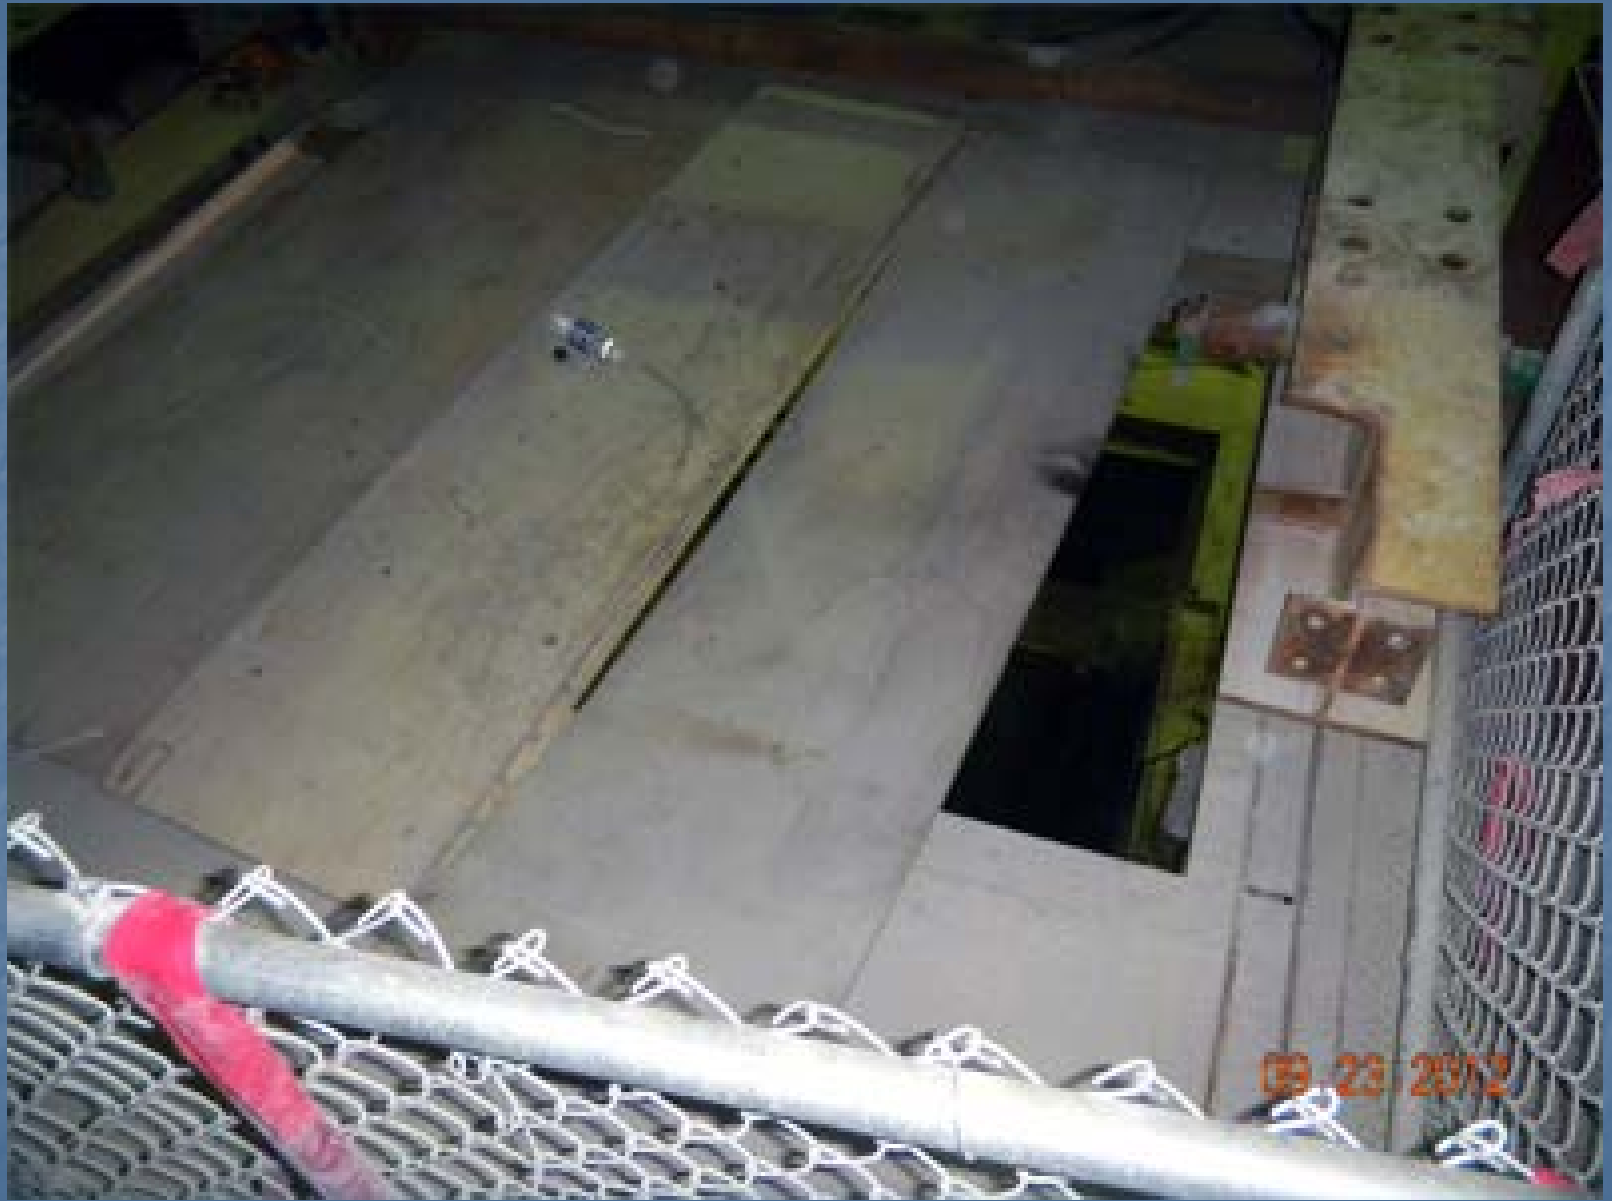
The victim was killed when he fell through an opening on the 4th floor of the secondary crusher building and landed approximately 30 feet below. The opening was covered with 2-inch by 4-inch by 102-inch boards and 3/4-inch thick plywood that was being used as a work platform. When the victim stepped onto the platform, two of the boards broke and he fell. A screen was attached over the 6-foot by 8-foot opening but had been removed for repairs.

The accident occurred due to mine and contract management's failure to ensure the work platform, covering the hole where the victim fell, was of substantial construction, barricaded, and provided with warning signs to prevent a fall hazard to persons working in the secondary crusher building. The accident occurred in an area where the victim was not assigned to work. Statements made during interviews indicate he was missing for approximately 1 hour and 45 minutes before a search began. The victim had six days of experience on the job.

Root Cause: Mine and contract management failed to ensure the work platform covering the hole where the victim fell was of substantial construction, barricaded, and provided with warning signs to prevent a fall hazard to any person working in the secondary crusher building.

Corrective Action: Mine management instituted a policy of using engineered metal covers on all accessible open holes to prevent a future fall hazard to miners. An improved system is in place using signs and barricades to warn and prevent access to hazardous areas that are not immediately obvious to persons.
