MNM Fatal 2012-16

- Powered Haulage Accident
- October 24, 2012 (Nebraska)
- Underground Crushed Stone Operation
- Utility Miner
- 52 years old
- 19 years of experience

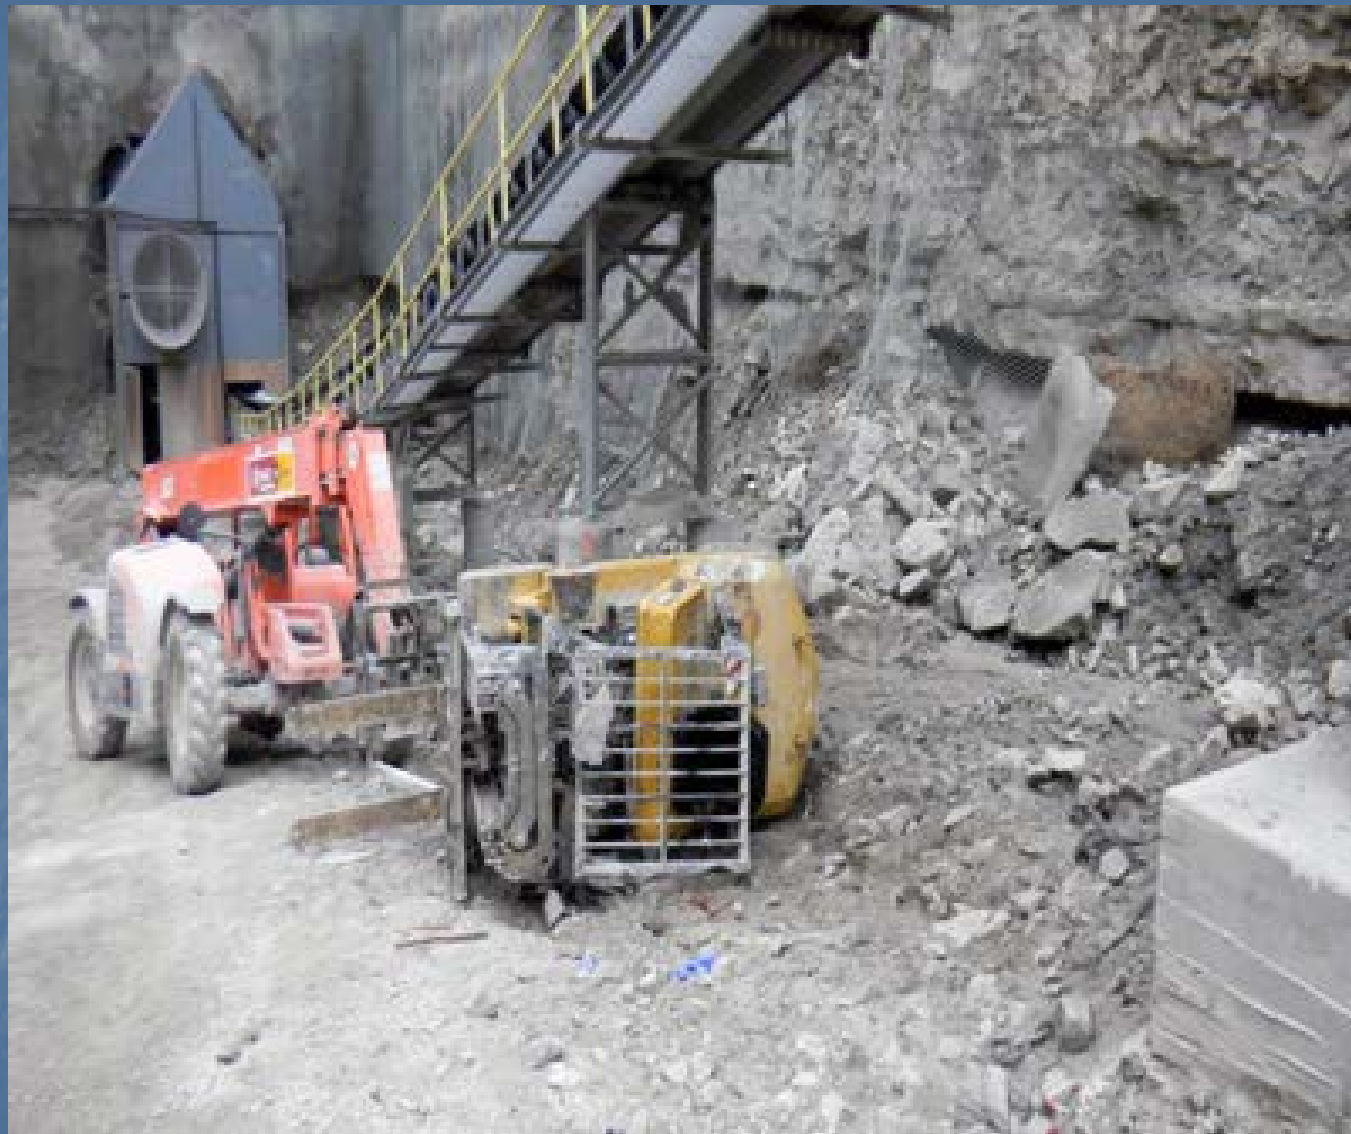
The victim was killed while operating a lift truck, traveling down a decline ramp toward the mine entrance, when he lost control of the vehicle. The lift truck traveled across the haul road, striking a concrete support for a belt conveyor. The lift truck rolled to the right side, landed on its top, and came to rest on its left side. The victim was wearing a seat belt.

The accident occurred due to management's failure to ensure the lift truck was being used as intended by the manufacturer because it was designed to be used on improved surfaces not on rough surfaces as the decline ramp. Additionally, the victim had not been task trained to operate the lift truck and lost control of the lift truck while traveling down the decline ramp. He was descending an approximate 17% grade while carrying an empty trash dumpster with the load downgrade.

CORRECTIVE ACTION: The mine operator evaluated the conditions and safety practices to identify equipment that is designed to operate on the grades subjected to on the decline ramp. The mine operator purchased a lift truck, capable of operating on the decline ramp within the design of the manufacturer, to pick up the trash inside the mine. Additionally, warning signs were posted at the approaches of the decline ramp.

CORRECTIVE ACTION: All persons assigned to operate the new lift truck on the decline ramp were task trained to operate the vehicle and trained to look for the warning signs posted at the approaches of the decline ramp.
