MNMF Fatal 2012-17

- Machinery Accident
- November 1, 2012 (New York)
- Common Shale Operation
- Driller
- 30 years old
- 6 years of experience

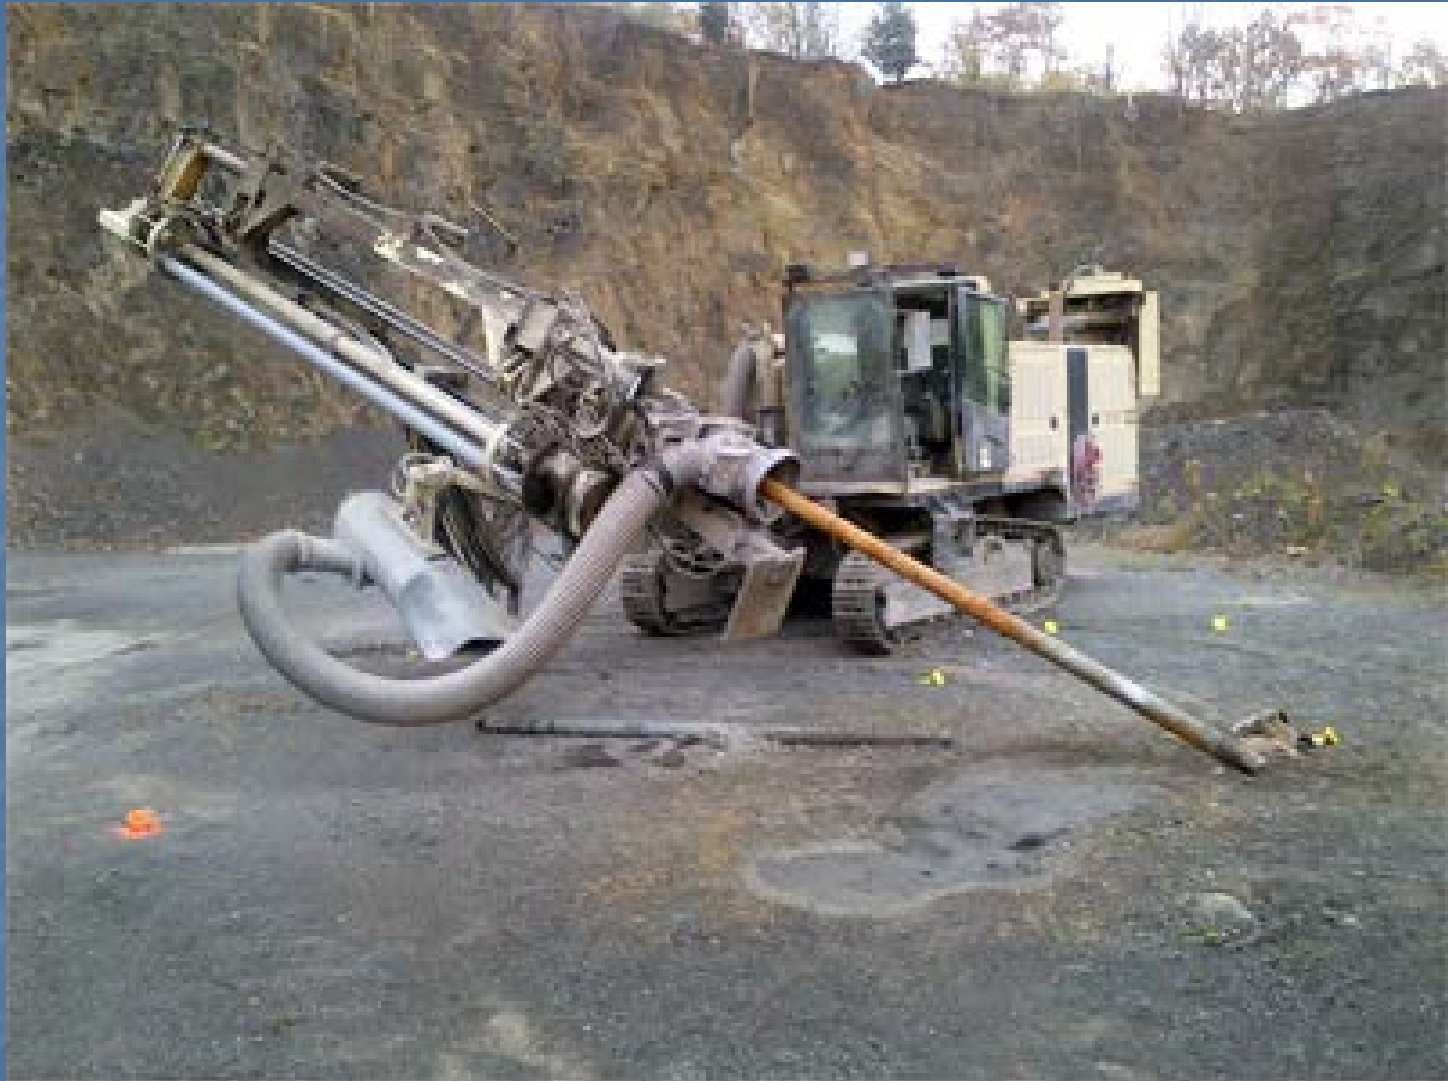
The victim was killed while attempting to manually load a threaded drill steel into the mast of a crawler drilling machine by engaging it with the rotating drill head when he became entangled in the rotating drill steel.

The accident occurred due to contract management's failure to implement policies and procedures to ensure that drillers stayed clear of a rotating drill steel, specifically while performing drill steel loading operations. The victim had approximately six months of drilling experience and did not receive effective task training addressing the safe work procedures for loading a drill steel and the potential hazards associated with the task. Additionally, he was assigned to perform work alone where hazardous conditions existed and he could not communicate with others, be heard, or be seen.

Root Cause: The victim did not receive effective task training regarding procedures to safely load drill steels. Contract management policies and procedures failed to ensure that drillers stayed clear of a rotating drill steel, specifically while performing drill steel loading operations.

Root Cause: Contract management required drillers to work alone where hazardous conditions existed and they could communicate with others, could be heard, or be seen while working in the quarry.

Corrective Action: Contract management established written policies and safe work procedures to ensure that drillers stayed clear of rotating drill steels during drill steel loading operations. These new procedures incorporate the manufacturer's recommendations for loading drill steels and require a minimum of two properly trained persons to perform the task. All persons were provided task training regarding the new policies.

Corrective Action: Contract management implemented safe work procedures for loading drill steels which incorporate the manufacturer's recommendations for loading drill steels and require a minimum of two properly trained persons to perform the task. All persons were provided task training regarding the new procedures. In addition, the mine operator has implemented policies and procedures for management personnel to provide increased oversight of contractors working at the site.
