# MNM Fatal 2013-01

- Fall of Highwall Accident
- January 7, 2013 (Kentucky)
  - Victim died January 19, 2013
- Crushed Stone Operation
- Assistant Plant Manager
- 49 years old
- 30 years of experience

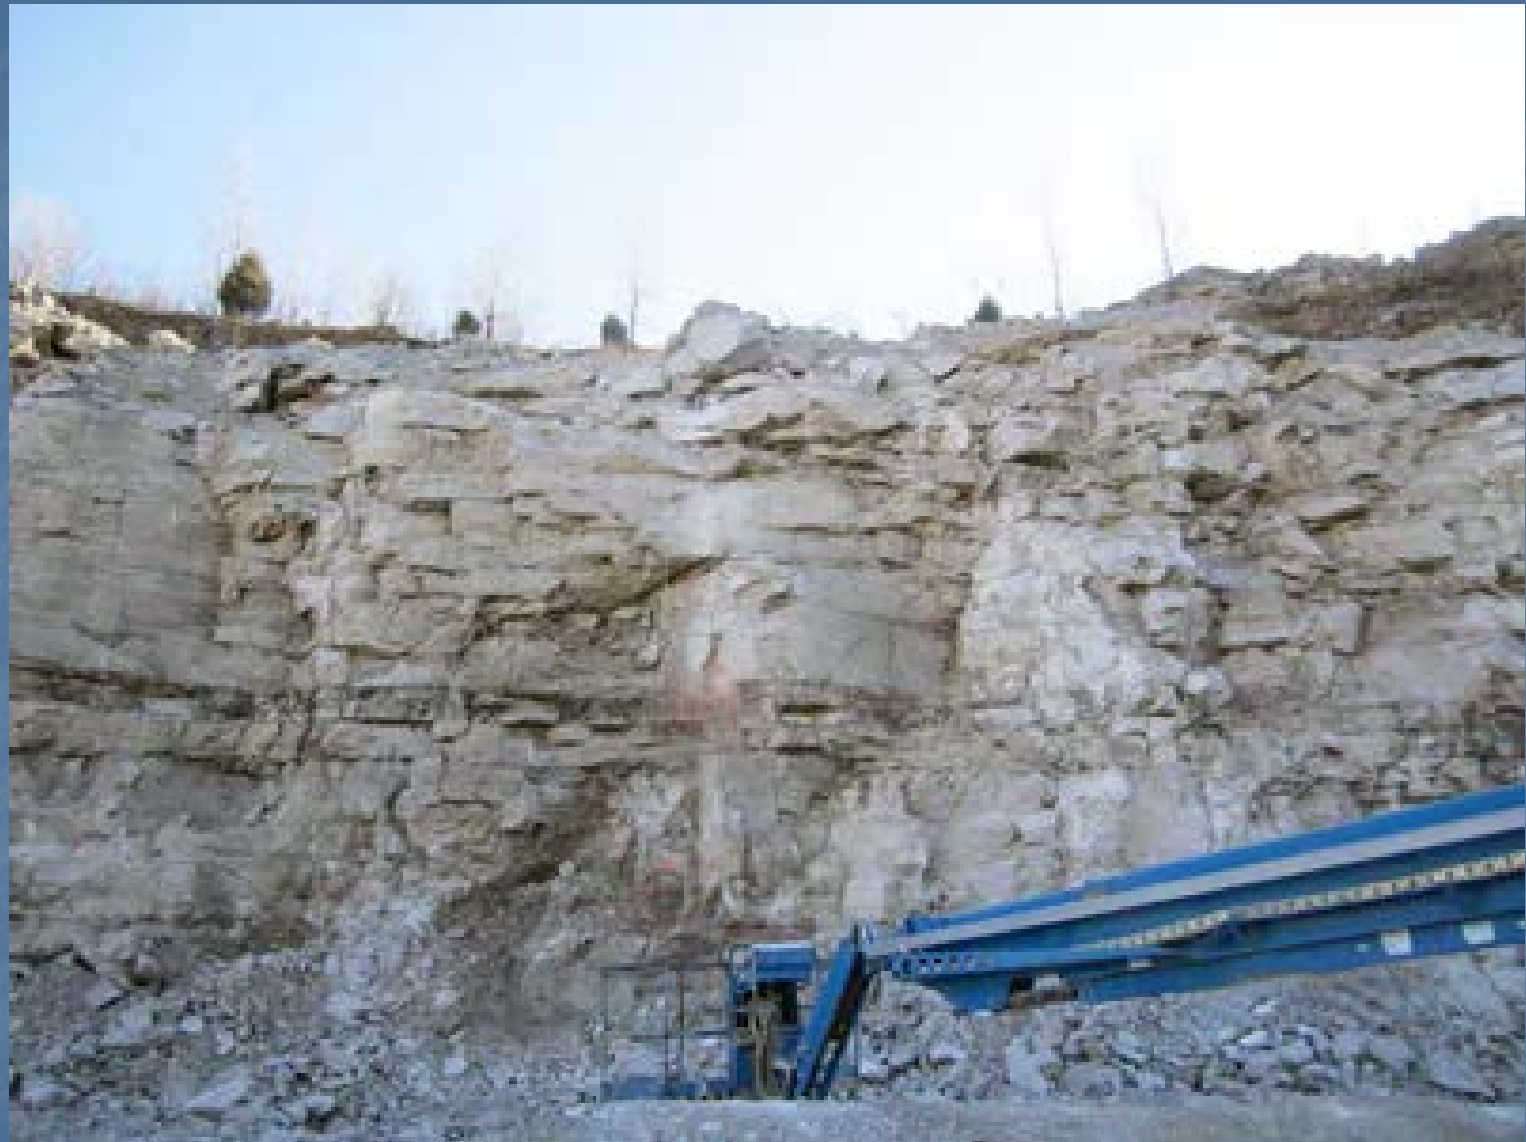
The victim was injured when a large rock fell from a highwall and struck him in the left shoulder. He was working from a telescopic boom work platform (manlift) gathering rock samples from the face of the highwall. He was hospitalized and died on January 19, 2013, as a result of his injuries.

The accident occurred due to management's lack of procedures and controls to prevent ground conditions from creating a hazard of falling rocks before work or travel was permitted in the affected area. The victim was working close to the face of a highwall taking rock samples. Additionally, he did not receive newly hired experienced miner training when he was hired.

**Corrective Action:** Management established new procedures and controls to collect rock samples from drill shavings, eliminating the need for persons to take samples near highwalls. All persons required to take rock samples were instructed in these new policies and procedures. Additionally, management provided extensive training to all persons regarding working near highwalls.
