MNM Fatal 2013-12

- Falling/Sliding Material Accident
- September 18, 2013 (Kentucky)
- Crushed Stone Mine
- Front-end Loader Operator
- 56 years old
- 16 years of experience

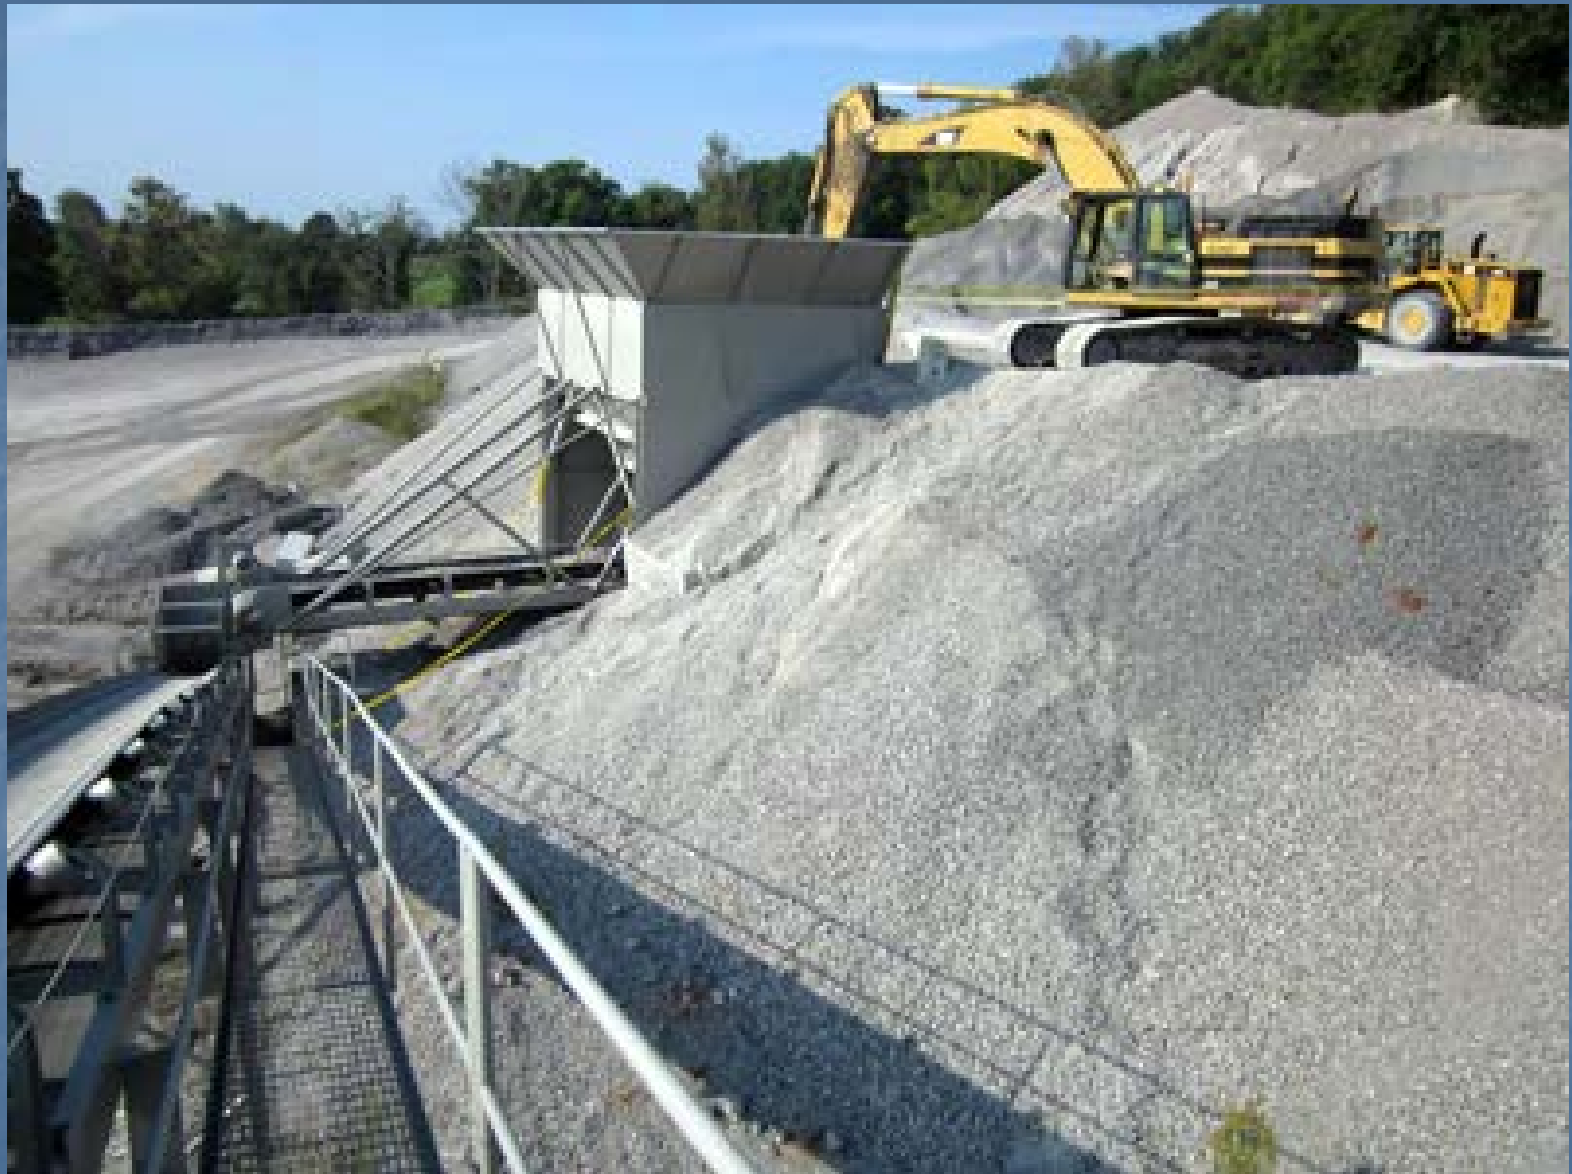
The victim was killed when he was engulfed by material in a pug mill hopper (hopper). He used a front-end loader to place material into the hopper. He then entered the top of the hopper to remove a lump of stone that would not feed onto the belt conveyor below. The unconsolidated material that the victim was standing on collapsed, engulfing him. The hopper was operating at the time of the accident.

The hopper did not have a heavy screen (grizzly) installed to control the size of material and prevent clogging. Additionally, the hopper was not equipped with any mechanical devices or other effective means of handling material so persons can work where they are not exposed to entrapment by sliding material.

Corrective Action: Management installed a grating designed to cover the top of the chute. It has been welded to the top of the hopper to prevent persons from accessing the hopper. This grating also prevents lumps from clogging the discharge chute.
