MNM Fatal 2013-18

- Electrical
- November 18, 2013 (Kentucky)
- Crushed Stone Mine
- Contract Electrician Foreman
- 33 years old
- 14 years of experience

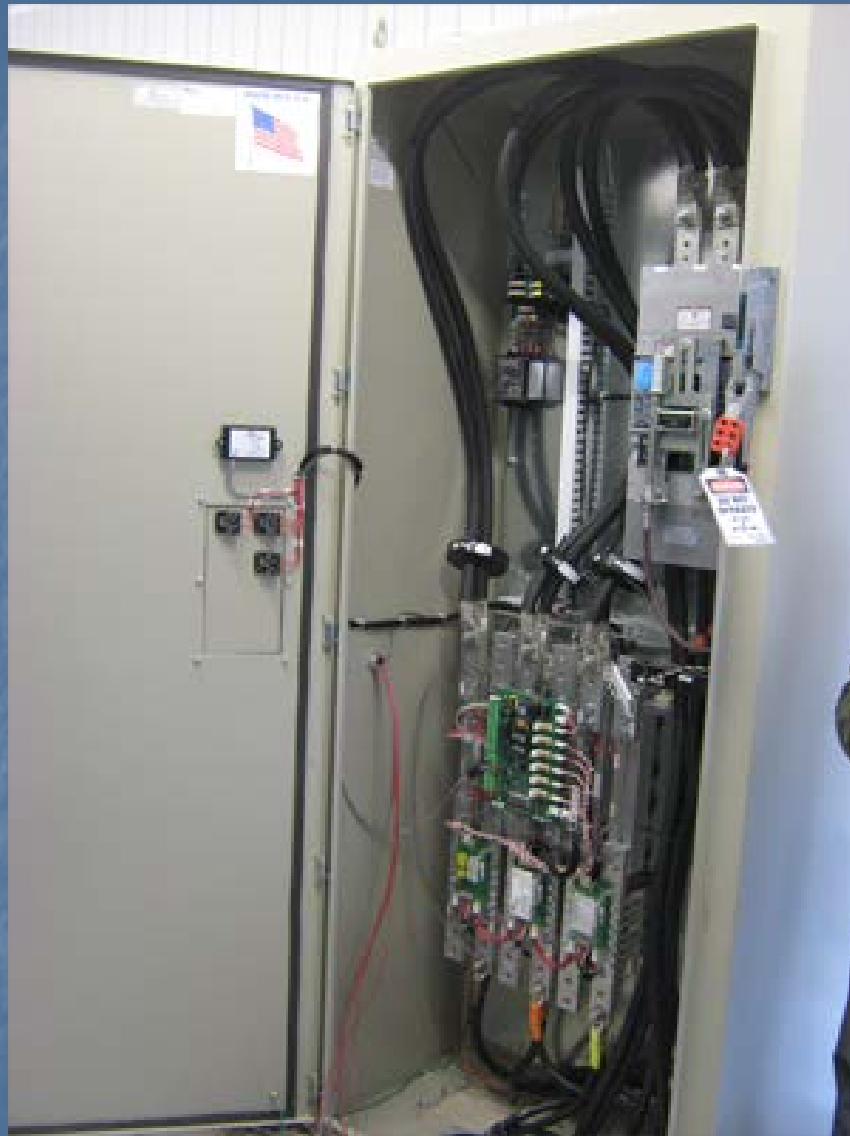
The victim was received an electrical shock on November 18, 2013. He was working in a motor control building when he contacted an energized conductor inside an electrical enclosure. The victim was transported to a hospital where he died on November 22, 2013, as a result of his injuries.

The accident occurred because the electrical circuit was not deenergized prior to work being performed on it. Additionally, the electrical circuit was not locked out, tagged out, or tested to verify it was de-energized.

Corrective Action: The contractor re-instructed all persons regarding the procedures to be followed when performing work on electrical equipment.
