Fatality #10 - August 5, 2013

Machinery – New York – Crushed, Broken Limestone NEC

MJL Crushing LLC - MJL Crushing LLC

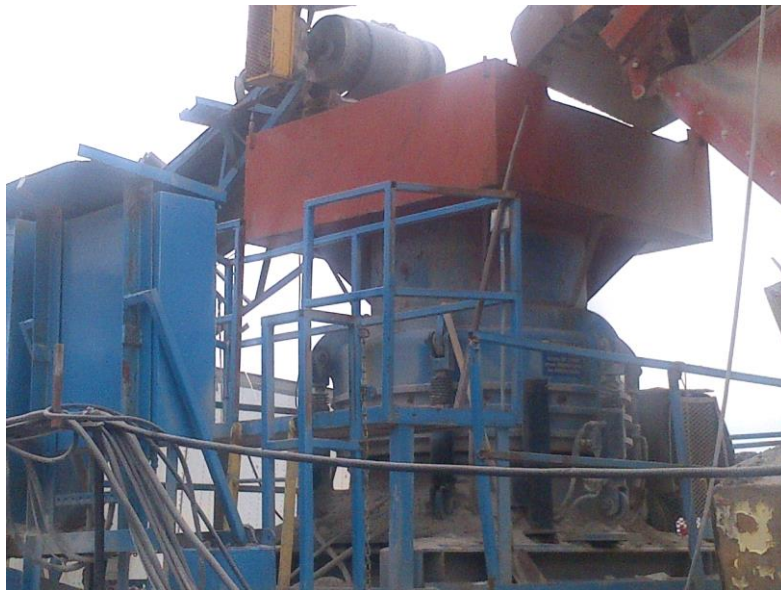
METAL/NONMETAL MINE FATALITY – On August 5, 2013, a 55-year old plant manager with 5 years of experience was killed at a crushed stone operation. The victim looked into an operating crusher and a tooth, that broke free from an excavator bucket, was ejected from the crusher and struck him.

- Establish and discuss policies and procedures for safely clearing a cone crusher. Consider a mechanical method for clearing material to minimize exposure to persons performing the work.

- Task train persons to recognize all potential hazardous conditions and to understand safe job procedures for elimination of the hazards before beginning work.

- Before working on or near equipment, ensure the equipment power is off and locked out/tagged out. Ensure the equipment has been securely blocked against hazardous motion to ensure energy cannot be released while performing work.

- Always maintain equipment in a safe operating condition.
- Provide a safe means of access for persons required to maintain a cone crusher.
- Provide guards, shields, or other devices to protect persons from the hazard of flying or falling materials generated from the operation of screens, crushers, or conveyors.

- Implement measures to ensure persons are properly positioned and protected from hazards while performing a task.
