REPORT OF INVESTIGATION

Surface Nonmetal Mine
(Crushed and Broken Limestone)

Fatal Falling/Sliding Material Accident
September 18, 2013

Gaddie-Shamrock LLC
Caldwell Quarry
Albany, Clinton County, Kentucky
ID No. 15-00091

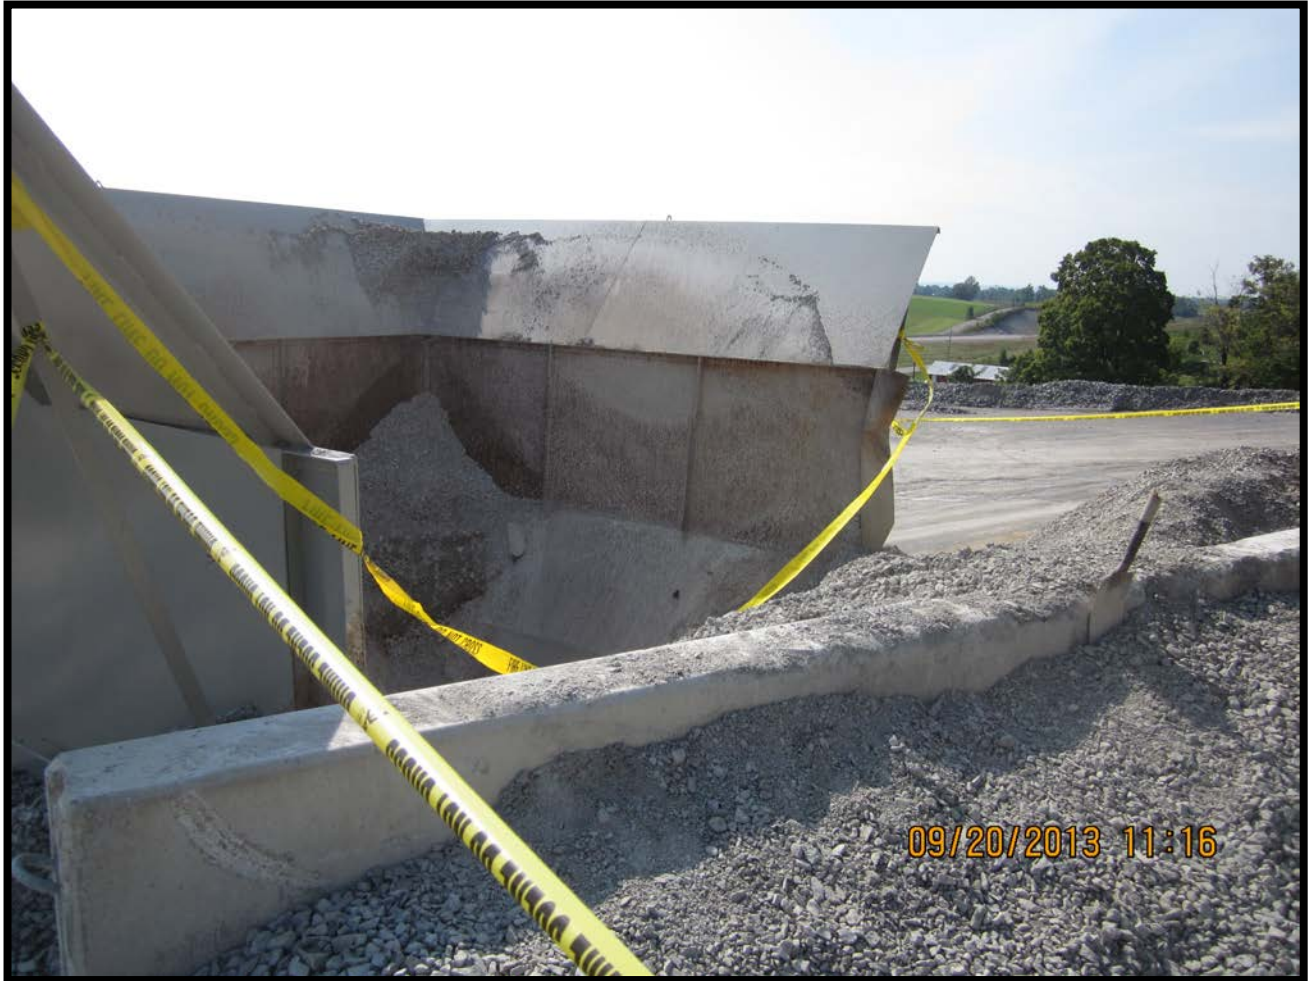
On September 18, 2013, Lonnie Ferrell, Front-end Loader Operator, age 56, was killed when he was engulfed by material in a pug mill hopper (hopper). Ferrell used a front-end loader to place material into the hopper. He then entered the top of the hopper to remove a lump of stone that would not feed onto the belt conveyor below. The unconsolidated material that Ferrell was standing on collapsed, engulfing him. The hopper was operating at the time of the accident.

The pug mill hopper is a square bin, approximately 12 feet high, designed to allow material to be dumped into the top via a 14-foot x 14-foot square opening. The material is then gravity fed into a 12-inch x 12-inch discharge chute open at the bottom of the bin. The bin is equipped with a vibrator attached to the outside of the bin structure to prevent material from sticking to the inside of the bin. The material from the discharge chute is loaded on the first of two belt conveyors.

Corrective Action: Management installed a grating designed to cover the top of the chute. It has been welded to the top of the hopper to prevent persons from accessing the hopper. This grating also prevents lumps from clogging the discharge chute.
