# MNMF Fatal 2014-22

- Powered Haulage
- November 25, 2014 (Pennsylvania)
- Sandstone Mine
- Truck Driver
- 67 years old
- 10½ years of experience

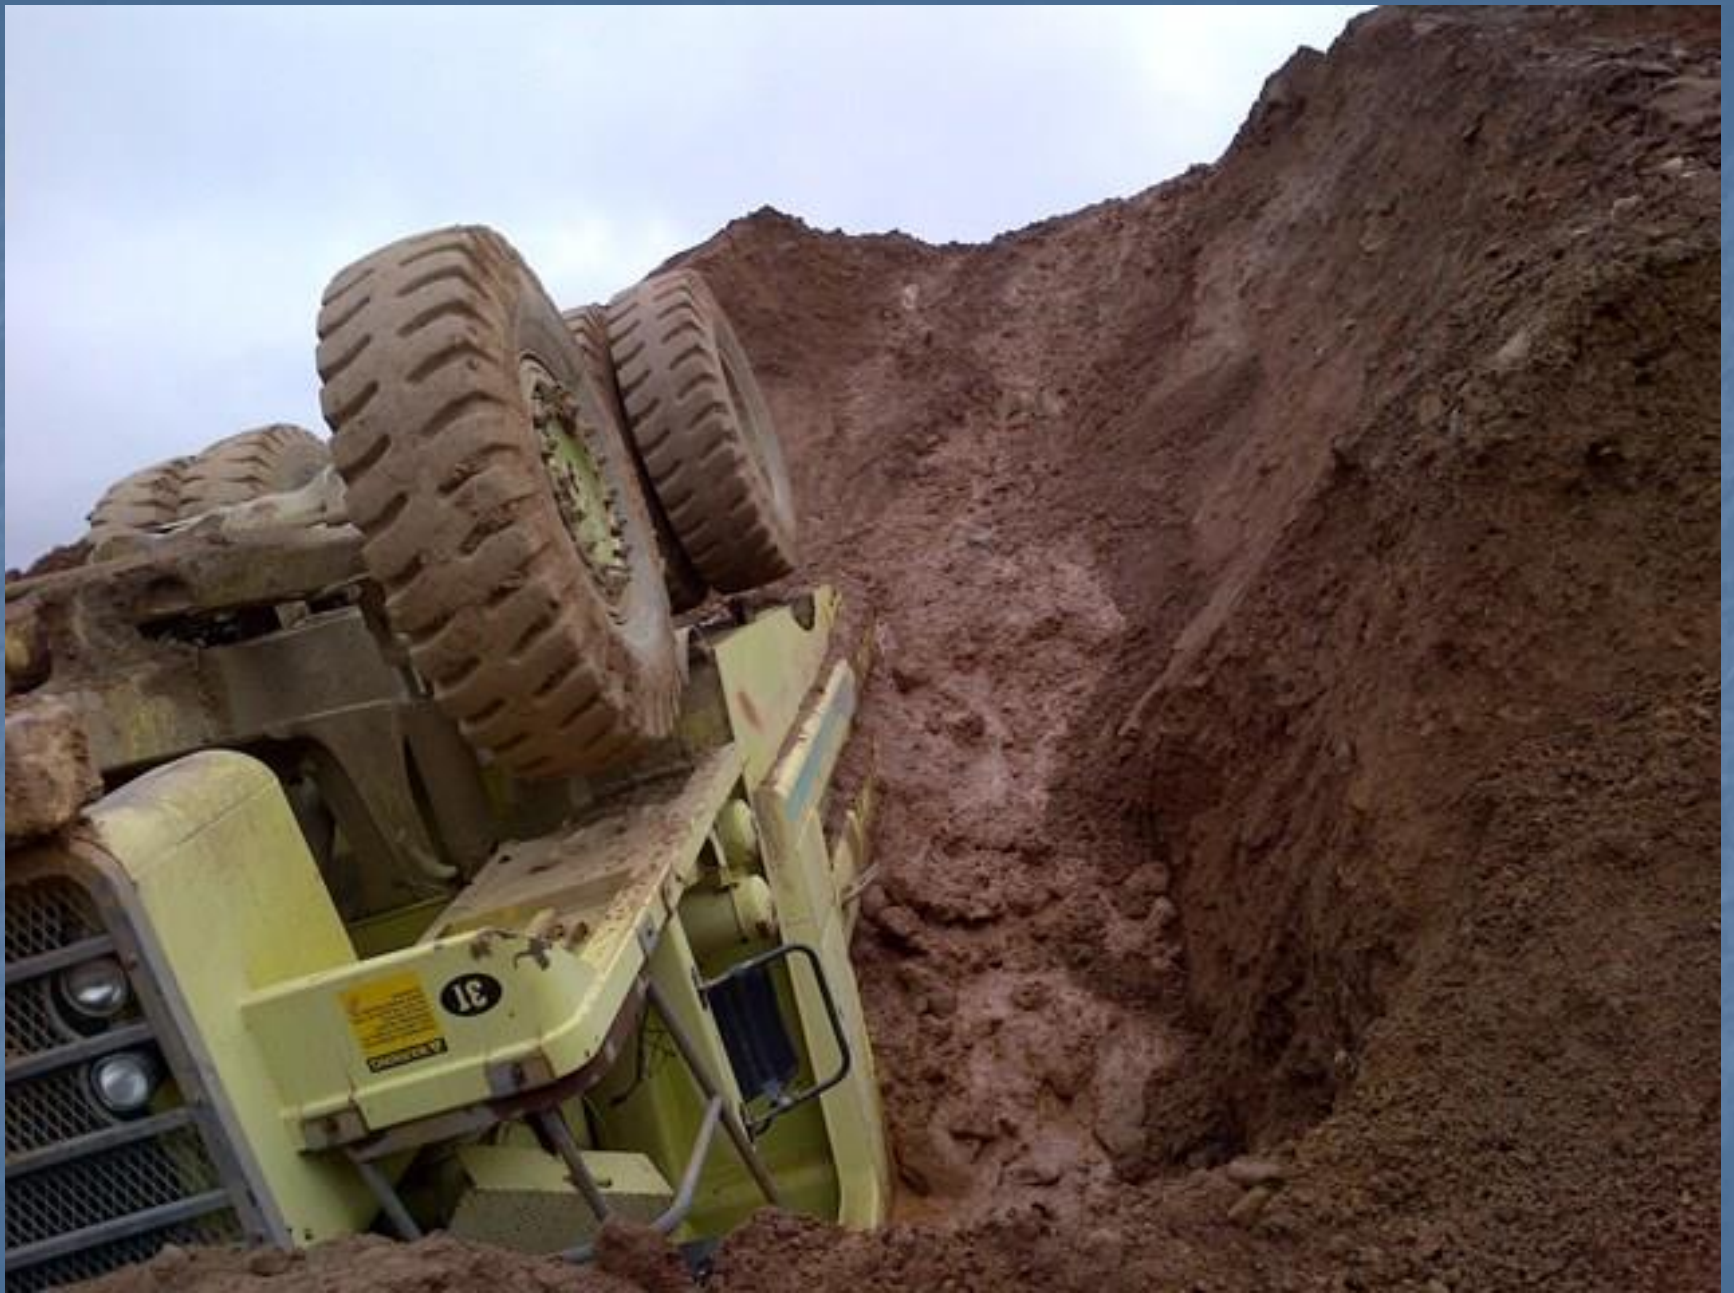
The victim was killed while operating a haul truck. He backed the haul truck to the edge of an overburden dumpsite and started to raise the truck's bed to dump a load of material. The bank failed, causing the truck to overturn and fall 30 feet below.

An excavator removed material from the toe area of the overburden stockpile as material was being dumped from the haul truck at the top. Removing material from the pile steepened the slope angle from 30 to 39 degrees, creating an unstable condition at the dump site. The loaded haul truck backed very close to the edge of the overburden stockpile where the weight from the truck caused a localized failure and loss of ground under the back wheels of the loaded truck. As the rear of the truck dropped, the downward and lateral momentum caused it to flip over onto the cab, landing approximately 30 feet down the slope of the overburden stockpile.

- **Root Cause:** Management failed to inspect the dumping location periodically throughout the shift as changing conditions warranted. Material had been loaded from the stockpile directly below the dump location which steepened the slope angle and reduced the stability.
- **Corrective Action:** Management established policies and procedures to ensure that dumping locations are inspected at the beginning of the shift and during mining operations for signs of slope instability. The top of the dump area is to be examined for cracks, unstable ground, and sunken or soft areas. The load-out area is to be examined for signs of undercutting and over steepening of the slope. All mobile equipment operators were trained in these new policies and procedures.

- **Root Cause:** Management failed to ensure that loads were dumped a safe distance back from the undercut edge of the overburden stockpile.
- **Corrective Action:** Management established policies and procedures to ensure that loads are dumped a safe distance back from the edge of the overburden stockpile. A front-end loader will be used to push the material over the edge. No material will be dumped over the edge while material is being removed from the toe of the stockpile. All mobile equipment operators were trained in these new policies and procedures.
