MNM Fatal 2015-06

- Machinery
- March 23, 2015 (Pennsylvania)
- Dimension Sandstone
- Owner / Operator
- 46 years old
- 20 years of experience

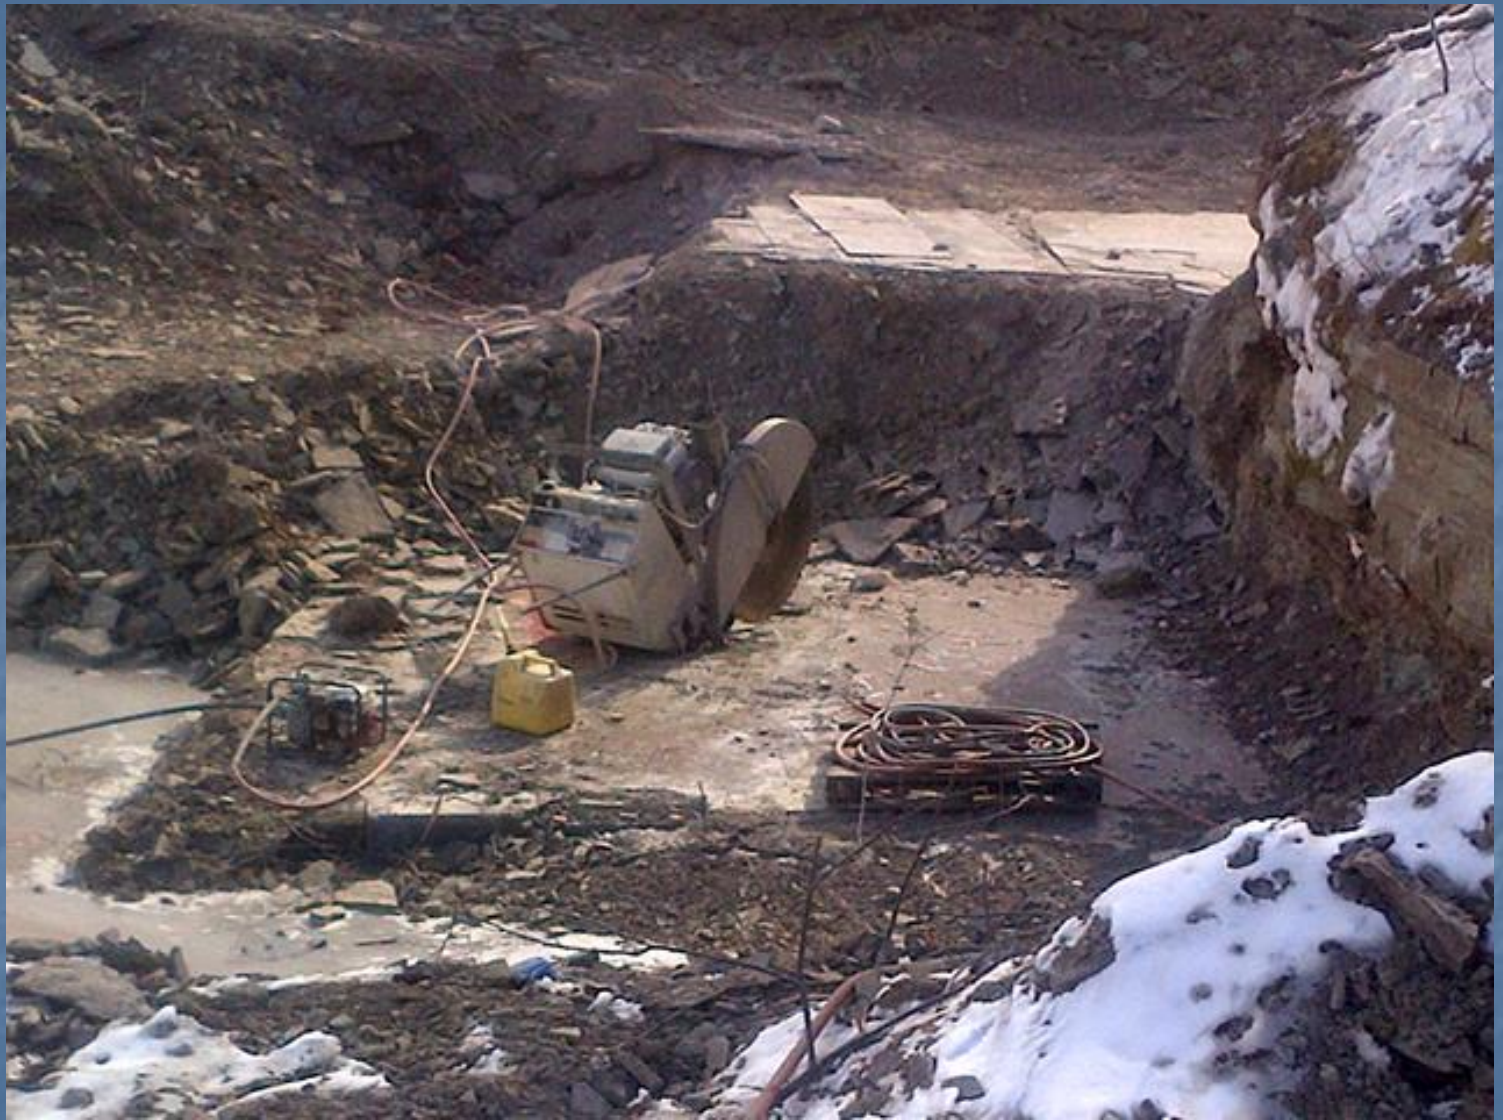
On March 23, 2015, Daniel Acker, Owner/Operator, age 48, was killed while cutting stone on top of a bench using a walk-behind, self-propelled concrete saw. Daniel Acker was positioned between the saw and the ledge, when he tripped and fell. The victim and the saw went over the 4½-foot ledge, resulting in the saw falling on him.

The accident occurred due to the victim's failure to maintain control of the self-propelled concrete saw that he was operating in reverse gear while repositioning to cut stone.

Root Cause: The victim failed to maintain control of the self-propelled concrete saw that he was operating in reverse gear while repositioning to cut stone. No procedures were in place for persons to safely operate the walk-behind, self-propelled concrete saw on an elevated bench.

Corrective Action: The victim was a sole proprietor and; therefore, the business terminated at the time of his death. Consequently, no corrective action was taken.
