MNM Fatal 2015-15

- Falling, Rolling, or Sliding Rock or Material
- August 03, 2015 (Virginia)
- Crushed & Broken Granite Surface Mine
- Truck Driver (Seasonal Associate)
- 18 years old
- 9 weeks of experience

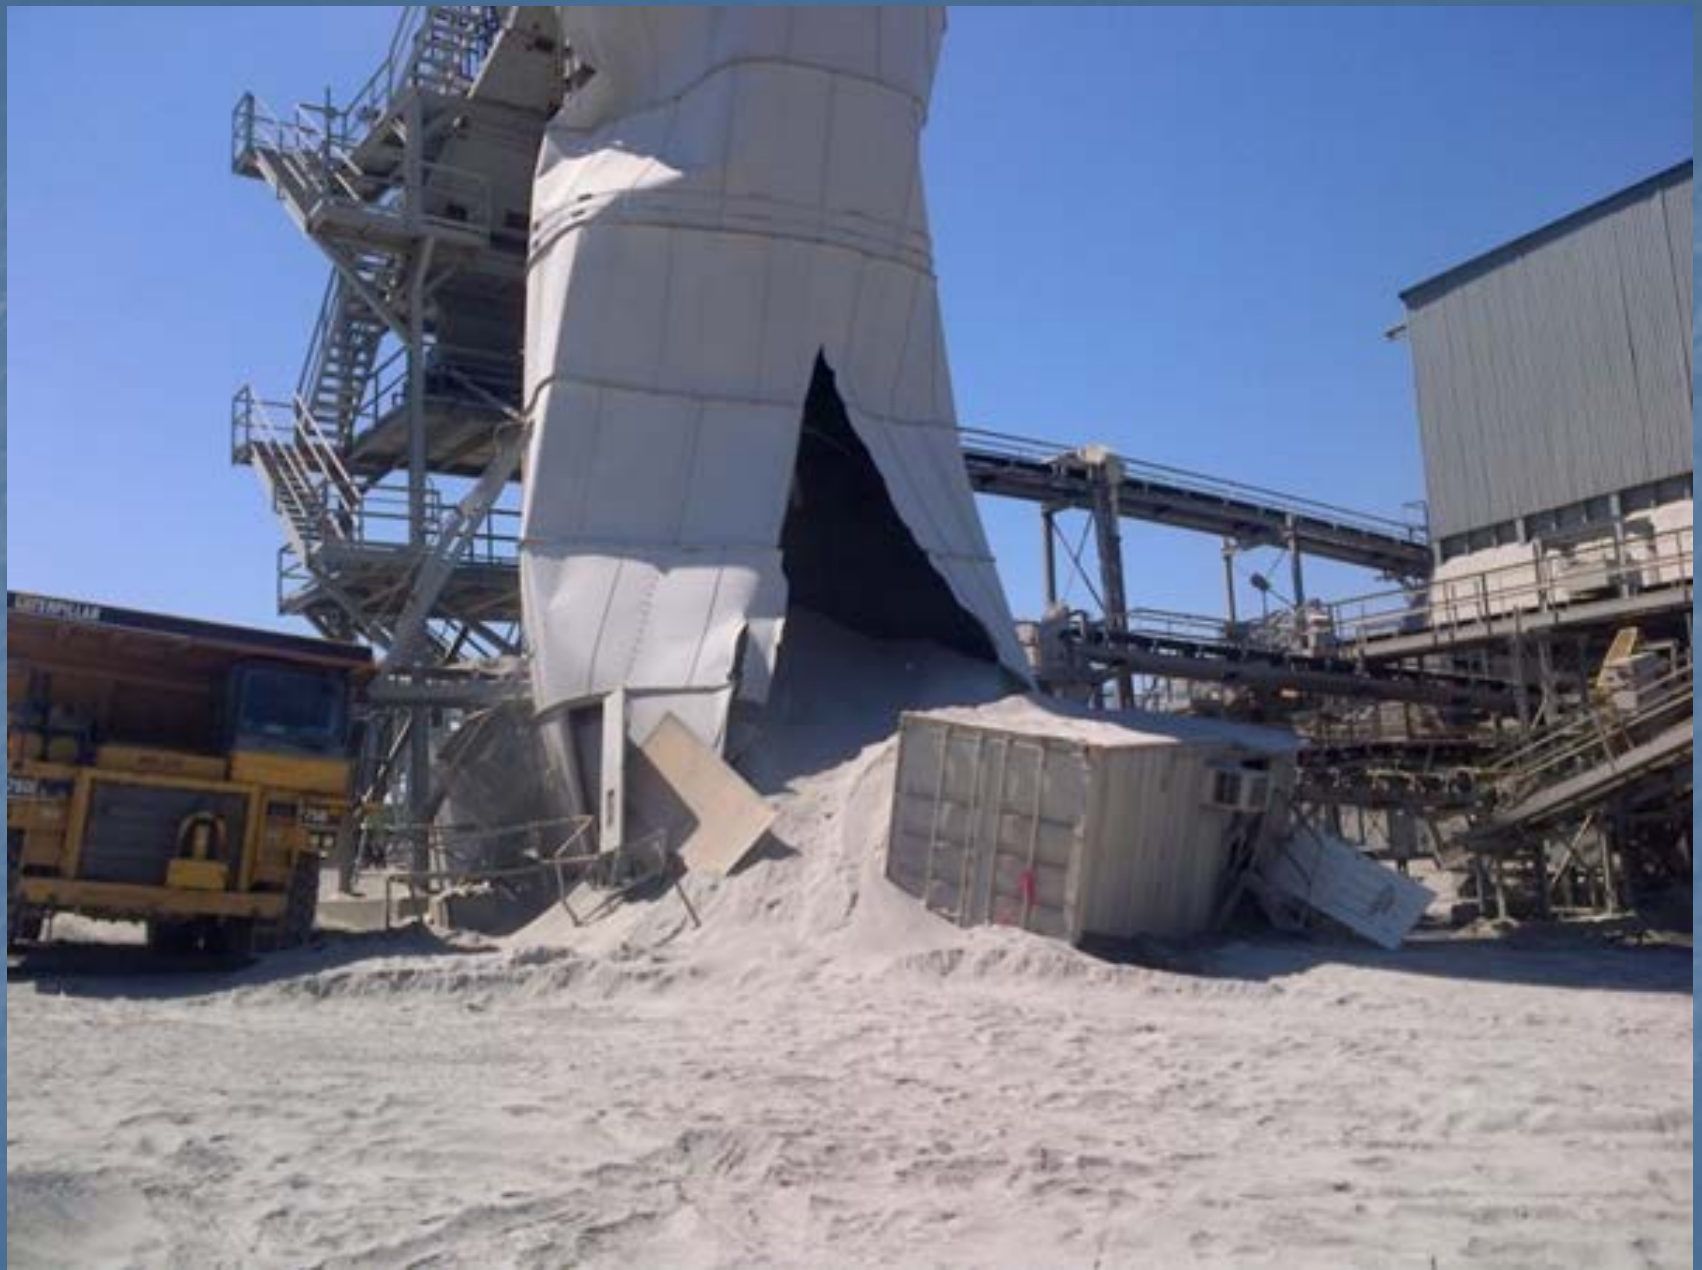
On August 3, 2015, Daniel C. Potter, truck driver / seasonal associate, age 18, was killed at the Leesburg Plant. Potter had parked his truck alongside the “sand plant fines” silo under a conveyor belt to load his truck. After exiting the truck, Potter entered a door leading underneath the silo. Soon after entering the silo, the hopper portion of the structure collapsed, burying Potter beneath the falling material.

The accident occurred due to management’s failure to ensure that adequate inspections were conducted to properly evaluate the structural integrity of the “sand plant fines” silo. In addition, management failed to take necessary follow-up actions to repair or replace components in order to maintain the stability of the structure.

Corrective Action: Management contracted an independent engineering firm to evaluate the existing structure to ensure that prompt corrective actions were taken to restore or replace the “sand plant fines” silo.
