METAL/NONMETAL MINE FATALITY – On May 10, 2016, a 46-year old maintenance man with 6 years of experience was fatally injured at a cement plant. The victim went to the top of the slurry tank to start the rake system. He fell 50 feet through a 3-foot by 4-foot opening in the walkway into the empty slurry tank below.

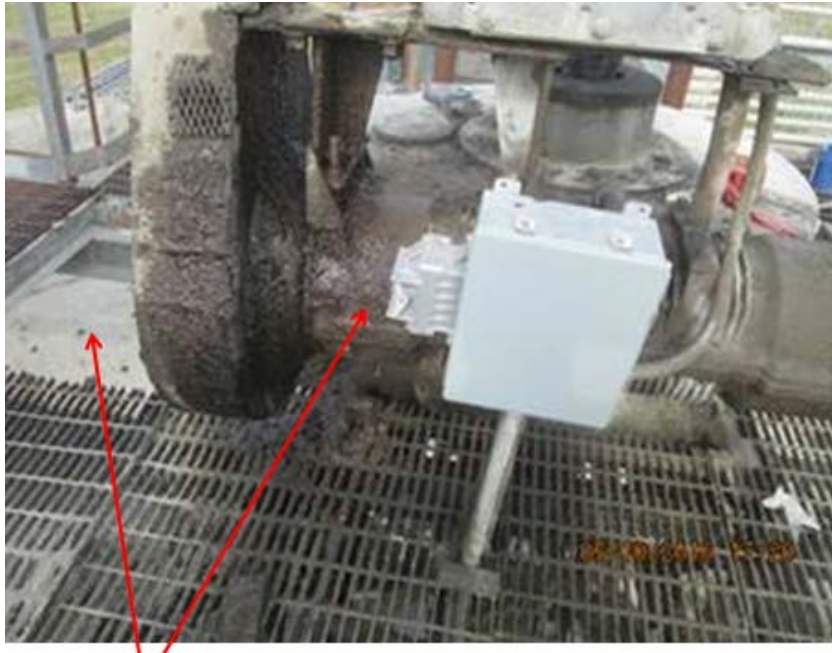
Arrows indicate missing grating and control switch to be used to move rakes

- Protect openings near travelways by installing railings, barriers, or covers.
- Ensure covers or railings protecting temporary access openings are secured in place at all times when an opening is not being used.
- Provide readily visible warning signs that clearly display the nature of the hazard and any protective action required.
- Wear fall protection where there is a danger of falling.
- Establish and discuss safe work procedures. Identify and control all hazards to finish the job safely.
- Train all persons, especially workplace examiners, to recognize and understand safe job procedures before beginning work. Communicate and correct hazards in a timely manner.
