REPORT OF INVESTIGATION

**Fatal Powered Haulage Accident
March 27, 2017**

**Bonito Pit
Black Rock Services
Los Lunas, New Mexico
Mine ID 29-02450**

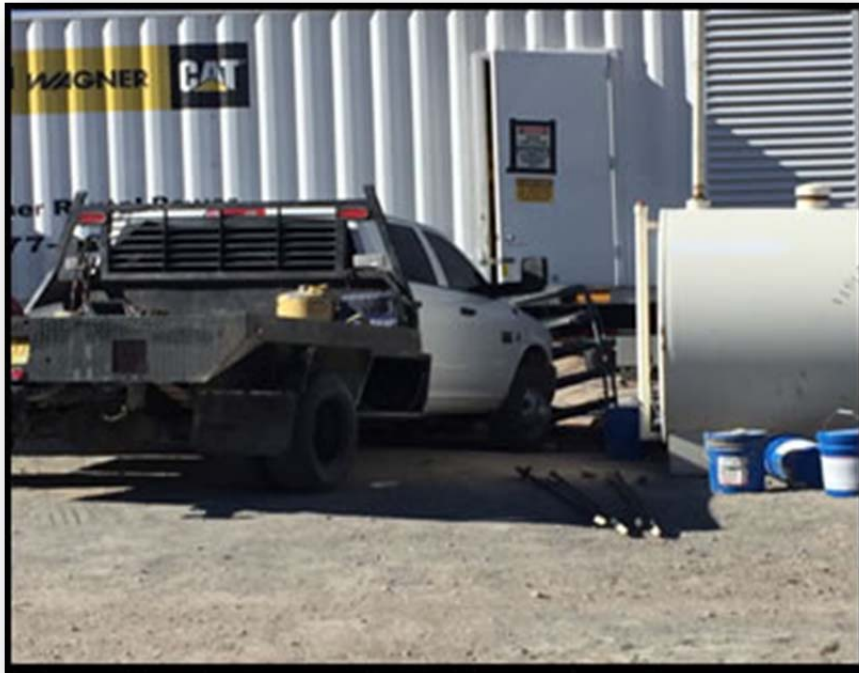
Steve Justice, plant operator, age 53, was fatally injured on March 27, 2017. Justice was outside of the operator's cab of his personal service truck near a generator trailer when the service truck rolled forward and pinned him between the truck and the trailer.

The accident occurred at the generator trailer located on the north side of the crushing plant. The victim's truck was facing south towards the generator trailer. The ground in the area generally sloped north away from the generator trailer, for the exception of the area located approximately 72" from the generator trailer, where the ground was identified to slope south toward the generator trailer at an approximately 16 degrees.

Corrective Action: Management has developed Standard Operating Procedures (SOP) on parking procedures for unattended mobile equipment. Mine management has provided training to all employees on the new SOP and will be including it in their Site-Specific Hazard Awareness Program to address all other vehicular traffic on the mine site.
