PROGRAM POLICY LETTER NO. P11-V-16

SUBJECT: Suitability, Safety and Performance of Circuit Breakers

RECOMMENDED GUIDELINES on REPAIR or REBUILD and MAINTENANCE of CIRCUIT BREAKERS

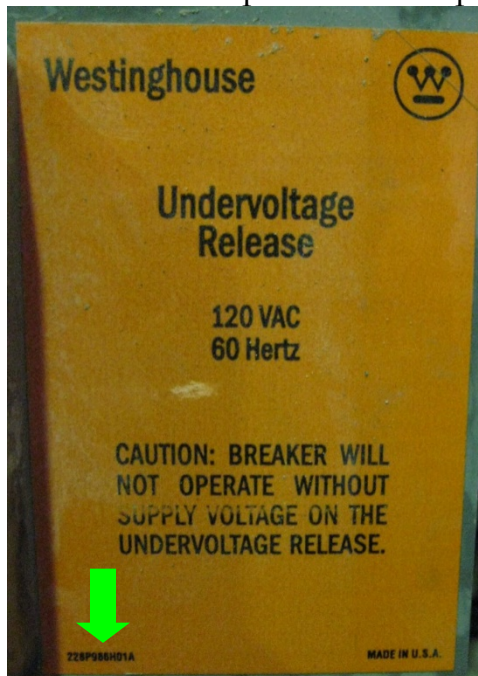
OEM

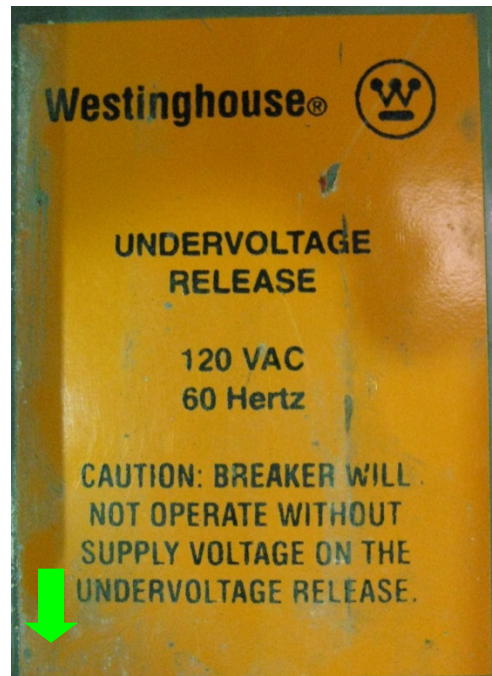
1. Labeling - if visible
 - a. If the circuit breaker has been rebuilt by a third party facility, it should have the name of that rebuild facility attached.
 - b. A new or OEM rebuilt breaker should have OEM labeling. Most OEM labeling can be identified by a label number. Comparison will show lack of a number; different font sizes; layouts not the same; and possible misspellings. OEM labels that have been reproduced may be an indication of problems. See pictures below.

NON-OEM

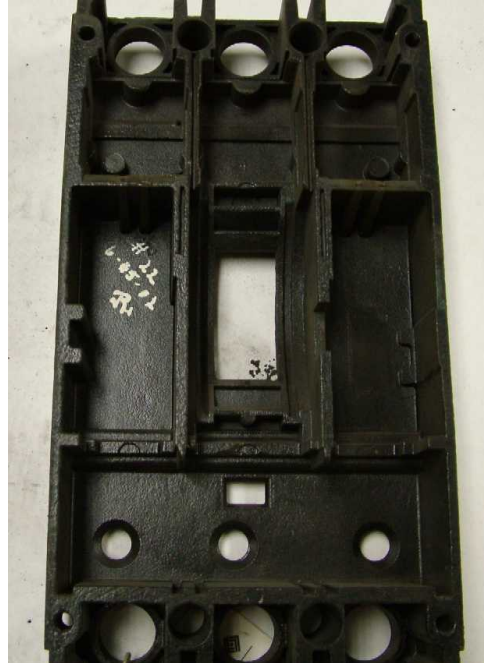
Shot blasting removes resin from the case and may weaken the structure so that it could fail under a catastrophic event inside the breaker, such as an arc blast. This is an indicator for further inspection.

Shot Blasted & Painted

- Cases and components have been found shot blasted as part of the cleaning process. Shot blasting decreases the insulating characteristics of the case and may compromise the physical integrity of the case.

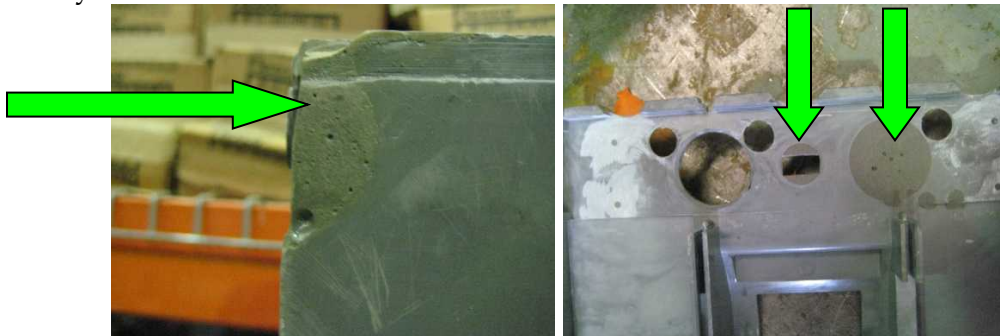
Cases repaired and/or modified using epoxy can be hazardous. A damaged case can be weak enough that an event occurring inside the circuit breaker can cause the case to fail and rupture causing the epoxy to become shrapnel that can injure personnel nearby. The patching material may not be enough to restore the case's strength. Some patching material may be conductive and can cause a shock hazard.

Epoxy Repair to Case Corner

Epoxy Modification to Cover

- Damaged and modified cases have been found repaired with epoxy. Epoxy or other repair materials used for case repair do not have the strength or insulating characteristics of the original material. In the event a circuit breaker has to clear a bolted fault, these areas could give way and allow pieces of the case to become shrapnel. A case that is cracked or is missing pieces should be destroyed and discarded.

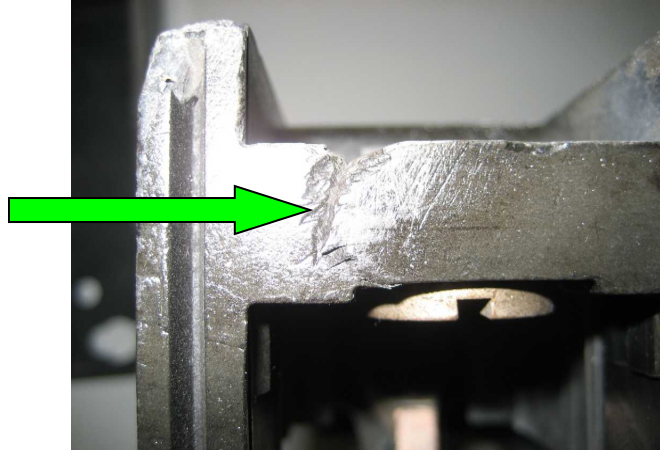
Hairline cracks and broken pieces on the case can present a serious hazard in that they compromise the integrity of the case in the event of a fault. Cracks in the case also compromise the electrical integrity of the circuit breaker and can pose a risk of arcing.

Cracked Case

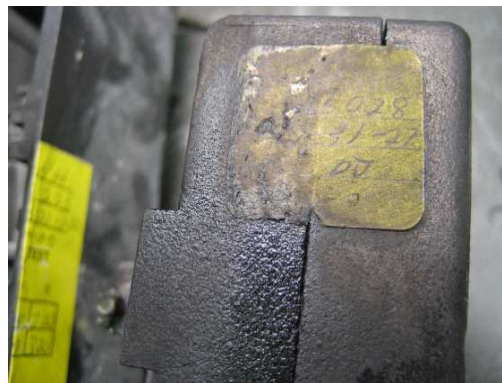
Signs of overheating (such as carbon smears, warped or melted case, and/or burnt areas) are cause for having the mine operator open a circuit breaker for a more in depth inspection or removal from service. These are indicators that the circuit breaker case integrity has been compromised. Signs of overheating are also indicators that the electrical insulation between the phases may have been compromised through carbon tracking.

Bubbled & Charred

- Circuit breaker cases have been found with significant overheating signs. Overheating is an indication that something abnormal is occurring inside the case. This could be the result of a loose connection or a failing contact tip and could lead to a catastrophic failure of the circuit breaker.

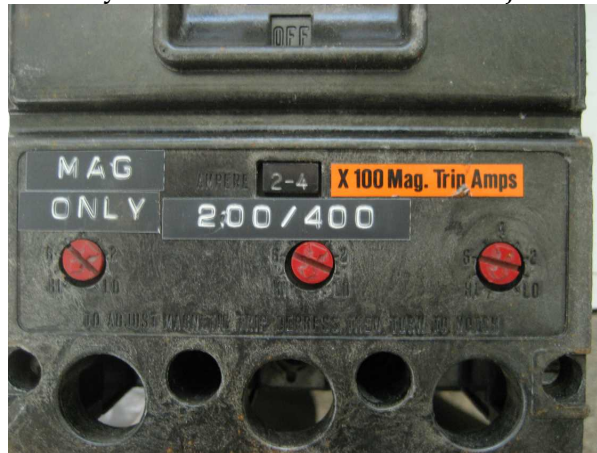
If the circuit breaker trip unit is not properly set, it can cause damage to the cable it is protecting. It also poses the hazards of shock and fire. The trip unit must be visibly identified to ensure it is adjusted correctly.

Settings on High

- Trip unit settings have been found to be set too high. This can cause damage to the cable being protected, as well as posing a risk of electrical shock and fire.

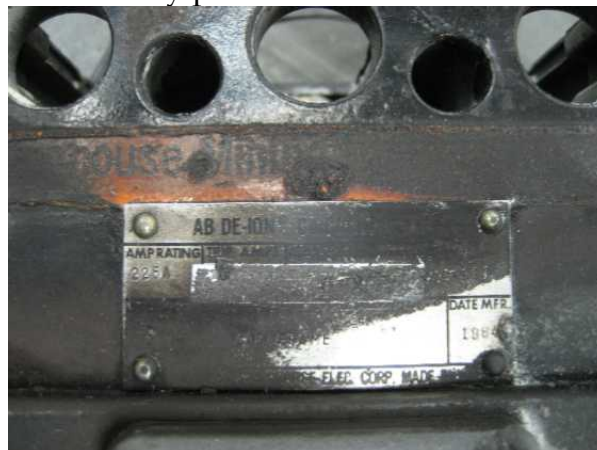
Circuit breakers should not have anything attached to the case, and especially not with metallic fasteners. However, some of the older circuit breakers still in use have metallic ID tags fastened to the outside of the breaker with metal rivets. The metallic plate is an indicator to inspect for insulating material inside the breaker. These rivets must not extend to the inside of the case. If the rivet hole is drilled through, it must be insulated with a suitable dielectric. Failure to follow this requirement could allow a dangerous electric potential to be present on the exterior of the breaker, which could be contacted by personnel.

Metallic Tag (Painted)

- Metallic fixtures have been found attached to a circuit breaker. Anything metallic that has not been designed to be attached to a circuit breaker can become energized and pose an electrical shock hazard.

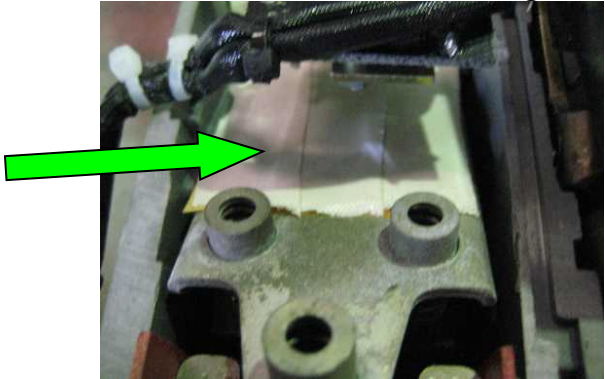
Tape Around Movable Arm

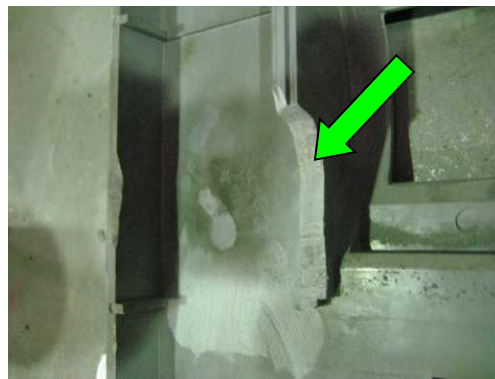
- holes through the outside of the case, except as allowed by the OEM. Example: a hole for wire from an auxiliary switch to pass through from the inside of the case that is no longer used would be allowed
- cut-outs between the phases that compromise the electrical separation
- cut-outs that are not as specified by the OEM for mounting a UVR or other certified component

- the potential for shock due to exposure of a miner to fault current
- arcing between phases
- case failure during an electrical fault

Case Phase Barrier Cut Away

- Internal modifications to the case have been found. An internal modification to the case can weaken its structural integrity. Specifically, modifying the ribs between the phases can cause an internal phase to phase short circuit to occur. Removing material from the sides of the case can prevent the case from containing a fault event and may leave an opening that can pose a shock hazard.

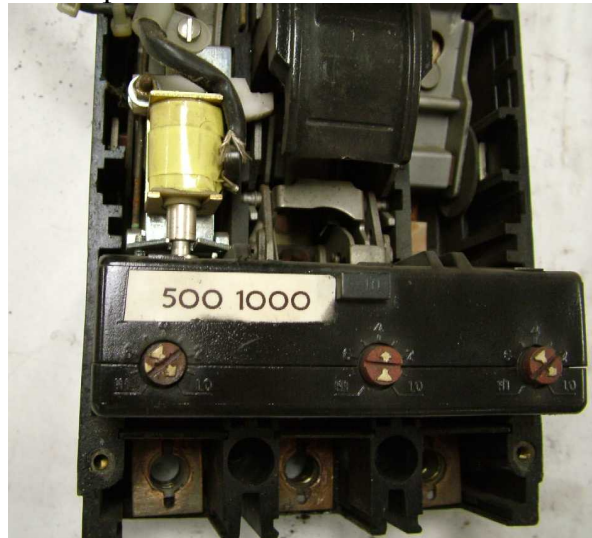
Paint inside the case of a circuit breaker creates at least two hazardous conditions. The first is a change in insulation characteristics of the molded case. Over time, the paint can deteriorate from the heat and ionization that occurs in the circuit breaker. This can lead to carbon tracking between the phases and subsequent phase to phase and/or phase to ground faults. The second hazard is the addition of a potentially flammable component to a plasma ball occurring because of a fault. Be aware, some Westinghouse 1000 volt circuit breakers do have a dielectric coating that resembles paint inside the breaker case and cover.

Painted & Shot Blasted

- Painted circuit breakers have been found in use in the mine. This decreases its insulating characteristics and can become a component of a plasma ball in the event of a catastrophic internal event, such as an arc blast. Painting the components inside of a circuit breaker, such as the arc chutes, have kept the component from performing its function, which allows internal damage to occur during normal operation.

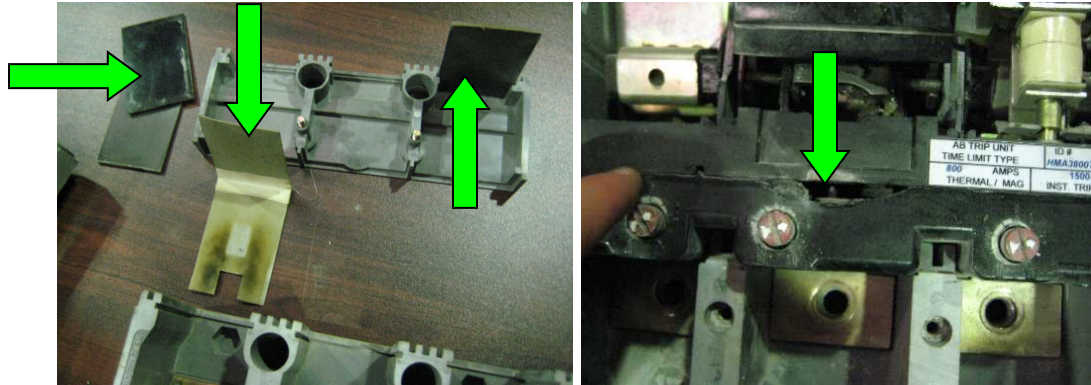
There are removable insulators (fish boards) within the circuit breaker case. If any of the fish boards, (cardboard like tabs around the tips), inserts along side of the reset handle that allow removal of the reset mechanism, or any of the top and/or bottom phase insulators are missing or broken, a short circuit hazard or electrical shock hazard is created. Missing components, such as missing or damaged arc chutes, can pose an arc flash hazard.

Fish Boards

Broken Trip Unit Housing

- Circuit breakers have been found with missing and broken components. Each component inside a circuit breaker has a designed purpose. Certain components prevent electrical shock; other components dampen the arc of a circuit breaker operating under load, or provide insulation that prevents an internal short circuit.

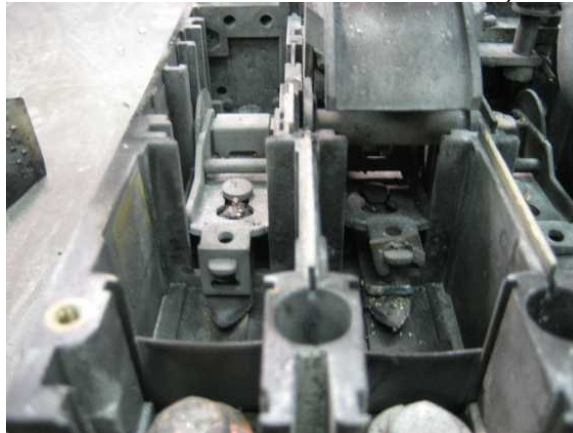
Contact tips used in mining circuit breakers are made of a special alloy that allows the tips to open under load without welding. The use of tips other than those specified by the circuit breaker manufacturer pose a risk of welding under load. The hazard is potentially life threatening and has caused the death of at least one miner and serious injuries to others.

Welded Contact Tips

- Replaced contact tips have been found that were not designed to work in a circuit breaker. The hazard in using contact tips not designed for a circuit breaker is that the tips can weld closed and affect the function of the breaker. This condition was the cause of a fatality.

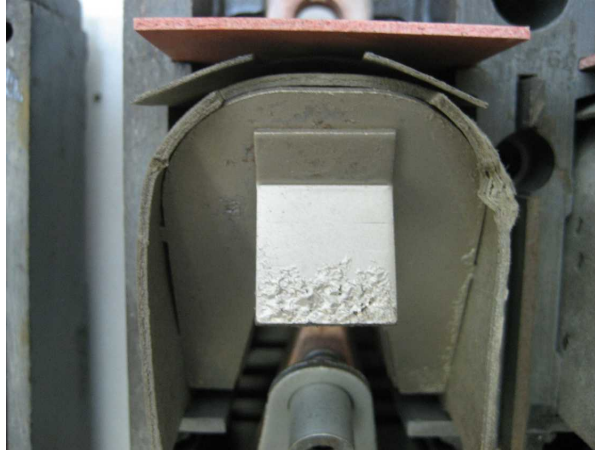
The arc chutes in a circuit breaker are designed to spread and cool the arc that occurs when the tips break. Paint covering the arc chute diminishes or prevents the arc from being extinguished in a controlled manner. In addition, the paint can contribute to the arc's heat and plasma ball. A damaged arc chute can also minimize the effect the arc chute has on extinguishing the arc. An uncontrolled arc can lead to a short circuit event inside the circuit breaker causing an arc explosion.

Painted Arc Chute

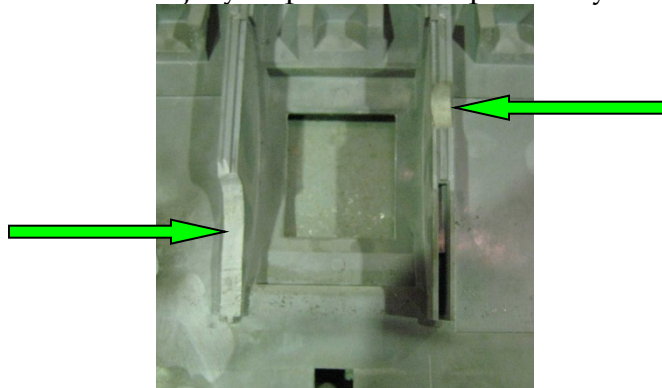
The circuit breaker case is designed to maintain the arc flash, caused by a breaker opening under load, inside the case and to prevent any shorting between the phases. The material of the case between the phases can be compromised through damage, such as cracks or broken pieces, or from modifications not approved by the manufacturer of the circuit breaker. This can cause the case to become weakened enough that it will no longer contain the force it was designed to contain and/or the electrical clearance between the phases could be compromised and allow an arcing short to occur. Either can cause injury to personnel in proximity to the breaker.

Cover Insulation Cut Away

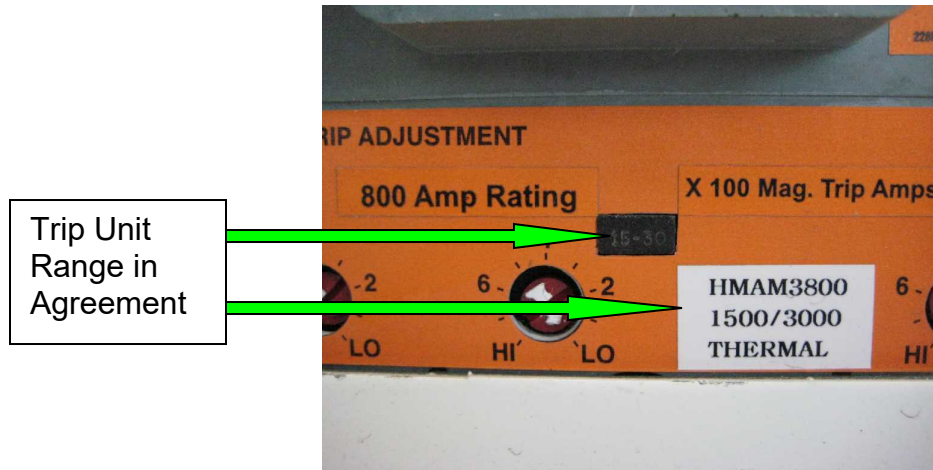
The trip unit must be visibly identified in order to ensure it is adjusted properly to protect the cable attached to the output connector. The identifier must be clearly visible and it must agree with the markings on the trip unit, if it is placed on the outside of breaker case. A trip unit that has had the identification markings removed or the wrong identification attached through human error could allow the cable it is protecting to experience enough current on a fault to generate enough heat to cause a fire.

Trip Unit
Range in
Agreement

Trip Unit ID and Settings

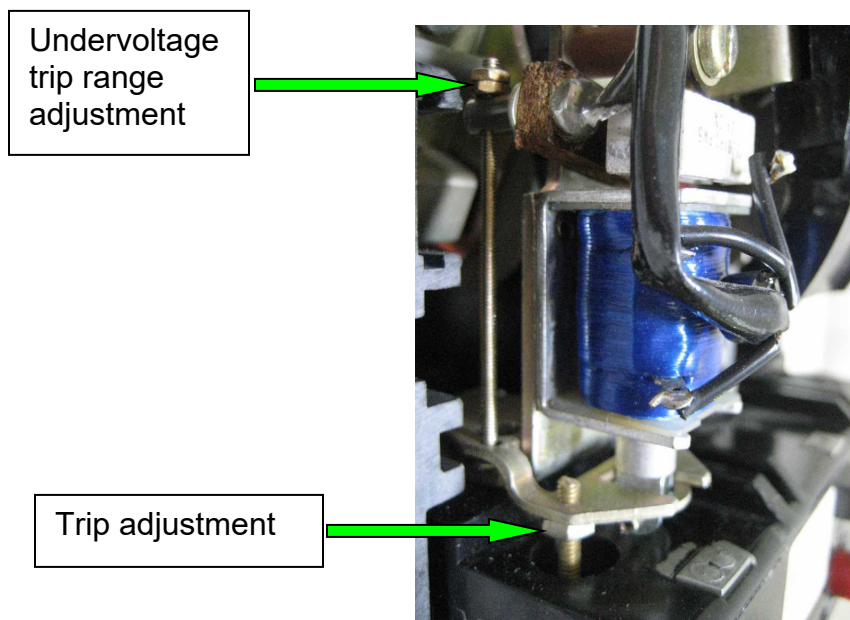
The ground fault, ground wire monitor, and undervoltage protection circuits rely on the undervoltage release relay (UVR). If the relay is damaged or not properly adjusted, these safety circuits cannot operate the breaker. An inoperative UVR poses hazards of injury, fire, and death.

Undervoltage
trip range
adjustment

Trip adjustment

UVR Adjustment Points

- UVRs have been adjusted or blocked to prevent the circuit breaker from tripping. If the UVR cannot perform its function, critical faults will not be cleared. This will cause a dangerous condition that can result in a serious injury or a fatality.
