MNM Fatal 2013-10

- Machinery Accident
- August 5, 2013 (New York)
- Crushed Stone Mine
- Plant Operator
- 55 years old
- 5 years of experience

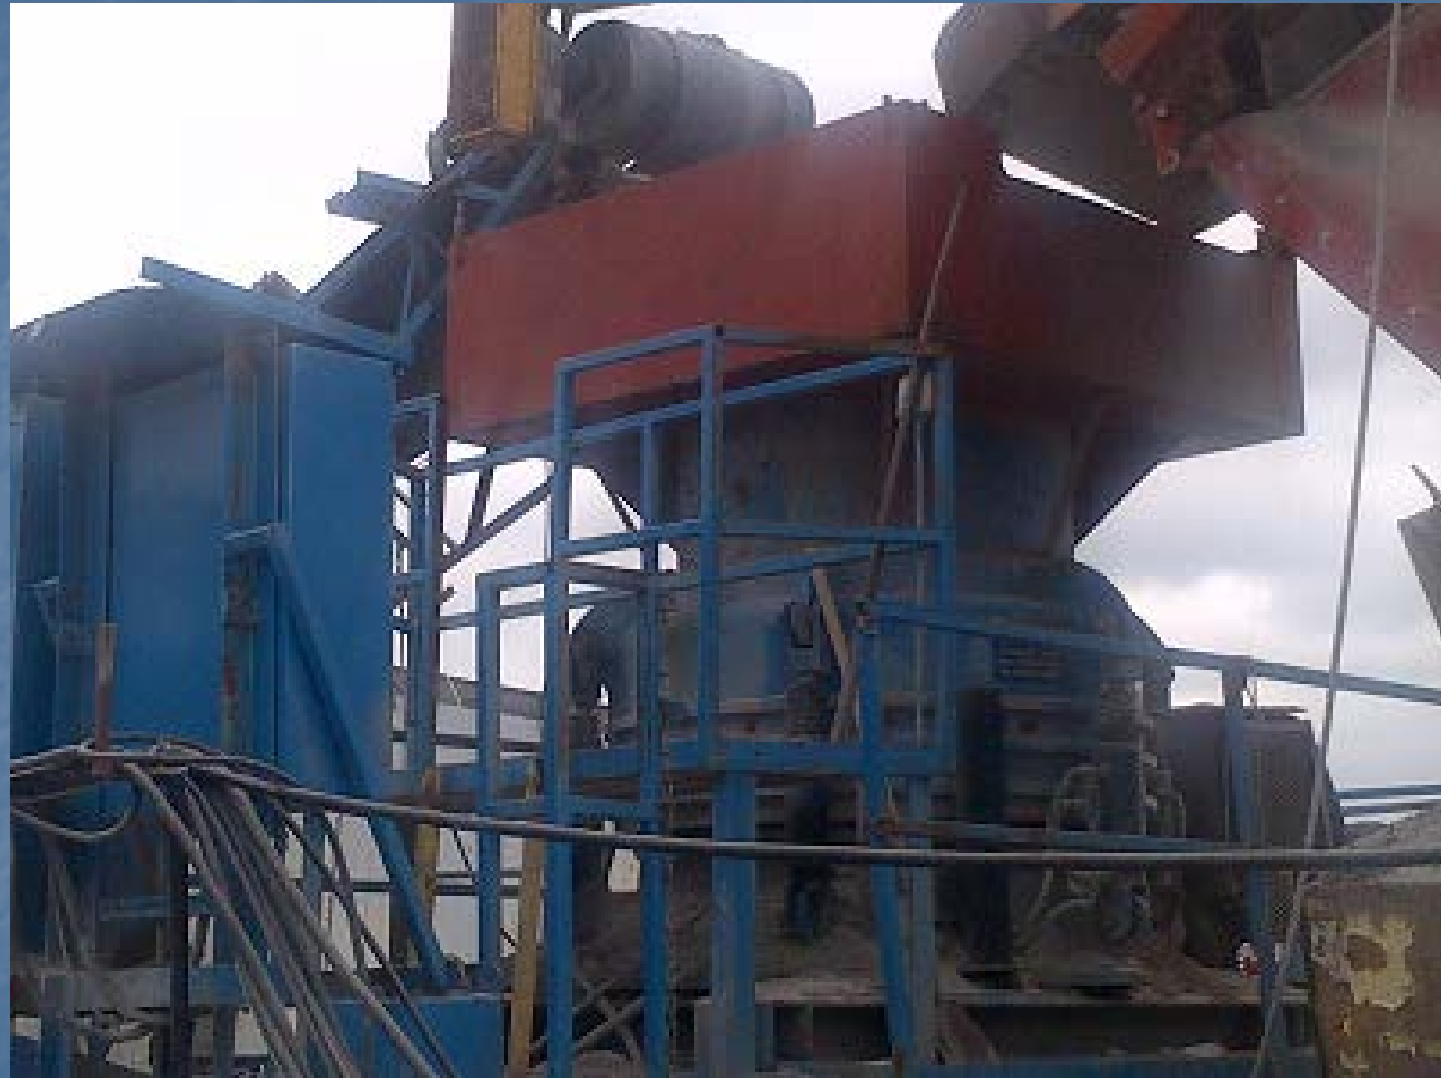
The victim was killed while standing near an operating cone crusher. When he looked into the cone crusher, a tooth, that had broken free from an excavator bucket, was ejected from the cone crusher and struck him.

The accident occurred due to management's failure to establish and implement policies and procedures to safely clear a cone crusher. There were no policies or procedures which should have included provisions to deenergize and lock out the power source; and block the cone crusher against hazardous motion. The cone crusher was not equipped with a guard, shield, or other device to protect miners from flying/falling materials created by its operation. Additionally, the victim did not receive task training addressing safe work procedures for clearing or dislodging material in a cone crusher and the potential hazards associated with the task.

- **Corrective Action:** Management has established written policies and safe work procedures to lock out, tag out, and block equipment against motion prior to any work being performed. The miners were trained in the new policies and procedures.

- **Corrective Action:** Management installed guarding around the crusher feed hopper to protect miners and established policies and procedures to maintain the guarding.

- **Corrective Action:** Management established written policies and safe work procedures for safely clearing and dislodging material to ensure that miners stayed clear of the operating cone crusher. The new procedures incorporate the manufacturer's recommendations for cleaning/dislodging material. Miners were trained in the new policies and procedures.
