UNITED STATES
DEPARTMENT OF LABOR
MINE SAFETY AND HEALTH ADMINISTRATION

REPORT OF INVESTIGATION

Fatal Powered Haulage Accident
May 2, 2023

Plant 280
Bowes Construction Inc
Brookings, Brookings County, South Dakota
ID No. 39-01505

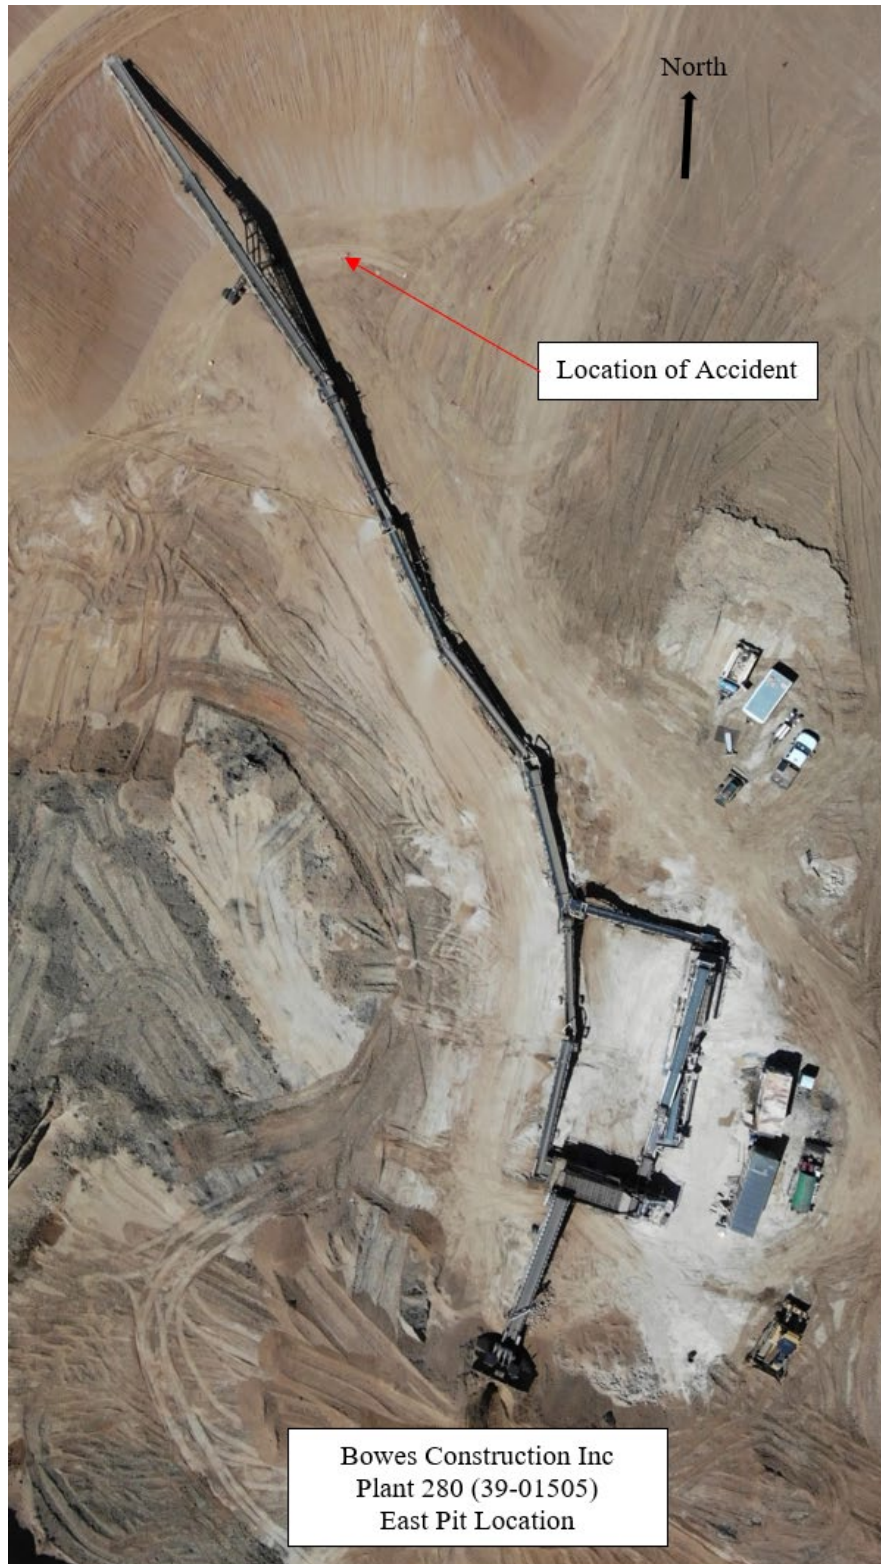
APPENDIX B – Aerial View of Plant Where the Accident Occurred

The accident occurred at the plant's radial stacker, located on the north end of the mine (see Appendix B). Interviews revealed that Waddel found Wixon with a crushed can of penetrating oil at his side. A pattern of oily residue distributed throughout the left side radial axle restricted access area indicates the location of the accident (see Appendix C). The manufacturer designed the area to allow miners to have access to the controls for the hydraulic jacking cylinders while the radial stacker was not in motion. The radial axle support, the left radial axle arm, the undercarriage, and the left radial arm locking bar enclose the left side radial drive access area, with no signage or conspicuous markings to warn against entry into this area when the equipment is operating. To travel into the area, a miner must step on or over the left radial arm locking bar which is approximately eight feet long and 19 inches above grade.
