REPORT OF INVESTIGATION

Surface  
(Crushed and Broken Stone)

Fatal Slip or Fall of Person Accident  
June 8, 2023

N Attleboro Plant  
Boro Sand & Stone Corp  
North Attleboro, Bristol County, Massachusetts  
ID No. 19-00290

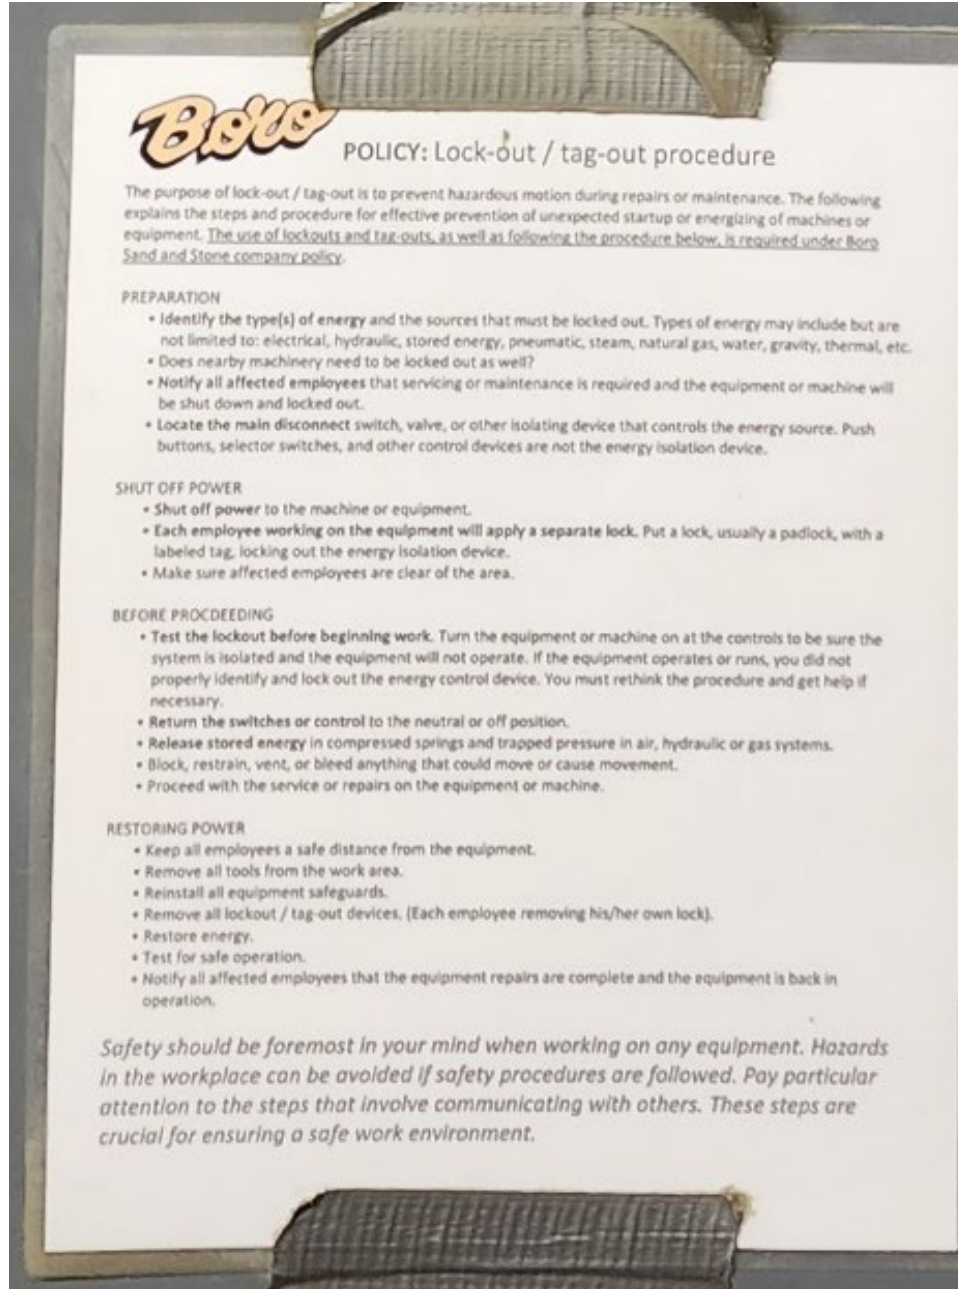
## APPENDIX D – N Attleboro Plant Lock-Out/Tag-Out Procedure

The disconnect panel for the Eriez Magnet Belt Conveyor, located in the electrical room, had the mine's lock-out, tag-out procedure posted on it (see Appendices C and D), and a lock and tag was available for use. Investigators determined that Ayick shut down the Return Belt Conveyor and the No. 2 Belt Conveyor but did not shut down the Eriez Magnet Belt Conveyor and did not lock-out and tag-out the disconnect. The mine operator did not ensure the belt conveyor was de-energized and blocked against hazardous motion before Ayick performed maintenance, which contributed to the accident.

Corrective Action: The mine operator retrained all miners in 1) blocking machinery and tools against hazardous motion during maintenance and repairs, and 2) lock-out tag-out procedures.
