Refuge Alternative Examinations, Approvals, and Refits

Stakeholder Meeting-MSHA HQ
June 27, 2012

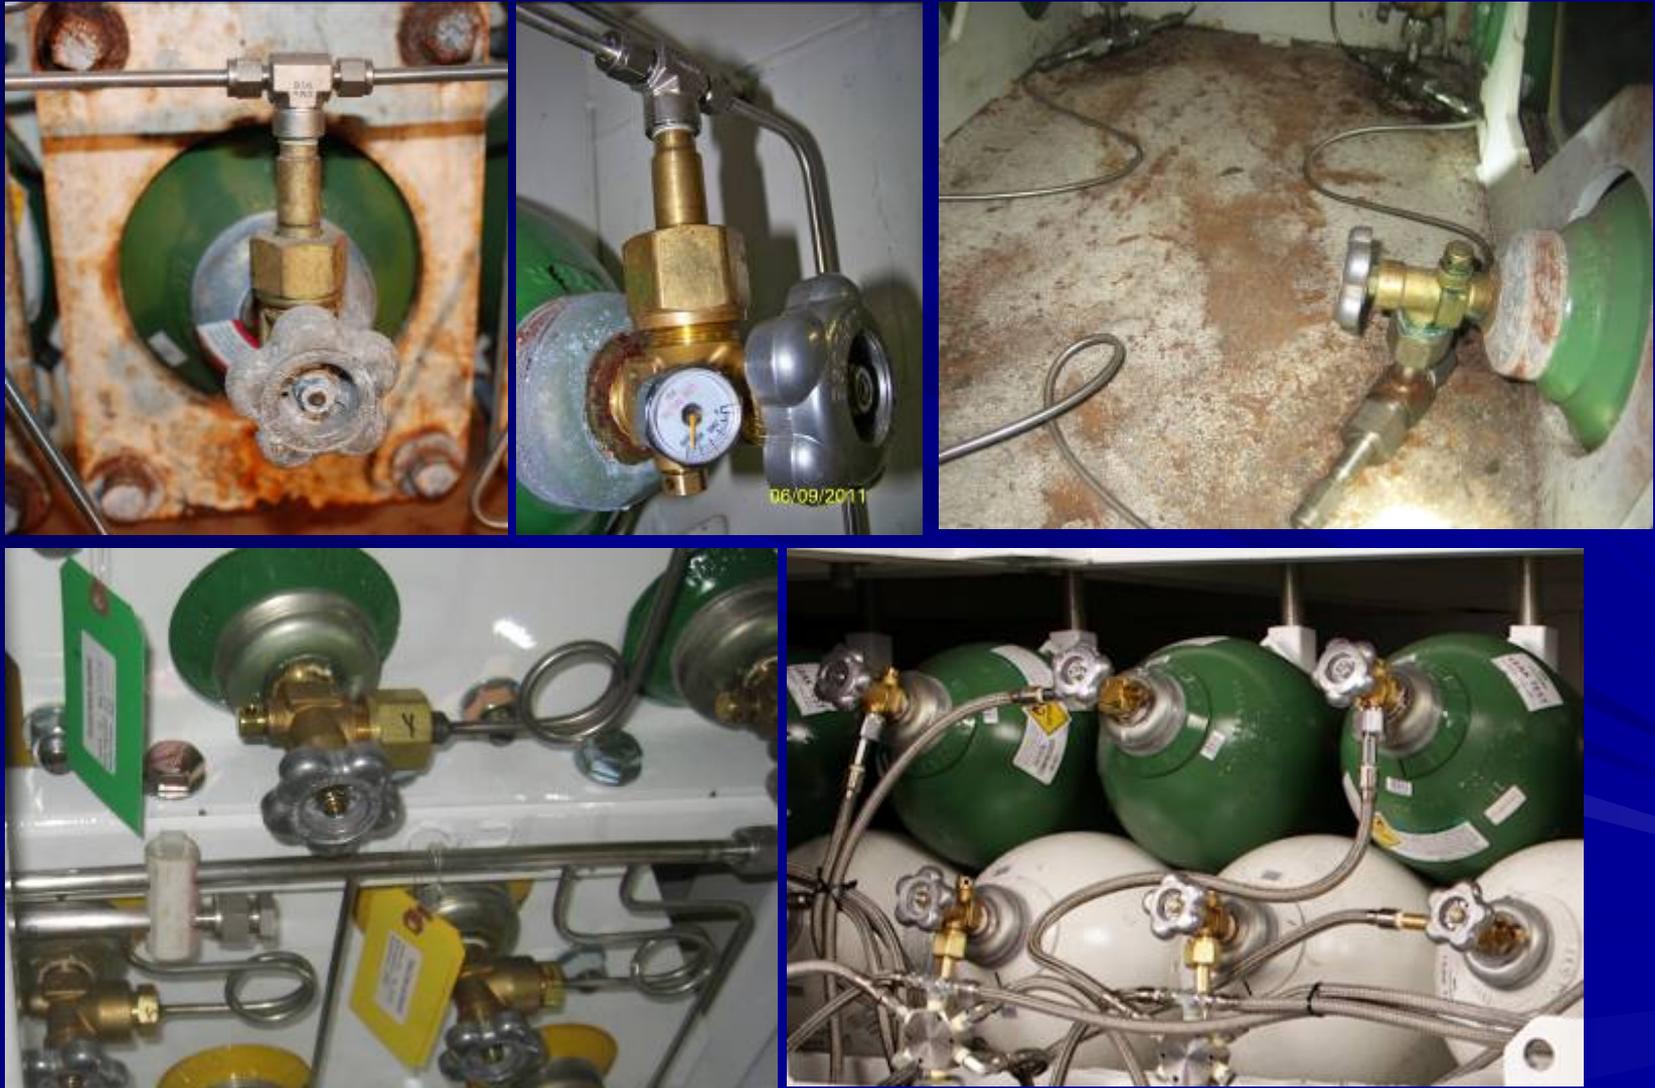
Views of Various Valve and Cylinder Arrangements Showing Differing Examination Access

Different methods and tools may need to be employed
