Coal Mine Fatal Accident 2003-22

Operator:	Warrior Coal LLC
Mine:	Cardinal Mine
Accident Date:	August 20, 2003
Classification:	Roof Fall
Location:	District10, Hopkins Co., Kentucky
Mine Type:	Underground
Employment:	220
Production	14,400 tons/day

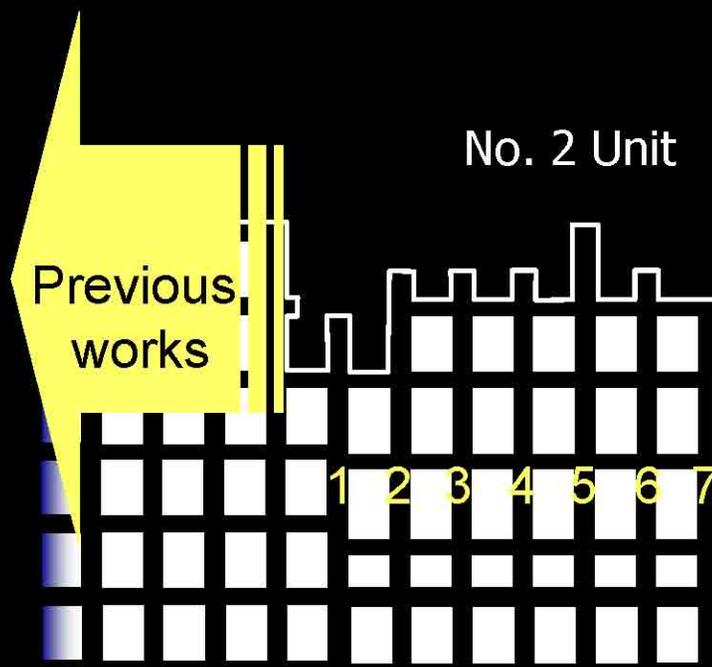
- The unit foreman entered the mine with his crew at 7:00 a.m. and arrived on the No. 2 Unit around 7:20 a.m.
- Production began at 7:30 a.m. and the shift proceeded normally.
- At approximately 1:40 p.m., the continuous mining machine finished extracting coal from the crosscut to the right of the No. 6 entry.
