## Coal Mine Fatal Accident 2004-21

Operator:	Jeddo Coal Company
Mine:	Jeddo No. 8 Preparation Plant
Accident Date:	October 1, 2004
Classification:	Powered Haulage
Location:	District 1, Luzerne County, PA
Mine Type:	Surface
Employment:	14
Production	1500 Tons/Day

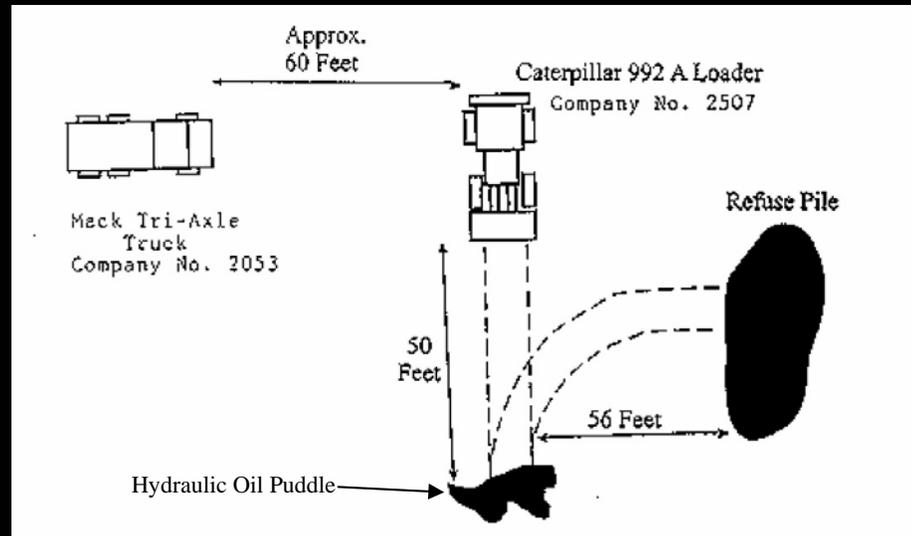
On Friday, October 1, 2004, a 51-year old front-end loader operator was loading Co-Gen material into a Mack tri-axle truck and dumping Co-Gen refuse rock on a refuse pile. As he drove the loader toward the refuse stockpile the truck driver noticed oil spraying between the operator's cab and the engine compartment of the loader. The truck driver called the loader operator on the radio and said, "... you got a big oil leak. Shut down."

The loader operator continued to the refuse stockpile, dumped the material out of the bucket, backed the loader up 56 feet, turned the loader to the left and drove 50 feet. As he stopped the loader, the oil ignited. The fire was located between the operator's cab and the engine compartment. Co-workers used seven fire extinguishers to extinguish the fire but the victim was unable to escape the cab.

*Causal Factor:* A steering hose, whose length was longer than the manufacturer's specifications, came in contact with other components of the loader resulting in abrasion and eventual failure of the hose. Hydraulic oil sprayed from this hose at the point of the abrasion.

The steering hose failed, which allowed hydraulic oil to contact the turbocharger/exhaust manifold, resulting in a fatal fire on the front-end loader. The hose failed due to external abrasion caused by contact with other components of the loader.

*Corrective Actions:* A procedure has been established to assure that when machinery is purchased, a competent person thoroughly inspects, examines and tests the machine to assure that its components and systems conform with the manufacturer's specifications. Any deficiencies will be corrected before the machine is put into operation. The company has incorporated this policy into their safety program and the same policy will be reviewed annually during refresher training.

- Reduce or eliminate the potential for hydraulic fluid discharging through hose failures onto hot engine components by installing a solid shroud or shield to deflect hydraulic fluid away from these hot surfaces.
- Ensure that adequate pre-operational checks on mobile equipment are performed and that all defects affecting safety are recorded and reported. Such defects must be corrected before the equipment is used.
- Thoroughly examine all hoses, fittings, and gaskets and replace according to manufacturer's recommendations.
- Take equipment out of service immediately if a hazardous fluid leakage is observed.
- Install a fire suppression system on all mobile equipment to increase the likelihood of a safe escape should a fire develop.
