Coal Mine Fatal Accident 2005-06

Operator:	The Pittsburg & Midway Coal Mining Co.
Mine:	North River #1 Underground Mine
Accident Date:	June 1, 2005
Classification:	Powered Haulage
Location:	Dist. 11, Tuscaloosa County, AL
Mine Type:	Underground
Employment:	360
Production:	3.5 million tons/year

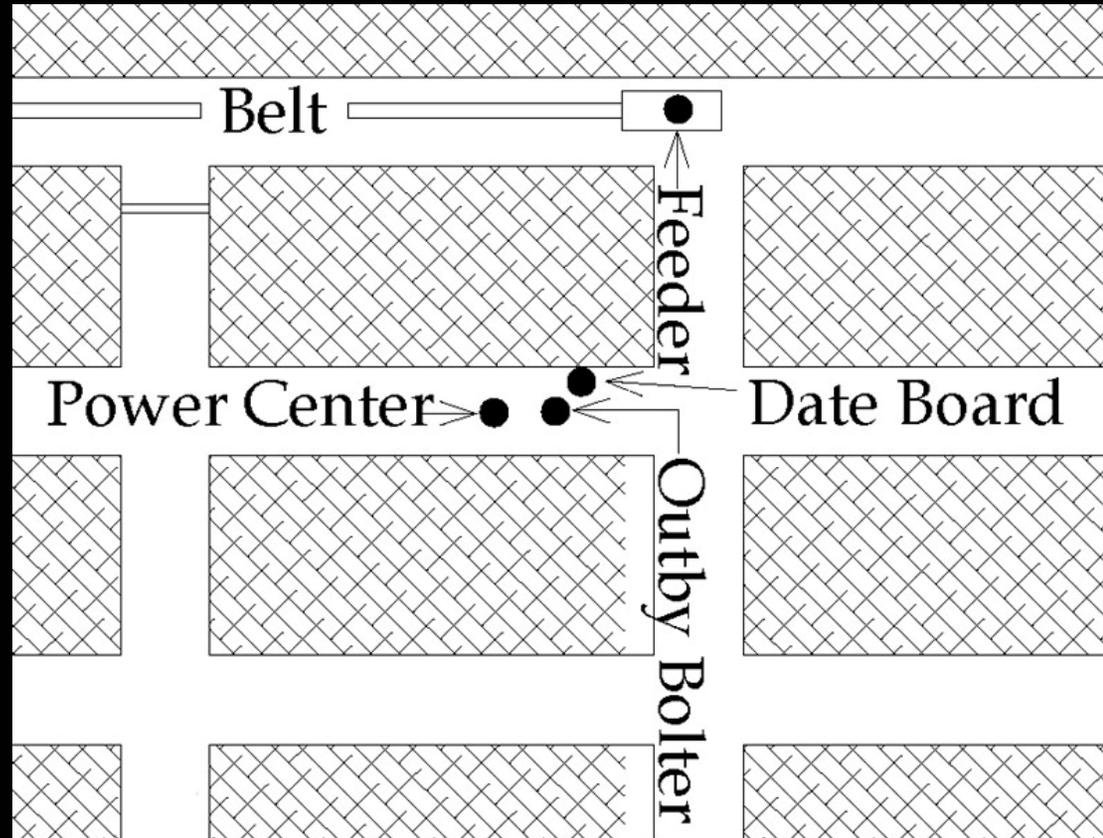
On Wednesday, June 1, 2005, a 42-year old electrician (victim) was assigned as section electrician. After arriving at the section, he talked to the section foreman about repairs to the outby roof bolting machine. He then walked to the power center and closed the circuit breakers to energize the section equipment.

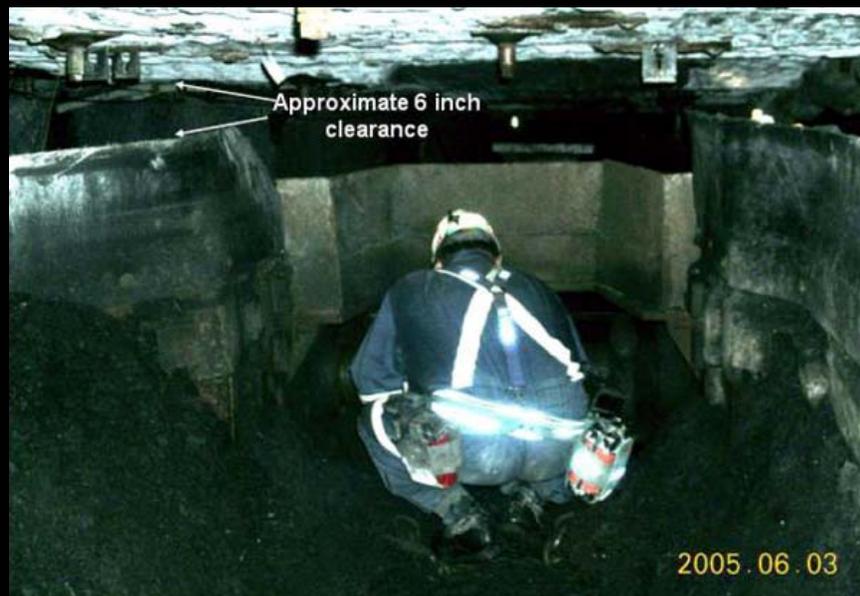
A §104(a) Citation was issued to the Pittsburgh & Midway Coal Mining Company, North River #1 Underground Mine, for a violation of §75.1725(c). A fatal accident occurred on June 1, 2005. The results of the investigation revealed that power was not removed and the machine was not blocked against motion prior to maintenance or repair on the Oldenburg Stamler Feeder, serial number 13713, located on the West 2 section.
