Coal Mine Fatal Accident 2006-18

Operator:	Long Branch Energy
Mine:	#18 Tunnel Mine
Accident Date:	February 1, 2006
Classification:	Fall of Rib
Location:	Dist. 4, Boone County, West Virginia
Mine Type:	Underground Coal Mine
Employment:	61
Production:	1,027 Tons/Day

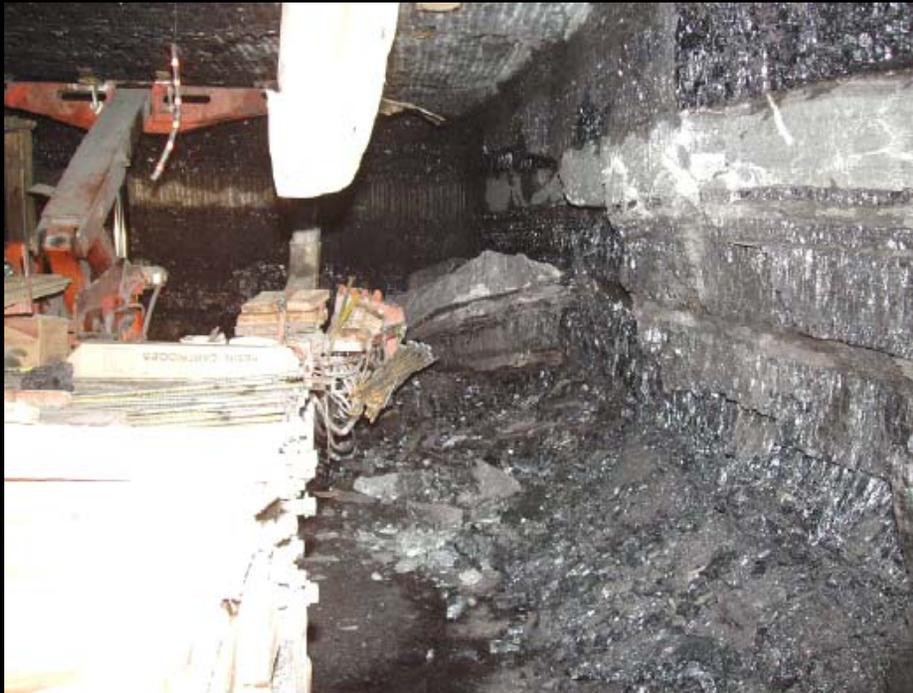
At approximately 12:40 p.m. on Wednesday, February 1, 2006, a 46-year old roof bolting machine operator was fatally injured from a rib roll which occurred in the number five entry of the 4 Left Mains section.

As the roof bolting machine operator was preparing to drill a hole in the mine roof to install permanent roof support, a large portion of the right rib fell, pinning the victim. The rib material which fell from the right rib of the number five entry measured: 13 feet long, 7 to 16 inches thick and 40 inches tall. The material fell from the rib from a height of approximately seven feet. When the rib material began to fall, the victim was positioned approximately 30 inches from the coal rib.

Causal Factor: The operator's procedures for controlling loose ribs did not ensure compliance with the approved roof control plan for protecting persons from hazards associated with falls of ribs. The practice of allowing loose rib material to fall prior to the installation of additional support resulted in twelve persons injured from rib rolls during the previous four year period. The current roof control plan required, "where loose ribs are encountered in active working areas, the loose rib will be removed or supported by the following methods: rib boards, metal straps, or plates, or timbers, or angled bolts, or mats or mesh."

Causal Factor: The approved roof control plan failed to address the increased overburden pressure which caused the severe rib control problems. The overburden depth of the active section was in excess of 1,100 feet. In addition, overmining in the No. 2 Gas seam concentrated the overburden stress on the active mining section.

Causal Factor: The roof bolting equipment provided by the mine operator was not suitable for mining conditions. The procedures for using the 4 Left Mains section roof bolting machine positioned the roof bolting machine operator between the machine and the hazardous rib conditions.

Corrective Action: The roof control plan was revised to require the installation of rib bolts installed on four foot maximum spacing on cycle as each row of roof bolts is installed when the mining height is greater than six feet and the overburden thickness is 800 feet or greater. Rib bolts will also be installed when the overburden is less than 800 feet and barrier pillars larger than 1,200 square feet are present in the Campbell's Creek Seam mine above. Miners received training on the roof control plan to ensure that that rib control precautions are implemented.

- Examine roof and ribs frequently during work assignments.
- Where needed, active rib supports (bolts) should be installed instead of passive roof supports (posts or jacks).
- Ensure that roof and rib control methods are adequate for the depth of cover and for the potential effects of any mines above or below active workings.
- Roof control plans should be frequently reviewed and revised to adjust for changing conditions.
