Coal Mine Fatal Accident 2006-23

Operator:	Jacob Mining Company LLC
Mine:	No. 1 Mine
Accident Date:	April 7, 2006
Classification:	Powered Haulage
Location:	Dist. 4, Mingo County, West Virginia
Mine Type:	Underground Coal Mine
Employment:	45
Production:	3,500 Tons/Day

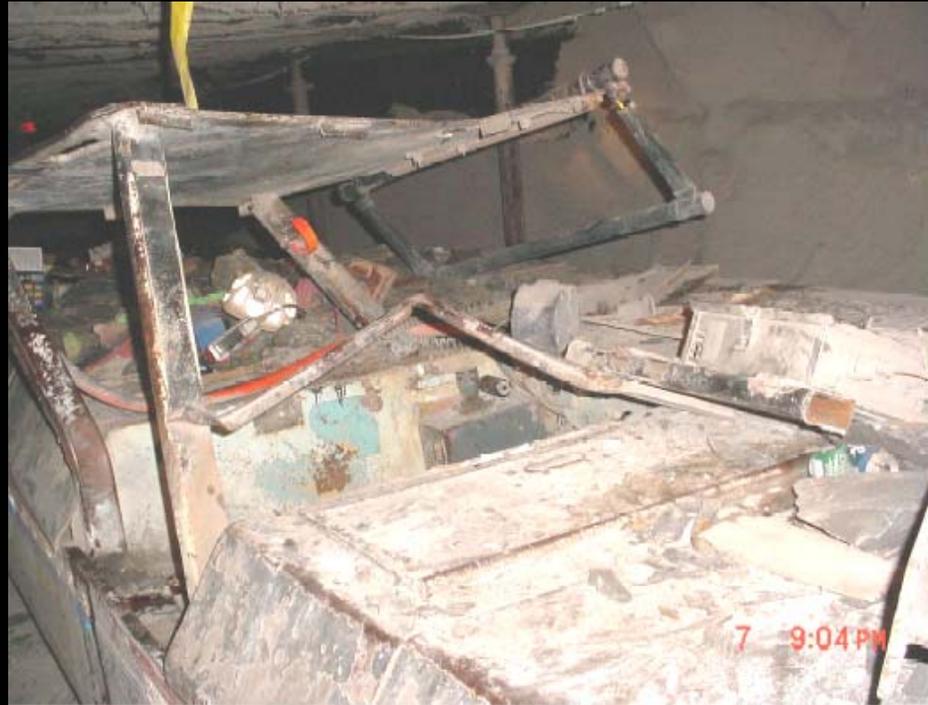
At approximately 2:15 p.m. on Friday, April 7, 2006, a 48-year-old superintendent, was fatally injured in a powered haulage accident. The accident occurred as the victim was operating a 14-ton locomotive between the Toms Branch Switch and the North Marrowbone Creek Portal. As the locomotive traveled along the mine track, the victim was struck by a 4-inch thick steel crossbar (I-beam) when it entered the operator's cab. The steel I-beam crossbar, intended as roof support, was dislodged and hanging from the mine roof.

Causal Factor: Jacob Mining Company LLC and Southern WV Resources LLC did not ensure compliance with the written procedures for installing roof support in road ways, as approved in the roof control plan. The approved roof control plan requires, "where crossbars are installed along haulage roadways they shall be provided with a means to prevent the crossbar from falling in the event the supporting legs are accidentally dislodged." This provision was not complied with at the accident site. Additionally, 138 additional steel crossbars were improperly installed from the Marrowbone Creek Switch to the Number 8 Belt Head.

Corrective Action: Page 6, Item 11 of the roof control plan was revised to require an examination by a certified foreman of all additional roof support. The examination must be conducted on the next preshift examination following the installation of the support. The foreman shall further verify that the crossbars have been properly secured and a record of the observation will be maintained in the preshift or on-shift examination record. The mine operator trained all employees on the revised provision of the roof control plan.
