Coal Mine Fatal Accident 2006-38

Operator:	Consolidation Coal Company
Mine:	Buchanan Mine #1
Contractor:	Nichols Construction LLC (PZF)
Accident Date:	May 4, 2006
Classification:	Electrical
Location:	Dist. 5, Buchanan County, Virginia
Mine Type:	Underground Coal Mine
Employment:	503
Production:	18,000 Tons/Day

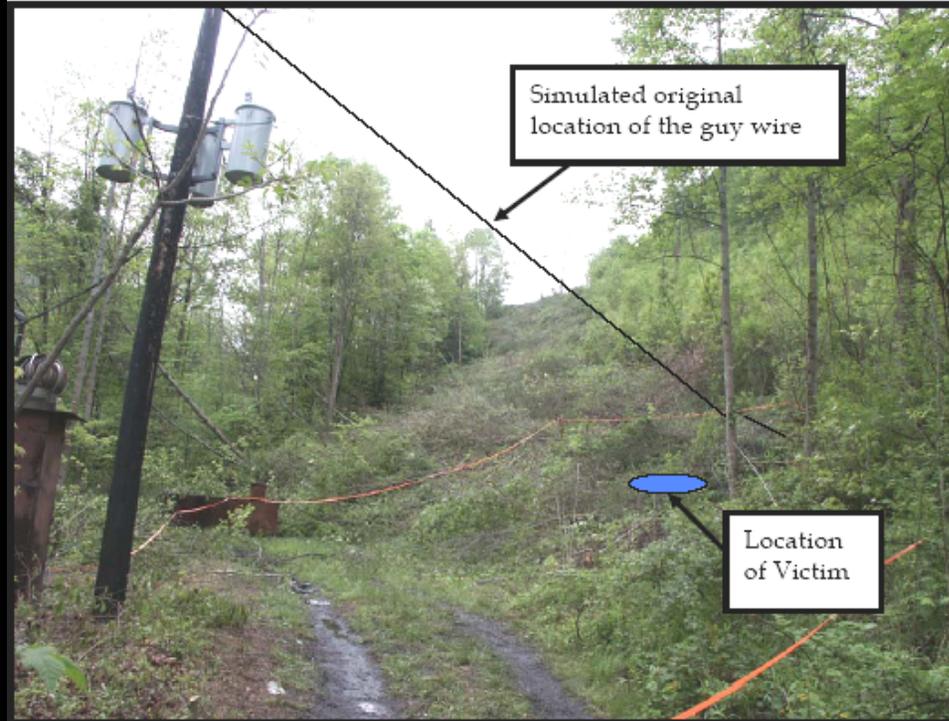
On Thursday, May 4, 2006, at approximately 1:00 p.m., a 40 year old Tree Trimmer/Equipment Operator with two and one-half years mining experience, was electrocuted while trimming brush along a power line that feeds power to a 480 volt bank of transformers. The victim came in contact with a guy wire that had become energized when the base of the guy wire came loose from the log it was wrapped around and the guy wire contacted one or more phases of 12,470 volts.

Root Cause: Management failed to ensure that the guy wire was securely anchored and provided with insulators or connected to the system ground. An adequate procedure or practice was not in place to ensure that electrical equipment, components and structures were properly installed and maintained.

“The monthly examination of the entire electrical installation including the starter/contacter box for the well pump at the Permac site of the Buchanan Preparation Plant was inadequate. The power pole supporting the bank of transformers for the electrical controls to the well pump was not maintained to assure safe operating conditions, in that, the guy wire was not grounded or insulated and was not adequately anchored.”

Corrective Action: The guy wire at the accident scene was removed. The company has undertaken an inspection of all power lines and supporting infrastructure on mine property to ensure they are maintained in safe operating condition.

- Connect guy wires securely to the system ground, and/or properly install insulators to protect miners in the event of a breakage.
- Anchor guy wires where they will not be contacted by vehicles and equipment or be disturbed by maintenance personnel.
- Examine areas surrounding electrical installations for potential hazards before beginning any work, including trimming weeds and brush.
- Mark guy wire anchor points for easy identification.
