REPORT OF INVESTIGATION

Fatal Methane Explosion

October 23, 2006

R&D Coal Company, Inc. Mine
R&D Coal Company, Inc.
Lincoln, Schuylkill County, PA.
ID No. 36-02053

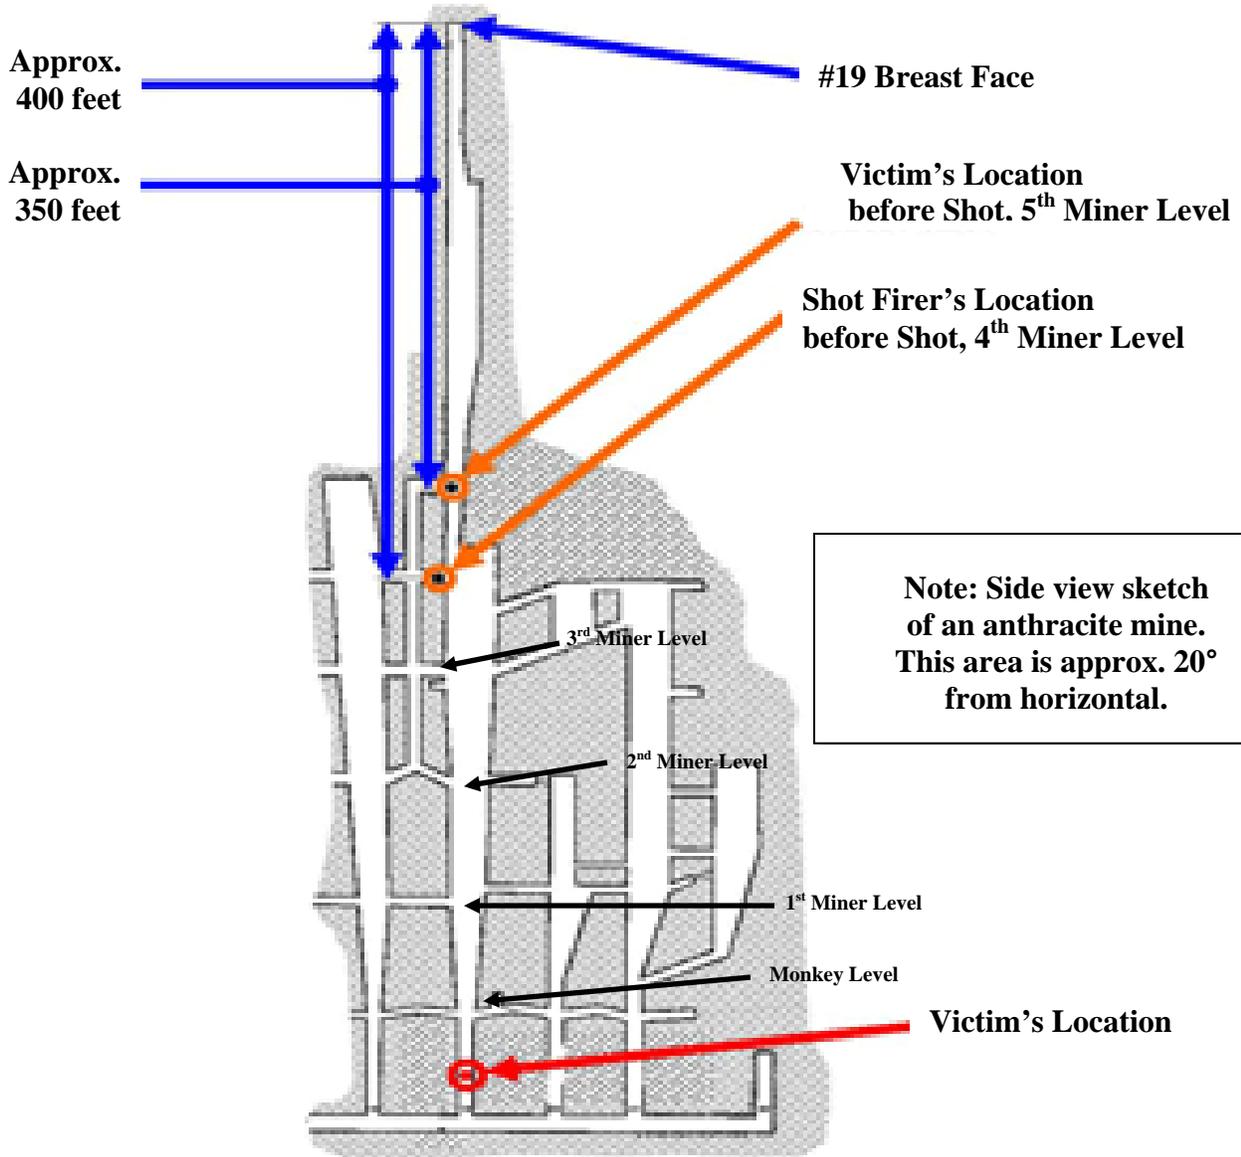
PROFILE SKETCH of ACCIDENT SCENE

On Monday, October 23, 2006, a 43-year old miner was fatally injured when a methane explosion occurred, initiated during an explosives detonation, in the #19 breast on the east side of the mine. The victim, Dale Reightler, was located in the manway of the #19 breast in the vicinity of the 5th miner heading when the explosion occurred. (See preceding sketch and Appendix C). Jeff Klinger, miner, located in the 4th miner heading off the #19 breast, had just fired the working face of the #19 breast when the explosion occurred.
