Coal Mine Fatal Accident 2007-08

Operator:	Twin Pines Coal Company Inc.
Mine:	Mine #2, #3, #4
Accident Date:	July 2, 2007
Classification:	Powered Haulage
Location:	Dist. 11, Cullman County, Alabama
Mine Type:	Surface Coal Mine
Employment:	66
Production:	50,000 clean tons/month

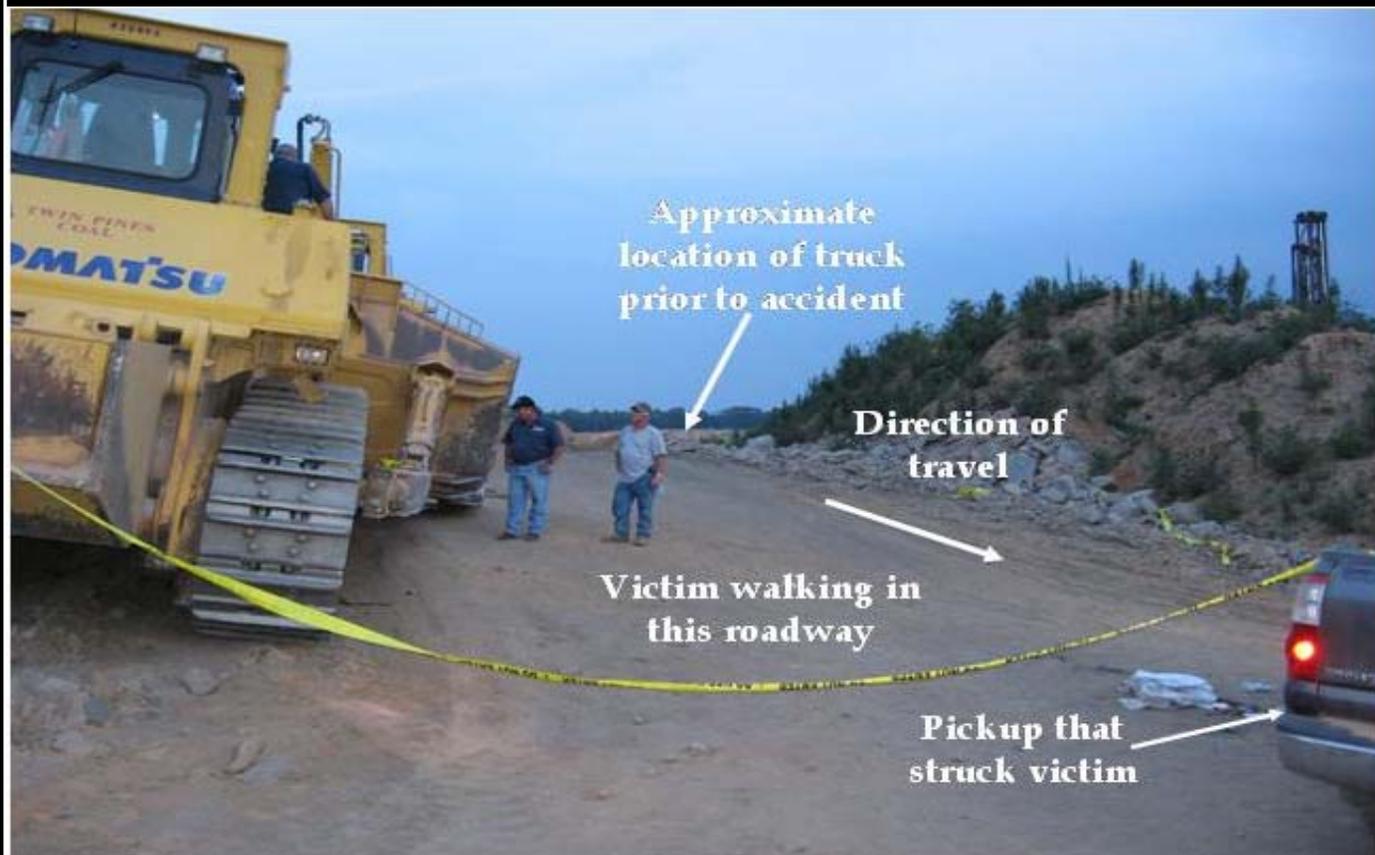
The bulldozers were parked in a line along the drill ground access road (see picture). The pit foreman drove up to the three operators and instructed them to move their bulldozers to an area across the entrance road in preparation for a highwall shot. The victim was walking back to his bulldozer when the foreman, who was using only the side view mirrors of the pickup truck, backed over him. The accident occurred because all available means (looking over the driver's shoulder and using the inside rearview mirror) were not used to assure that it was safe to operate the truck in a reverse direction.
