**UNITED STATES  
DEPARTMENT OF LABOR  
MINE SAFETY AND HEALTH ADMINISTRATION  
COAL MINE SAFETY AND HEALTH**

**REPORT OF INVESTIGATION  
Underground Coal Mine  
Fatal Handling Material Accident  
January 6, 2007**

**Elk Creek Mine  
Oxbow Mining, LLC  
Somerset, Gunnison County, Colorado  
ID No. 05-04674**

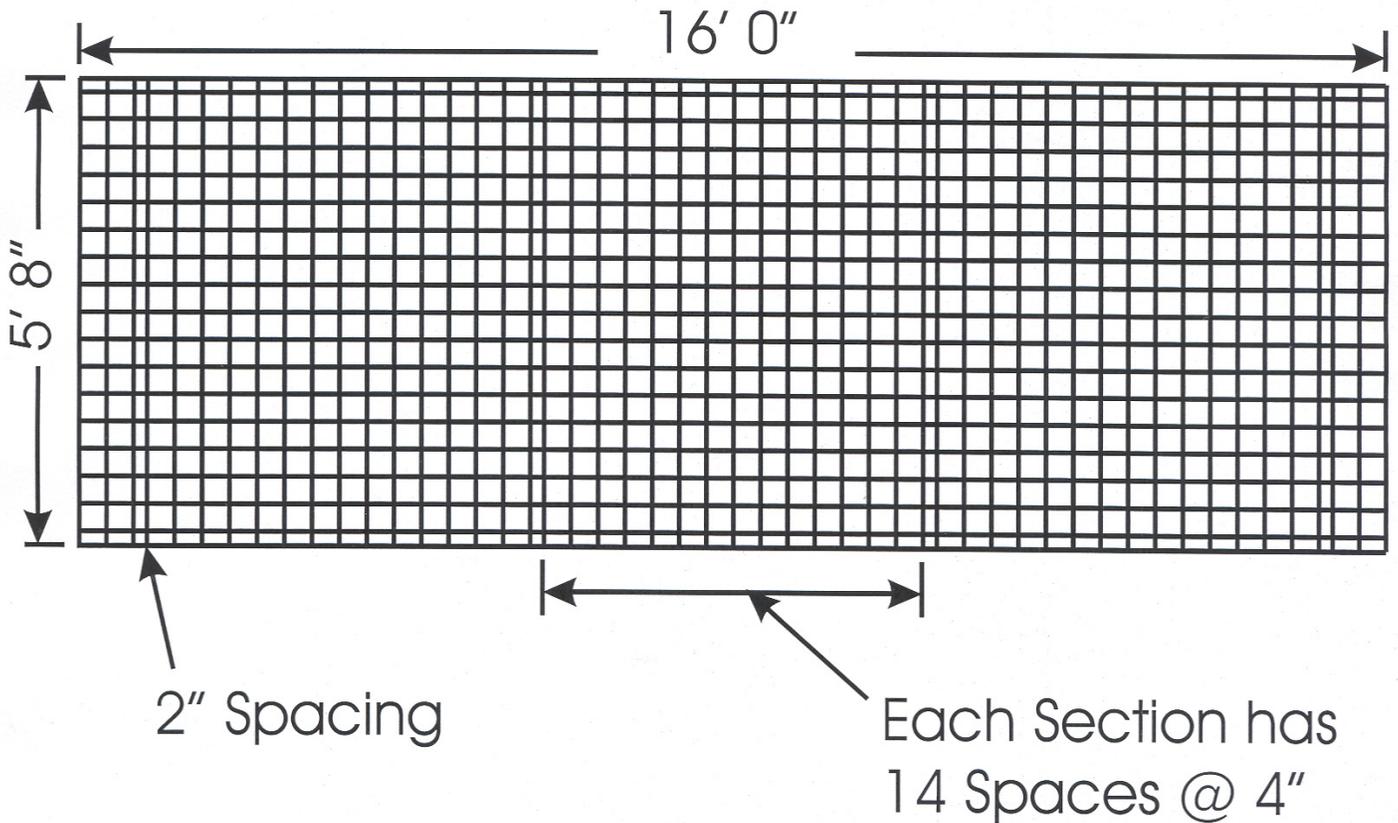
### SKETCH OF WIRE MESH PANEL

- Mesh is 16' by 5'8"
- Openings – 4" by 4"
- 6 gauge wire
- 2" openings between sections
- 2" wide openings on long edges
- Each panel weighs 58.3 pounds
