REPORT OF INVESTIGATION

FATAL MACHINERY ACCIDENT

June 24, 2010

Leeco Incorporated  
#68  
Jeff, Perry County, Kentucky  
I.D. No. 15-17497

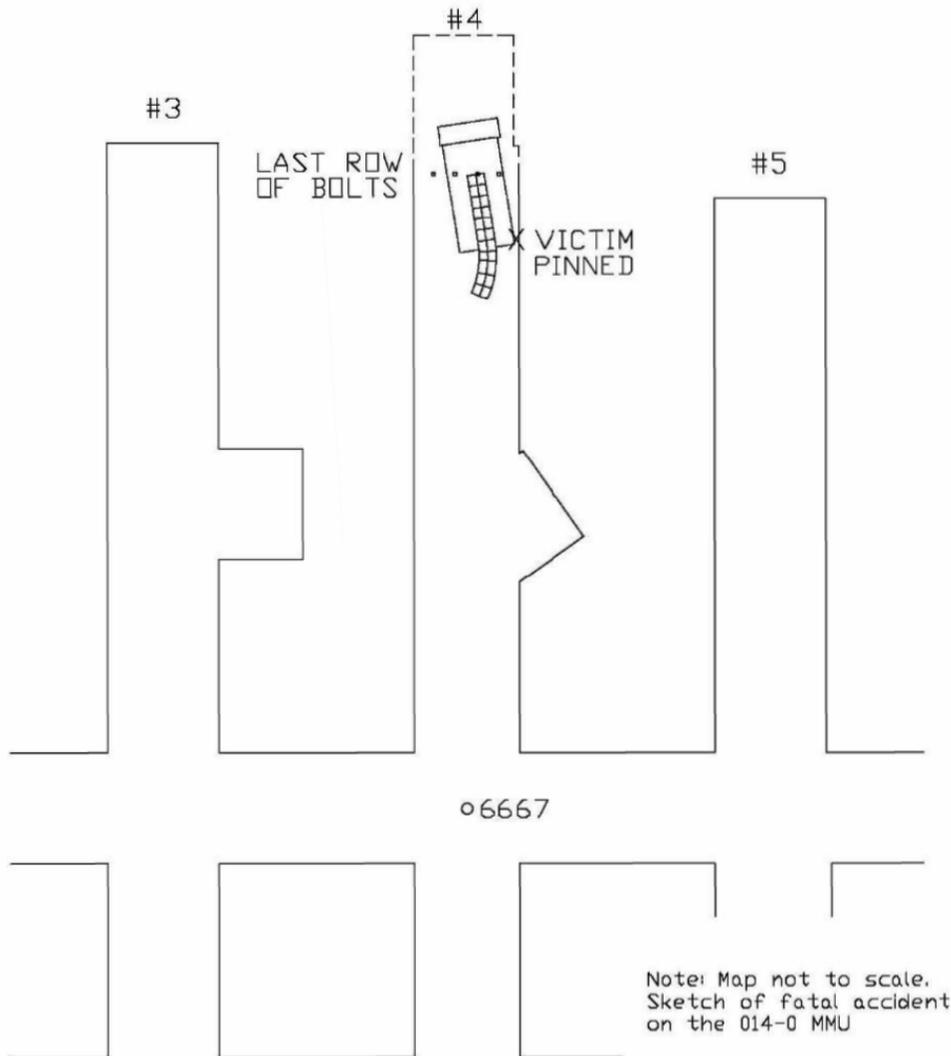
Leeco Inc. #68  
Mine ID: 15-17497  
Fatal Accident  
Location Map

At approximately 1:15 p.m. on Thursday, June 24, 2010, a 29 year old miner with twelve years mining experience was fatally injured when he became trapped between the continuous mining machine he was operating and the coal rib. The victim was tramming the mining machine by remote control along the right rib line to clean up the loose coal on the mine floor. While he was turning the front of the mining machine to the left, he became caught between the mining machine and the coal rib.
