**Internal Review of MSHA's
Actions at the Upper Big Branch Mine-South
Performance Coal Company
Montcoal, Raleigh County, West Virginia**

U.S. Department of Labor
Mine Safety and Health Administration
Program Evaluation and Information Resources

March 6, 2012

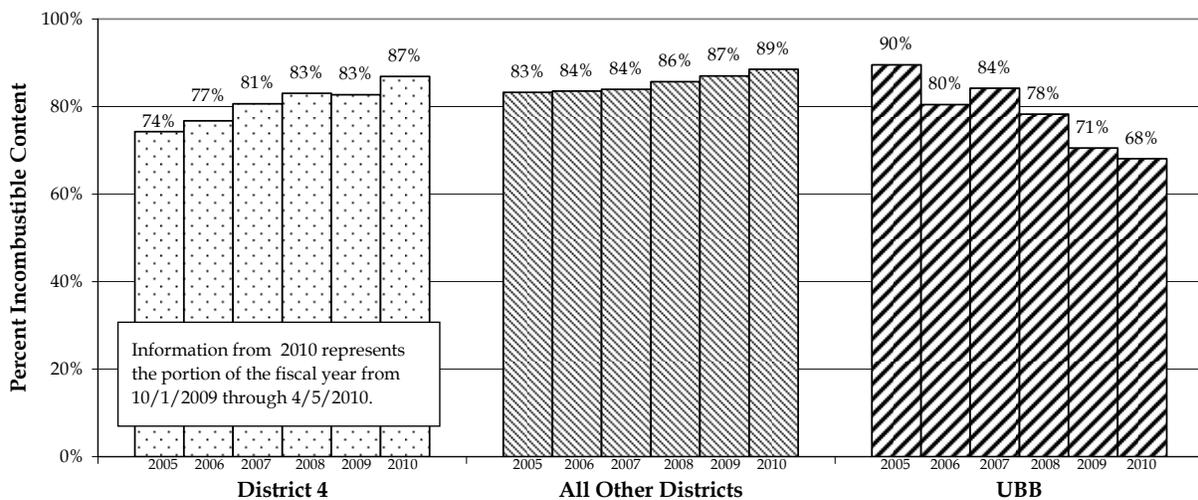
Figure 10 - Average Incombustible Content of Rock Dust Survey Samples by Fiscal Year

To measure the effect of increased sampling and enforcement on actual mine conditions, the average incombustible content (% IC) of survey samples were plotted over time. As shown in Figure 10, this value trended upward, both nationally and in District 4, which indicated that most operators increased their rock dust application rates each year during this period. However, the average % IC of rock dust samples declined at UBB from 90% in fiscal 2005 to 68% during the first two quarters of fiscal 2010.

Nationally, prior to the explosion, samples collected during compliant surveys averaged 91% IC and the non-compliant surveys averaged 77% IC. The % IC at UBB during fiscal years 2009 and 2010 averaged well below levels expected to result in compliant surveys.

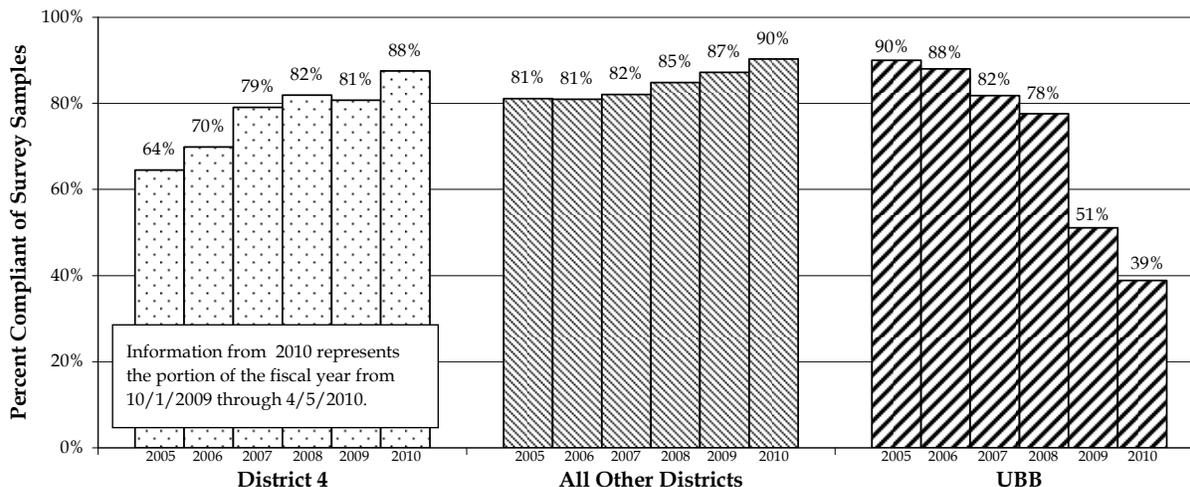
Figure 11 - Percent Compliant Rock Dust Survey Samples by Fiscal Year

Trends in rock dust application correlated to that of individual rock dust sample compliance. As shown in Figure 11, the percentage of compliant rock dust samples collected during surveys increased both

nationally and in District 4. However, the percentage of compliant samples at UBB dropped from 90% to 39% during fiscals 2005 to 2010.

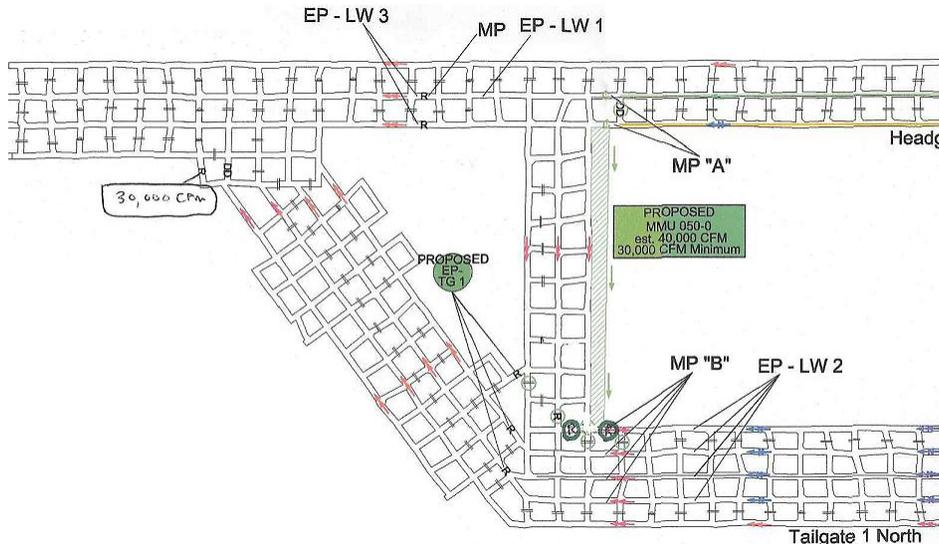
Figure 15 - Original evaluation point locations approved September 11, 2009, in mine ventilation plan

Before the 1 North Longwall started production, the Operator submitted a method to evaluate the bleeder system for the longwall panel in a ventilation plan supplement approved by the District 4 Manager on August 6, 2009. The supplement was later incorporated into a new base ventilation plan approved on September 11, 2009. The approval included a mine map with the evaluation points (EPs) identified. A section of that map is shown in Figure 15.

Inlet and outlet evaluation points established by the Operator for the system were identified in the approved base ventilation plan. The No. 1 entry of the 1 North Longwall tailgate and the No. 3 entry of the longwall headgate were maintained as isolated development section returns. Air flow into the worked-out area from these splits was limited to leakage. Therefore the initial evaluation points established did not need to account for airflow in these air courses.

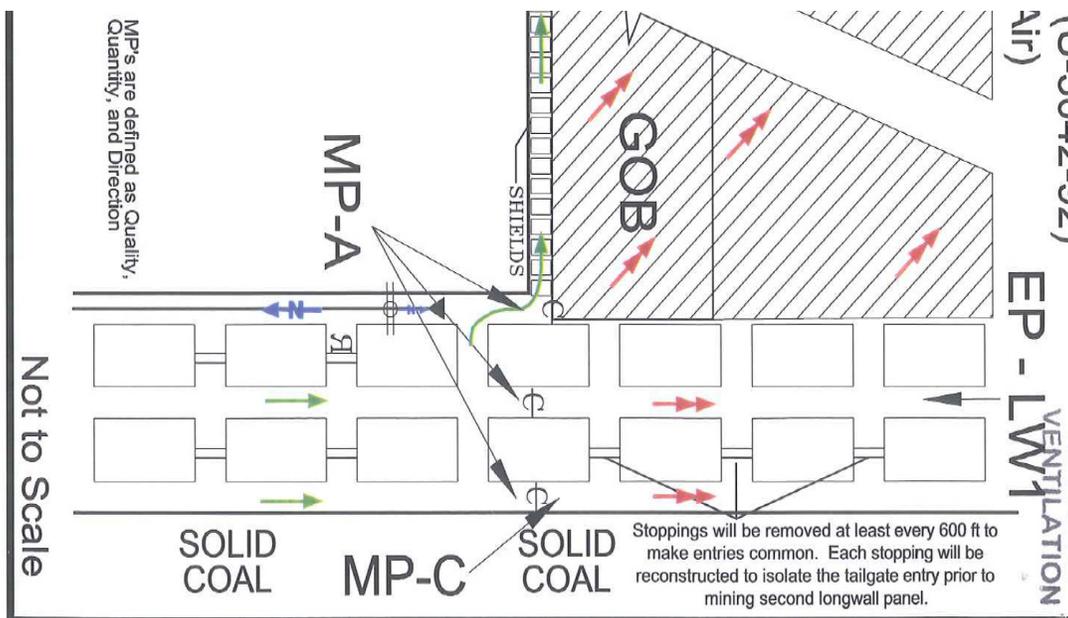
Figure 16 - Portion of drawing from ventilation plan supplement approved December 18, 2009

The Operator submitted a ventilation plan supplement on December 14, 2009, that provided for stoppings to be removed at intervals of at least every 600 feet between the No. 3 and No. 2 longwall Headgate entries. As a result, the No. 3 and No. 2 longwall headgate entries became common, with the No. 3 entry becoming part of the worked-out area. The supplement specified these stoppings would be reconstructed to isolate the future tailgate entry prior to mining the adjacent longwall panel. The supplement also established an additional measuring point where intake air entered the worked out area in the No. 3 entry of the headgate, identified as MP-C in Figure 16.

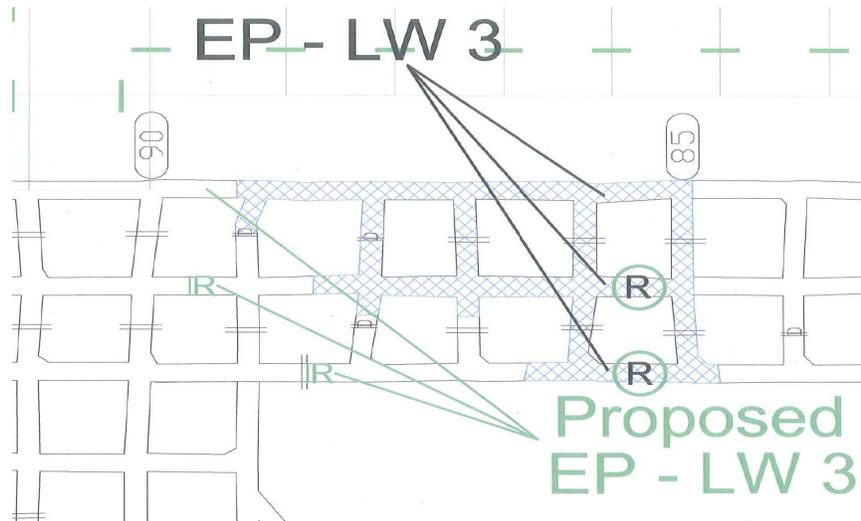
Figure 17 - Drawing of evaluation points from supplement approved February 22, 2010

In addition, an evaluation point was established in the No. 3 entry at EP-LW3 behind the longwall panel. This EP was needed since air was exiting the worked-out area at this location, and would have been necessary to properly evaluate the bleeder system. In a ventilation plan supplement approved on February 22, 2010, this EP was relocated from crosscut 85 to crosscut 90 due to a water accumulation. (See Figure 17.)
