MINE SAFETY AND HEALTH ADMINISTRATION

ANALYSIS OF FAILURE TO BLOCK OR SECURE
MINING EQUIPMENT IN A RAISED POSITION,
COAL MINING 1973-1980

Harvey Padgett
Mine Safety Specialist^{1/}

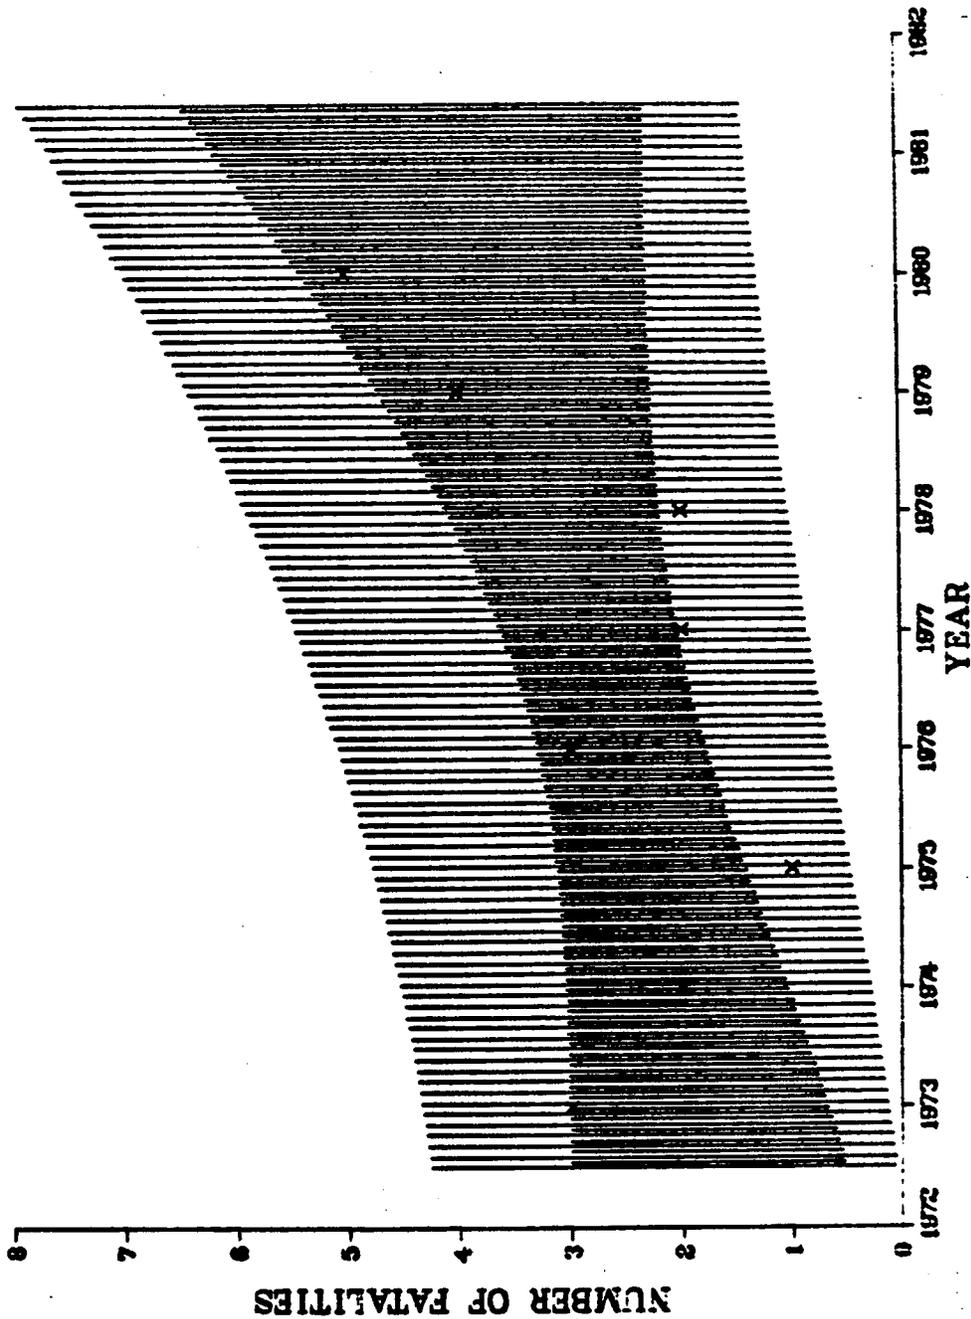
FATALITIES CAUSED BY FAILURE TO BLOCK EQUIPMENT

Unsecured mining equipment has accounted for twenty-two coal mine industry fatalities from 1973 through 1980. Fatalities have increased the last two years. Fourteen fatalities were the result of employees positioning themselves under, or between raised, unblocked mining equipment that moved or shifted. Seven other fatalities were caused by faulty, improper blocking methods or inadequate blocking material. Two of these fatalities occurred when the employees securely blocked the loading machine conveyor boom then positioned themselves between the bumper and boom. When the pressure to the boomjacks was removed, the bumper raised, crushing the victims against the boom. The remaining fatality occurred when a shuttle car was raised onto blocking material. The car rolled off the material, crushing the employee performing repairs underneath. The equipment involved in these accidents is shown in table 1.
