**Internal Review of MSHA's
Actions at the Upper Big Branch Mine-South
Performance Coal Company
Montcoal, Raleigh County, West Virginia**

U.S. Department of Labor
Mine Safety and Health Administration
Program Evaluation and Information Resources

March 6, 2012

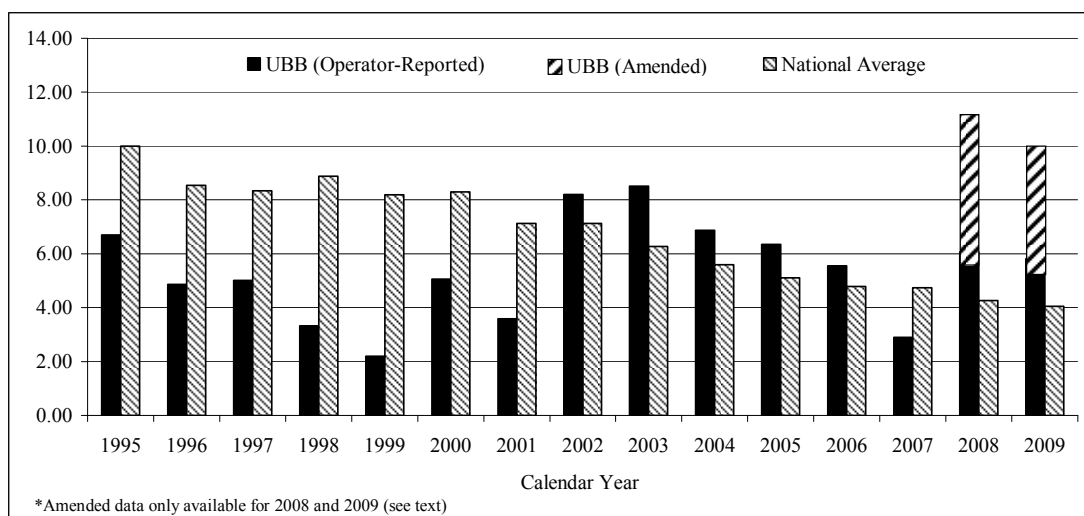
Figure 2 - Non-Fatal Days Lost (NFDL) Incidence Rate (UBB vs. National Average)

Figure 2 shows the Operator-reported NFDL injury incidence rate at UBB, the amended NFDL rate at UBB, and the national average for all underground bituminous coal mines.⁵ From 1995 to 2001, the Operator-reported NFDL rate at UBB was lower than the national average. However, from 2002 to 2009, the Operator-reported NFDL rate at UBB was higher than the national average in seven of the eight years.

Figure 2 also shows the amended NFDL rate at UBB after factoring in the previously unreported injuries and amendments to the reported employment and production figures.⁸ The amended NFDL rates for 2008 and 2009 were 89% and 76%, respectively, higher than originally reported. This issue is discussed in greater detail in the Enforcement of 30 CFR Part 50 section of Appendix D.

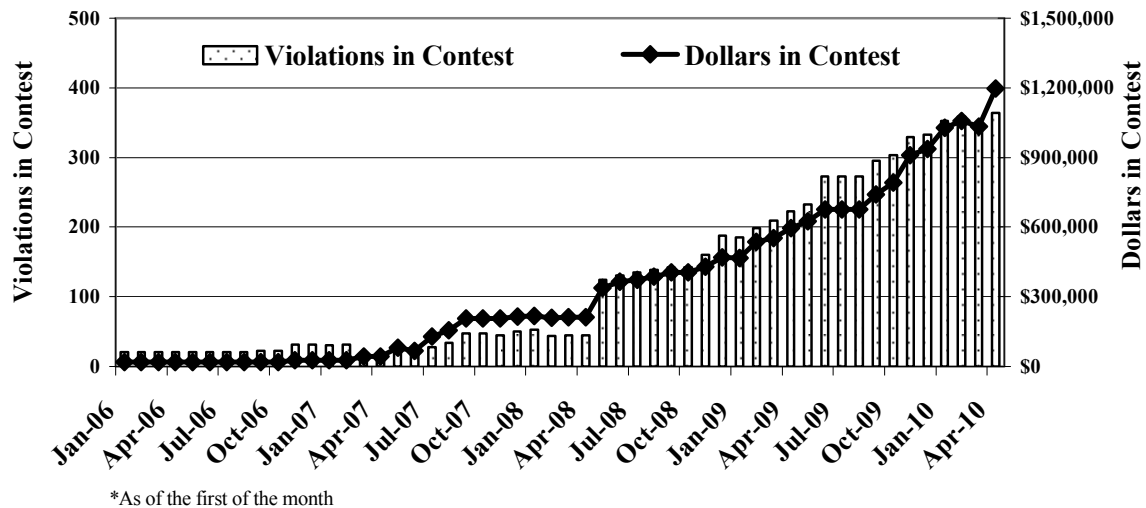
Figure 7 - UBB Pending Contested Violations and Dollars by Month

The number of violations cited at UBB awaiting resolution before the Commission, and the associated proposed penalties, increased significantly in the two years preceding the April 5 explosion. Figure 7 depicts the growth in contested, pending UBB violations and the associated proposed penalties.

During the 18-month review period, Performance Coal Company paid \$239,907 in civil penalties for 353 violations cited at UBB. However, 366 violations cited at UBB totaling nearly \$1.2 million in proposed penalties were pending before the Commission on the day of the explosion. This included violations cited as far back as June 2006.

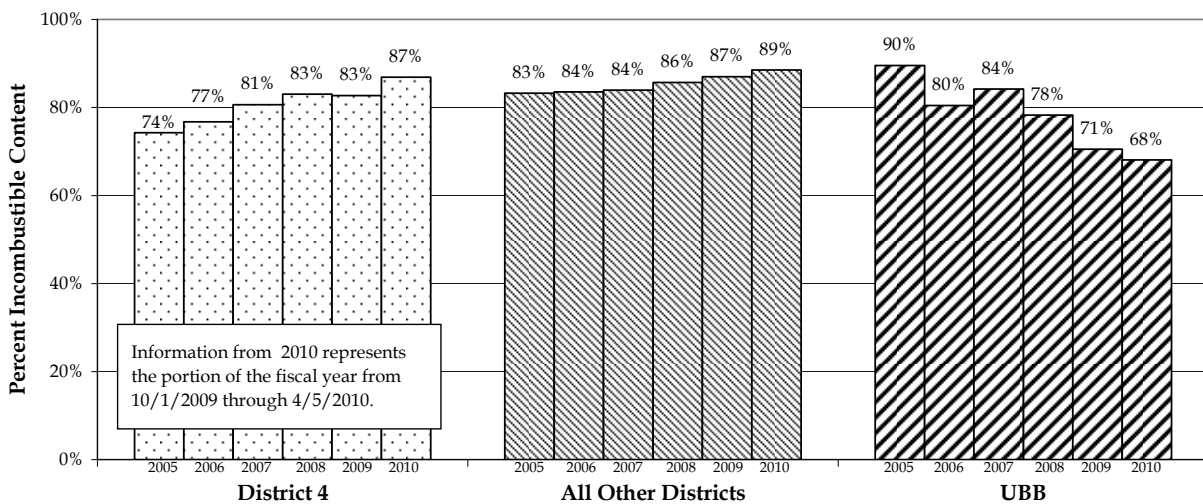
Figure 10 - Average Incombustible Content of Rock Dust Survey Samples by Fiscal Year

To measure the effect of increased sampling and enforcement on actual mine conditions, the average incombustible content (% IC) of survey samples were plotted over time. As shown in Figure 10, this value trended upward, both nationally and in District 4, which indicated that most operators increased their rock dust application rates each year during this period. However, the average % IC of rock dust samples declined at UBB from 90% in fiscal 2005 to 68% during the first two quarters of fiscal 2010.

Nationally, prior to the explosion, samples collected during compliant surveys averaged 91% IC and the non-compliant surveys averaged 77% IC. The % IC at UBB during fiscal years 2009 and 2010 averaged well below levels expected to result in compliant surveys.

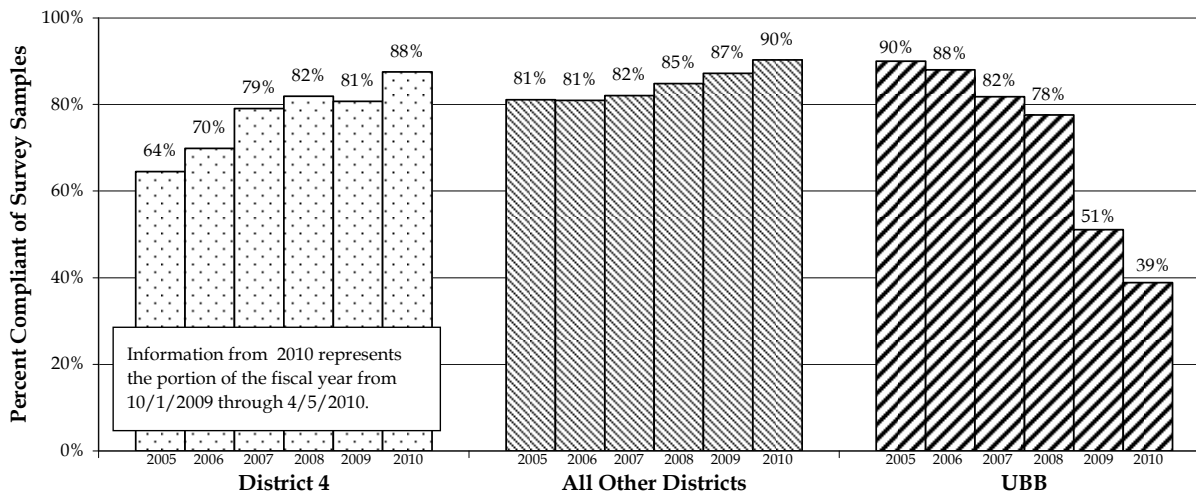
Figure 11 - Percent Compliant Rock Dust Survey Samples by Fiscal Year

Trends in rock dust application correlated to that of individual rock dust sample compliance. As shown in Figure 11, the percentage of compliant rock dust samples collected during surveys increased both

nationally and in District 4. However, the percentage of compliant samples at UBB dropped from 90% to 39% during fiscals 2005 to 2010.

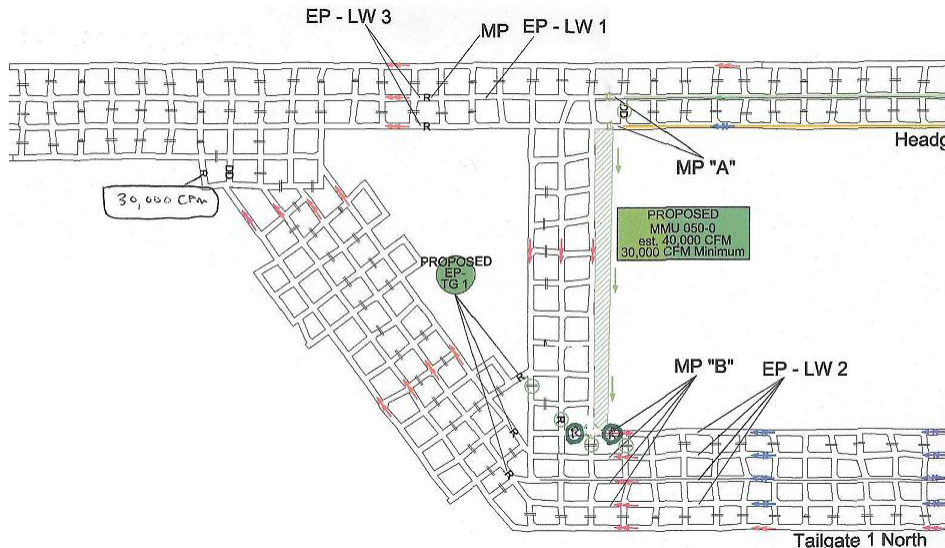
Figure 15 - Original evaluation point locations approved September 11, 2009, in mine ventilation plan

Before the 1 North Longwall started production, the Operator submitted a method to evaluate the bleeder system for the longwall panel in a ventilation plan supplement approved by the District 4 Manager on August 6, 2009. The supplement was later incorporated into a new base ventilation plan approved on September 11, 2009. The approval included a mine map with the evaluation points (EPs) identified. A section of that map is shown in Figure 15.

Inlet and outlet evaluation points established by the Operator for the system were identified in the approved base ventilation plan. The No. 1 entry of the 1 North Longwall tailgate and the No. 3 entry of the longwall headgate were maintained as isolated development section returns. Air flow into the worked-out area from these splits was limited to leakage. Therefore the initial evaluation points established did not need to account for airflow in these air courses.

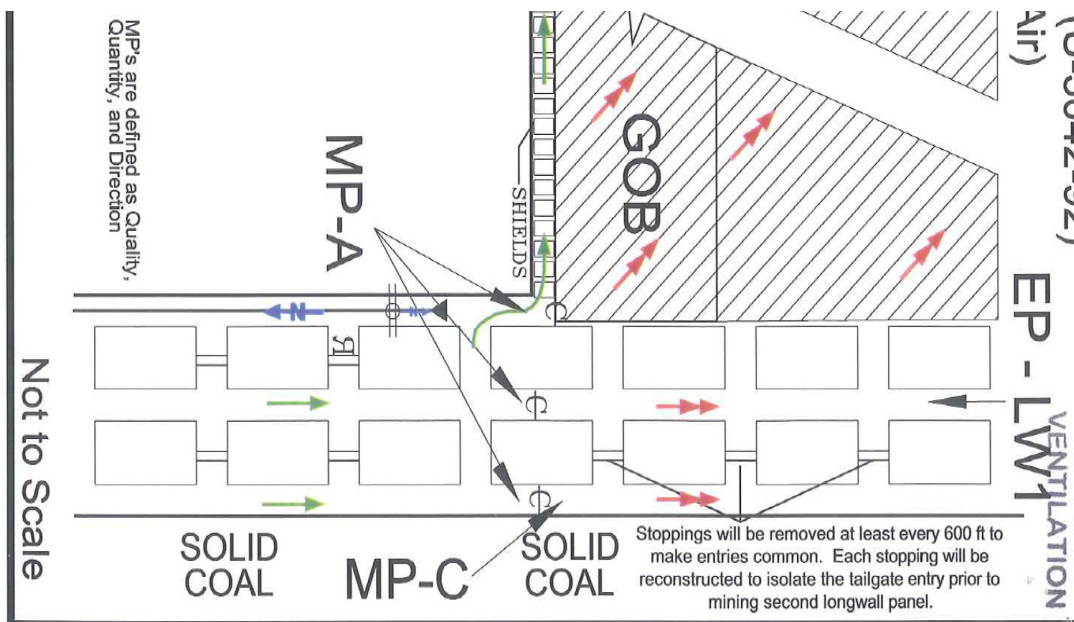
Figure 16 - Portion of drawing from ventilation plan supplement approved December 18, 2009

The Operator submitted a ventilation plan supplement on December 14, 2009, that provided for stoppings to be removed at intervals of at least every 600 feet between the No. 3 and No. 2 longwall Headgate entries. As a result, the No. 3 and No. 2 longwall headgate entries became common, with the No. 3 entry becoming part of the worked-out area. The supplement specified these stoppings would be reconstructed to isolate the future tailgate entry prior to mining the adjacent longwall panel. The supplement also established an additional measuring point where intake air entered the worked out area in the No. 3 entry of the headgate, identified as MP-C in Figure 16.
