REPORT OF INVESTIGATION

Fatal Powered Haulage Accident  
May 2, 2023

Plant 280  
Bowes Construction Inc  
Brookings, Brookings County, South Dakota  
ID No. 39-01505

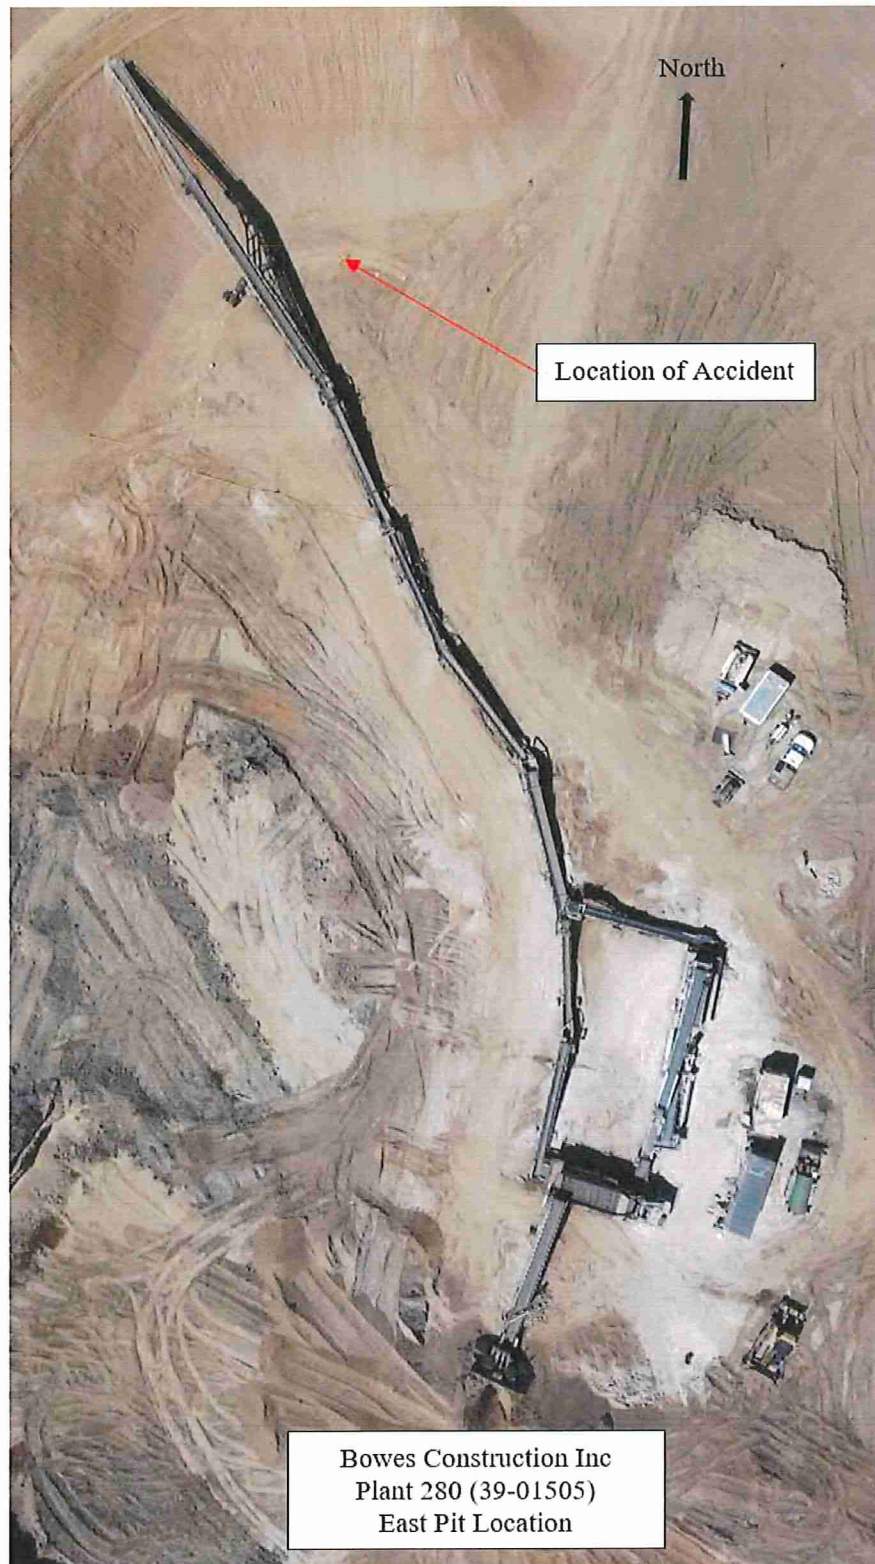
APPENDIX B – Aerial View of Plant Where the Accident Occurred

The accident occurred at the plant's radial stacker, located on the north end of the mine (see Appendix B). Interviews revealed that Waddel found Wixon with a crushed can of penetrating oil at his side. A pattern of oily residue distributed throughout the left side radial axle restricted access area indicates the location of the accident (see Appendix C). The manufacturer designed the area to allow miners to have access to the controls for the hydraulic jacking cylinders while the radial stacker was not in motion. The radial axle support, the left radial axle arm, the undercarriage, and the left radial arm locking bar enclose the left side radial drive access area, with no signage or conspicuous markings to warn against entry into this area when the equipment is operating. To travel into the area, a miner must step on or over the left radial arm locking bar which is approximately eight feet long and 19 inches above grade.
