REPORT OF INVESTIGATION

Surface Coal Mine
Fatal Electrical Accident
February 18, 2008

A-FN Machine Technology, Inc. (Contractor ID R317)
New Kensington, Pennsylvania

Consolidation Coal Company 14-North Impoundment
Consolidation Coal Company
Harmarville, Allegheny County, Pennsylvania
MSHA ID 36-08094

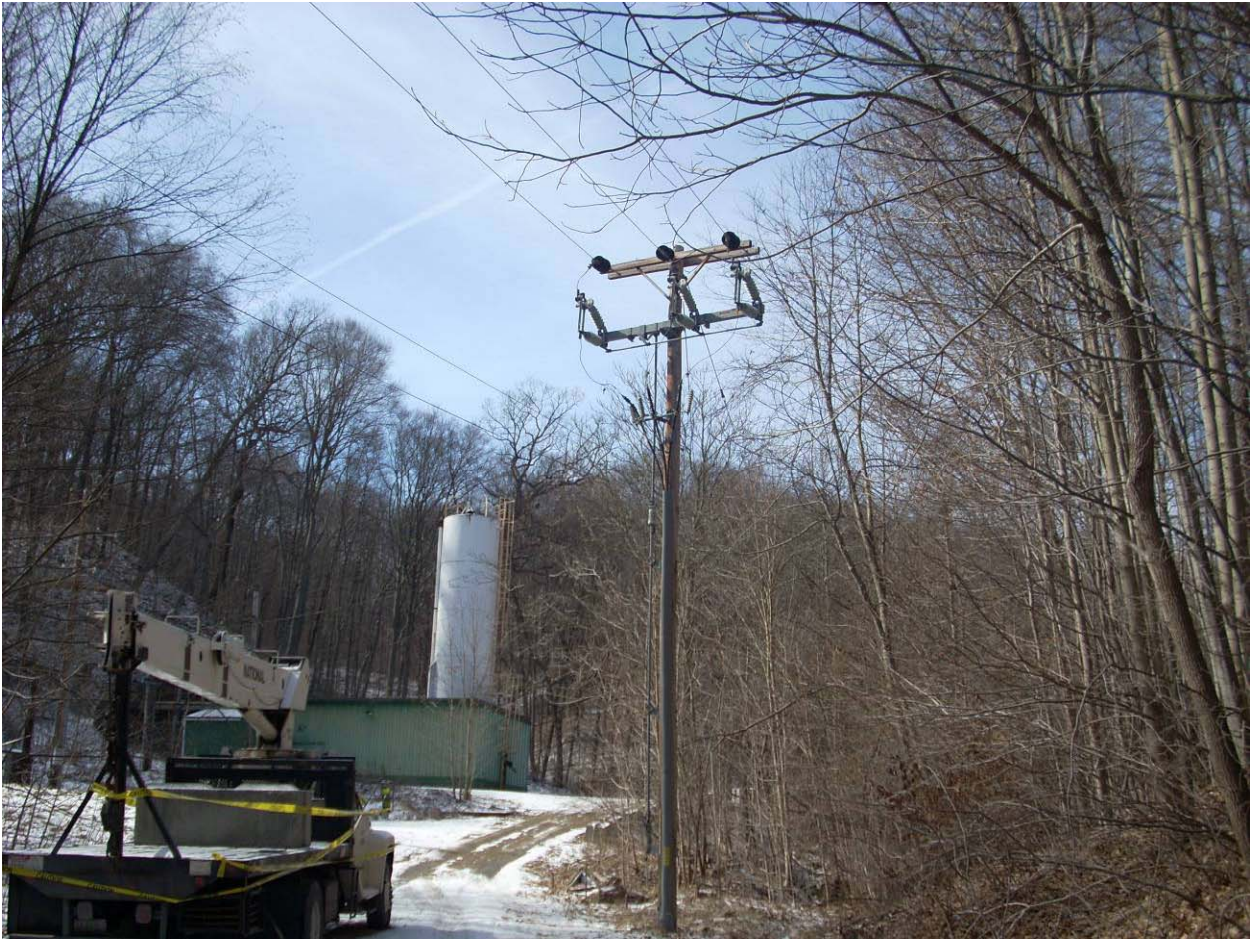
At approximately 12:35 p.m., the boom was energized by the overhead 25,000 high-voltage power line. Stoops observed a flash from the outriggers. While walking up the haul road to the impoundment, Rudzinski, Huston, and Lunn also heard a noise and observed a flash. Lunn called 911 while Rudzinski called Allegheny Power Company. Upon arrival at the mine site, the Allegheny County Coroner pronounced the victim dead due to electrocution.
