REPORT OF INVESTIGATION

Fatal Machinery Accident  
June 3, 2008

Gopher Contracting (R828)

Premier Elkhorn Coal Company  
Job 49  
Myra, Pike County, Kentucky  
I.D. No. 15-18946

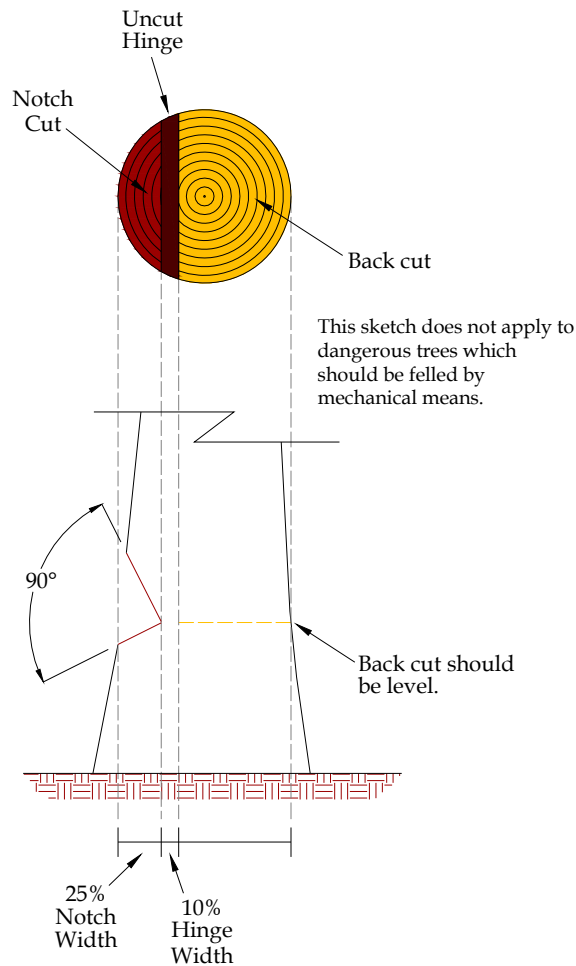
The size, top-heavy shape, and lean of the tree that Hill was cutting made it a dangerous tree. Evaluation of the tree should have resulted in a decision to fell the tree by mechanical means. A dozer or excavator could have been used to push the tree down. However, Gopher Contracting employees stated during interviews that they believed every tree had to be cut down with a chainsaw.

The technique used by Hill to cut this tree was improper in several respects:

1. Mechanical means of felling dangerous trees, such as pushing the tree over with a dozer or excavator, should be considered.
2. Before starting the actual cutting of the tree, an escape route at an angle of 45 degrees opposite of the intended direction of fall should be cleared in order to be able to quickly get away from the tree during the fall.

3. Proper tree cutting procedures require that an uncut hinge of wood be provided when felling a tree in order to guide the fall of the tree and hold it to the stump during most of the duration of the fall. The hinge should be a thickness of at least 10 per cent of the diameter of the tree. The procedure for developing the hinge is to first make a notch cut on the side of the tree in the desired direction of fall. The notch cut should be of a depth equal to 25 percent of the tree diameter and the angle created should be at least 70 degrees, 90 degrees is recommended. In order to assure that a proper hinge is provided on a large tree, a bore cut through the center of the tree, leaving the hinge, should be made after the notch is completed. The final cut should be made by either continuing the bore cut through the back of the tree or by starting a level final cut from the back side of the tree into the bore cut.

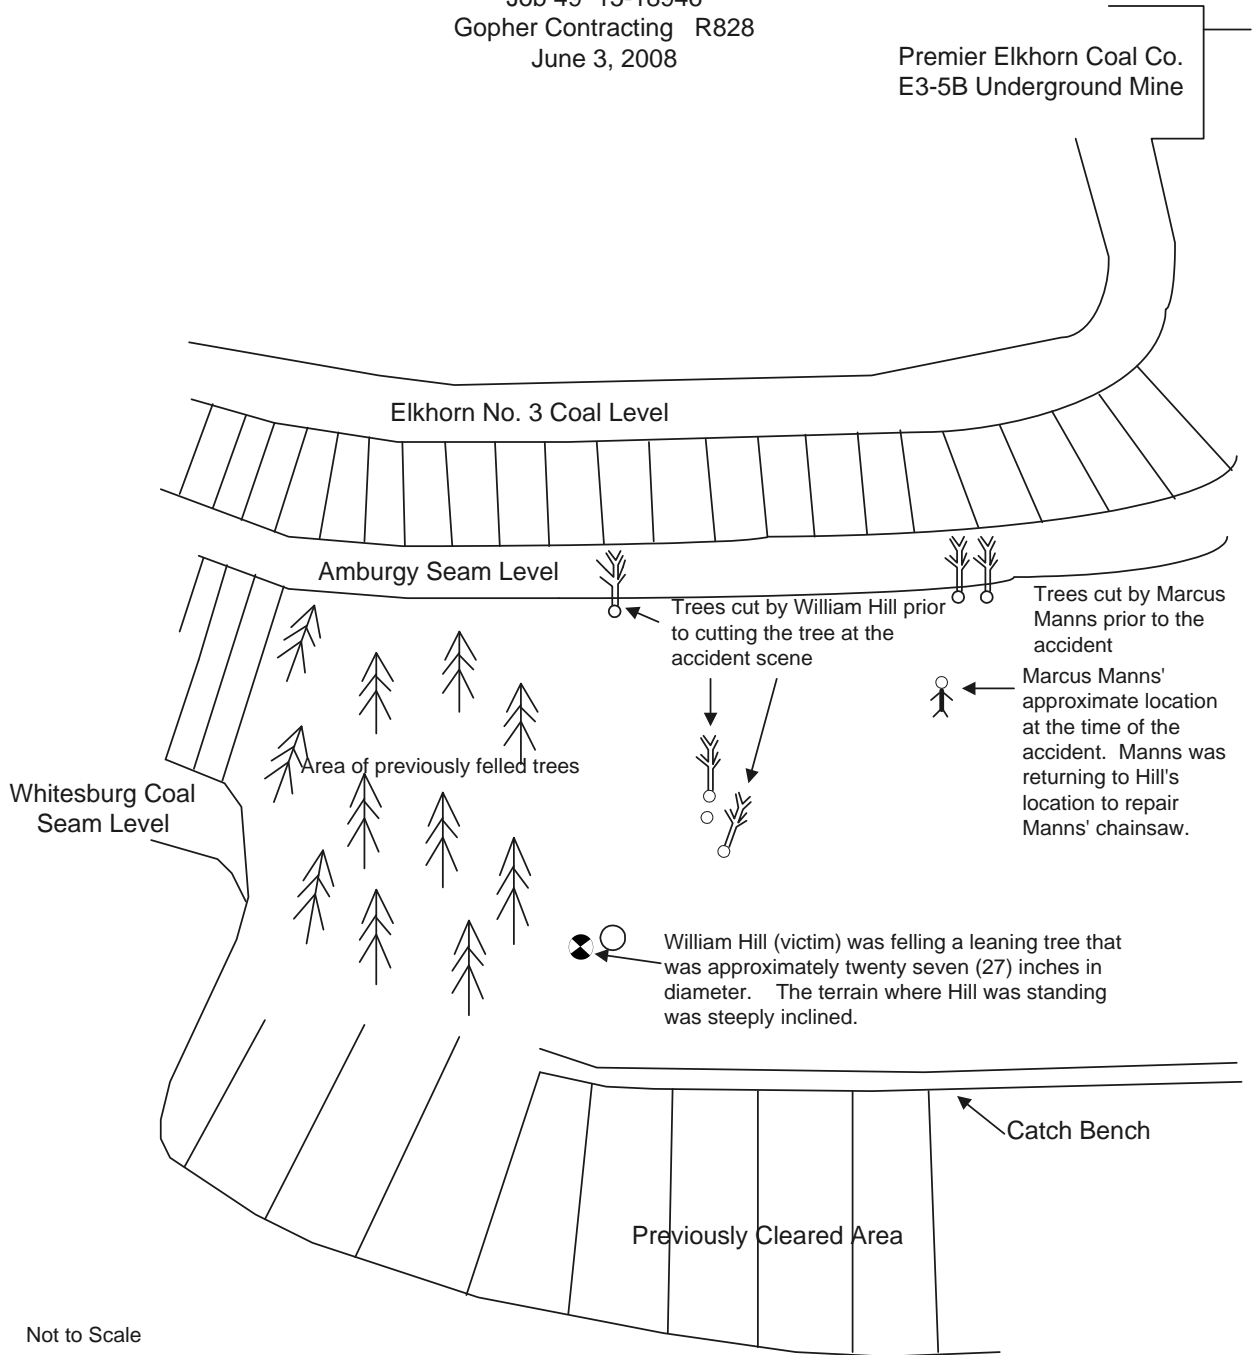
Area Sketch  
Premier Elkhorn Coal Company  
Job 49 15-18946  
Gopher Contracting R828  
June 3, 2008

Premier Elkhorn Coal Co.  
E3-5B Underground Mine
