REPORT OF INVESTIGATION

Fatal Hoisting Accident
October 27, 2009

Eagle Mine
Newtown Energy, Inc.
Comfort, Kanawha County, West Virginia
I.D. No. 46-08759

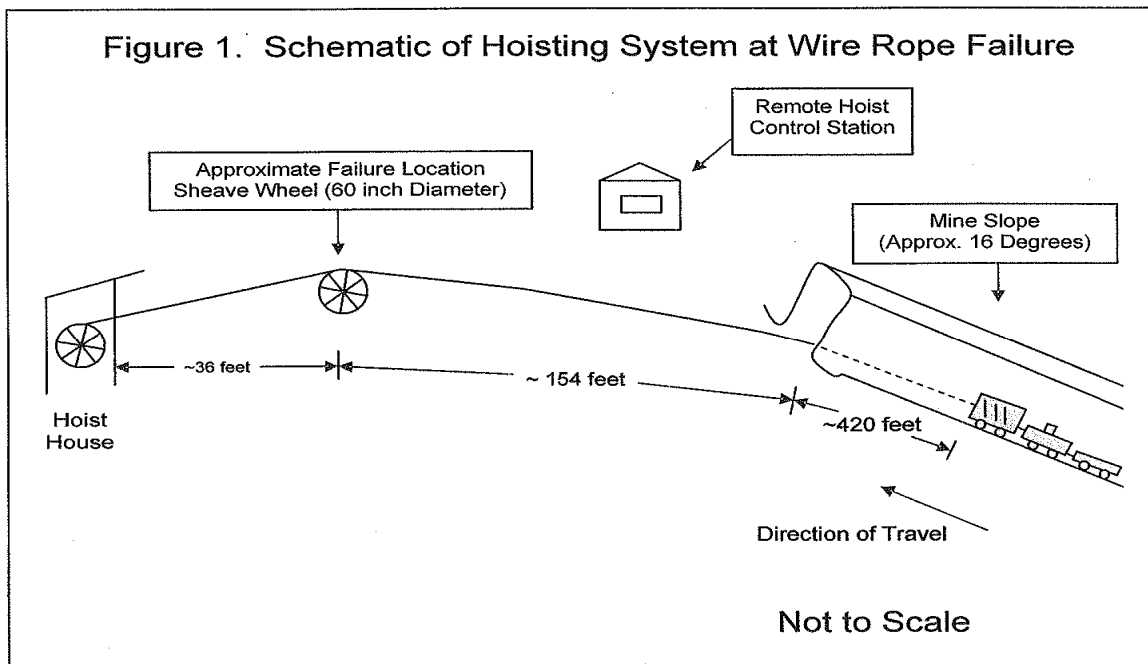
An examination of the environmental conditions of the slope was conducted on October 30, 2009. Starting from the zero point in the hoisting system (sheave wheel), the following conditions were noted.

- 154 feet - Slope Collar
- 530 feet - Water between rails
- 619-635 feet - Wet between rails
- 740 feet - Water dripping from roof of slope
- 1180-1227 feet - Water dripping from roof
- 1230-1380 feet - Not very wet
- 1380-1410 feet - Water between rails
- 1530 feet - Dry (appears to have been rock dusted)
- 1750 feet - Curve in track (Stopping Point)

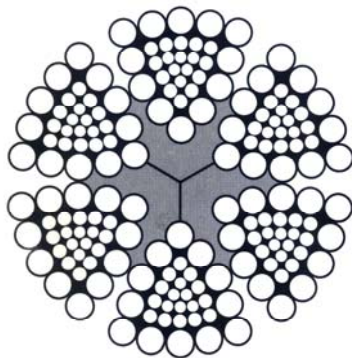
Cross Section of a
6X30 Type G fiber
core Wire Rope

The hoist wire rope, installed on June 22, 2007, was identified as a 1-1/8 inch diameter 6 X 30 STY G RL XXIP FC SL wire rope.

The breaking strength for this rope was listed as 70.1 tons in the Wire Rope Users Manual, 4th Edition. Company personnel provided a certificate from the Wire Rope Corporation of America indicating that the rope had an actual breaking strength of 78.1 tons. The minimum design factor required under Title 30 CFR Part 75.1431(a) was determined to be 5.4 based on a slope length of 1,600 feet. The weight of load being hoisted at the time of the accident, met the design requirements for the rope installed.

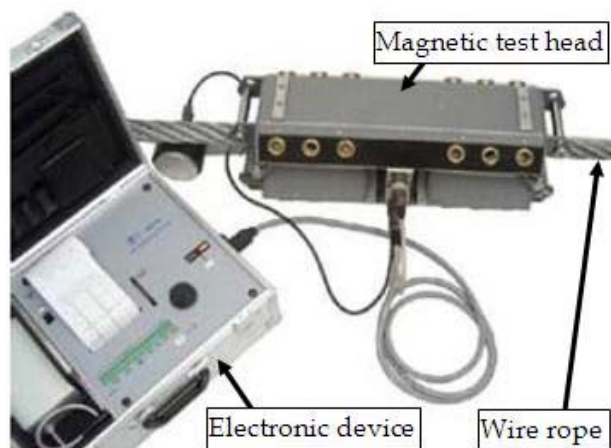
The NDT test head generates a magnetic field and detects damage and deterioration in the wire rope by measuring changes in the magnetic field. The magnetic test head is connected to an electronic device that records data electronically and prints a visual representation of collected data on a strip chart.

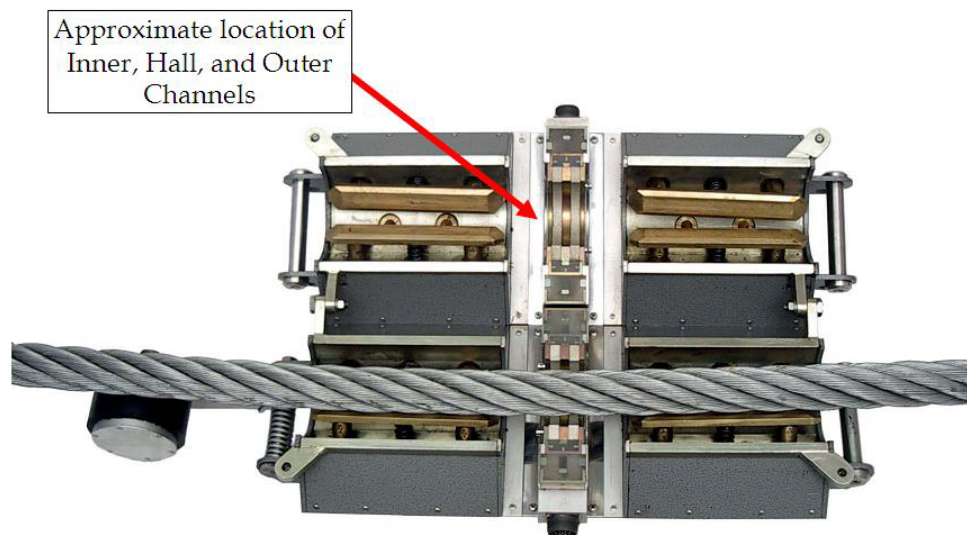
With the test head closed around a rope, the Inner sensor coil is located closest to the rope under test. The Hall sensor is the next closest to the rope and the Outer sensor coil is furthest away from a rope under test.
