REPORT OF INVESTIGATION

Underground Coal Mine

Fatal Injury, Other Accident
November 23, 2009

No. 7 Mine
Jim Walter Resources, Inc.
Brookwood, Tuscaloosa County, Alabama
MSHA I.D. No. 01-01401

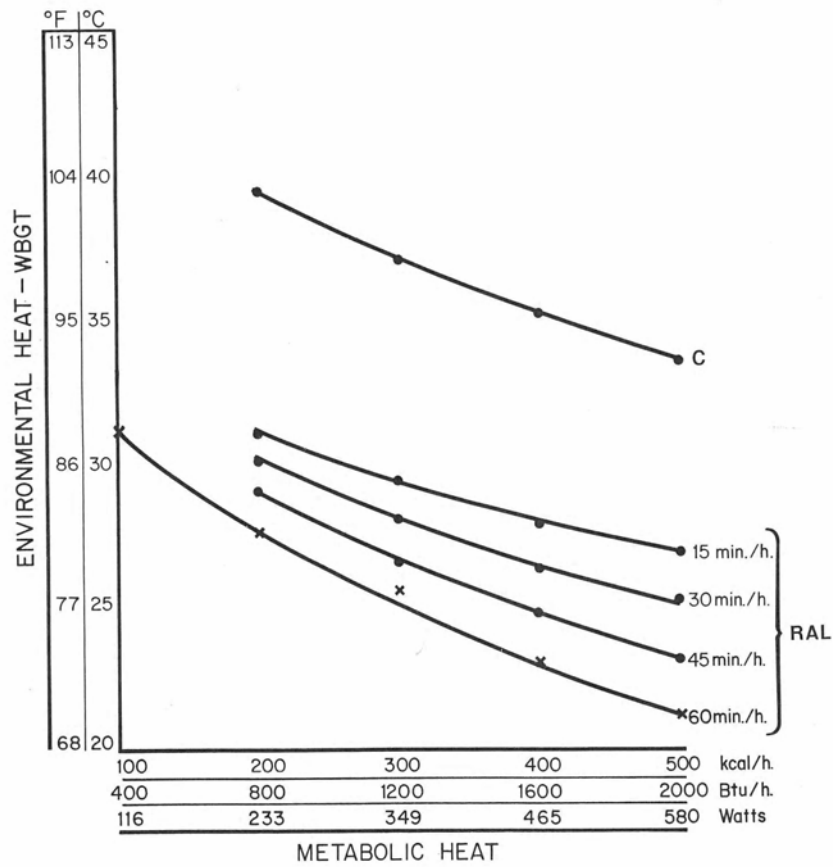
Figure 11 and Figure 12 show the NIOSH criteria for unacclimatized and acclimatized workers, respectively. The plotted criteria need to be adjusted for the type of clothing worn. These figures also show the ceiling limit for heat exposure.

Figure 11. Recommended Heat-Stress Alert Limits (RAL) - Heat-Unacclimatized Workers.

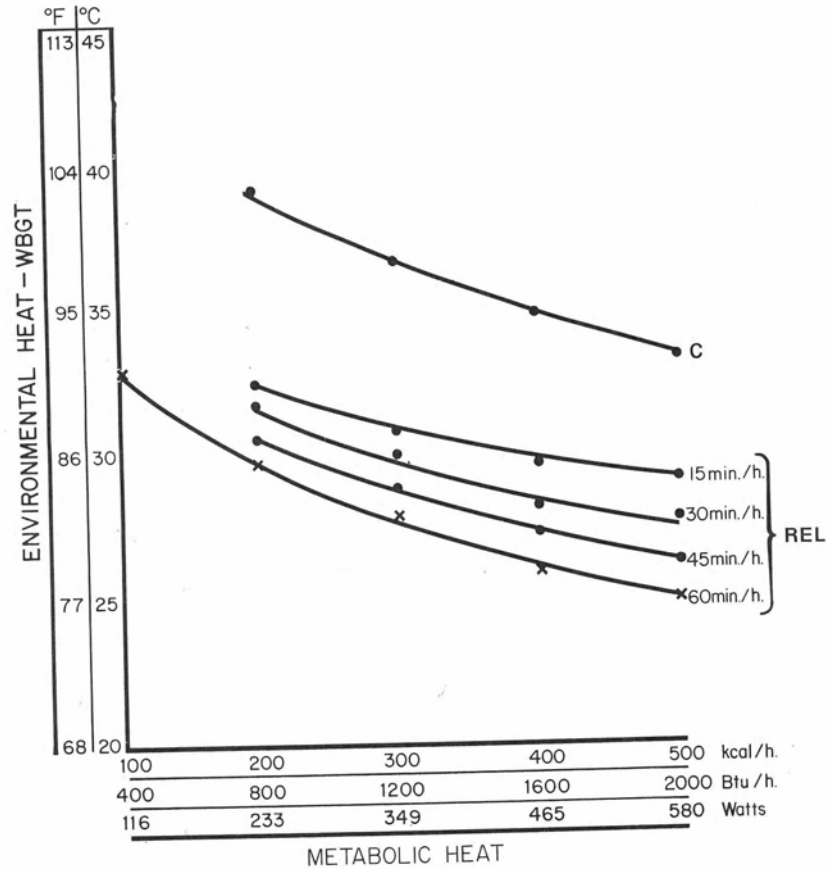
Figure 12. Recommended Heat-Stress Alert Limits (REL) - Heat-Acclimatized Workers.

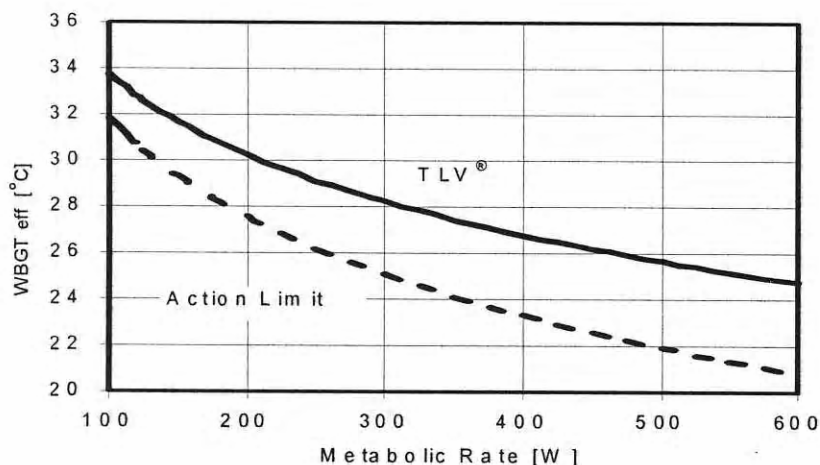
Another widely accepted heat stress criteria are those of the ACGIH.¹¹ Like the NIOSH criteria, the ACGIH criteria take into account work load, t_{nwb} , t_a , and t_g . The ACGIH preferred method for heat stress analysis is the WBGT. In addition, the criteria are separated into unacclimatized and acclimatized workers. Figure 13 shows the ACGIH criteria.

Figure 13. TLV® (solid line) and Action Limit (broken line) for Heat Stress. WBGT_{eff} is the measured WBGT plus the clothing adjustment factor.

The Action Limit levels apply to unacclimatized workers and the TLV® levels apply to acclimatized workers. ACGIH also published a table (see Table 5) showing criteria they suggest to be used as a screening tool. These values are more protective than those in Figure 13. When the values in Table 5 are exceeded, ACGIH recommends a more extensive heat stress survey should be conducted.

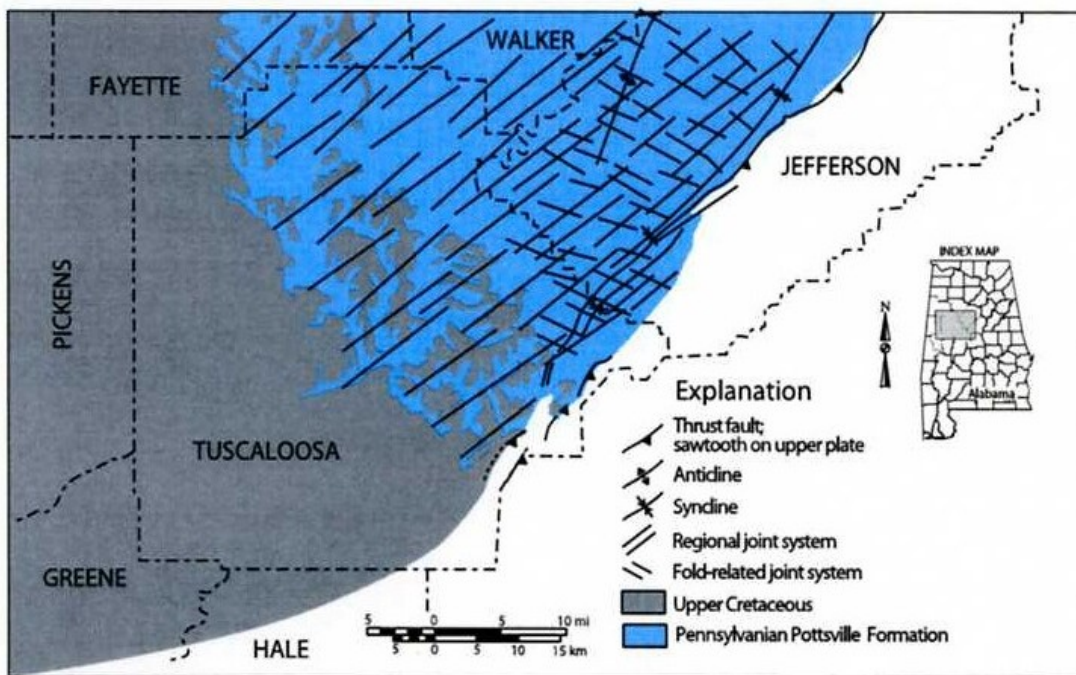
The dominant joint set observed in the Southwest A Longwall Panel gateroads ranged in orientation from N50°W to east-west but more commonly from N60°W to N70°W. This orientation is typical in the eastern portion of the Black Warrior Basin (Figure 2). Jointing was typically tight, planer and vertical. Joints were most easily observed in the roof where minor raveling or slaking exposed the joint plane. Because of the tightness of the joints and heavy coatings of rock dust on the roof, an accurate assessment of joint spacing was not possible. While it appears that spacing is on the order of several feet, localized areas exhibited tighter spacing. In an exposure of the immediate roof in a shallow failure between Crosscut 12 and Crosscut 13 in the tailgate Entry No. 2, joint spacing was less than one foot. Although areas of increased joint density may induce localized ground failures, there does not appear to be any correlation between jointing and heat flow.

Figure 2. Generalized map of joint systems in the southeastern Black Warrior Basin. (Hatch and Pawlewicz, 2007)

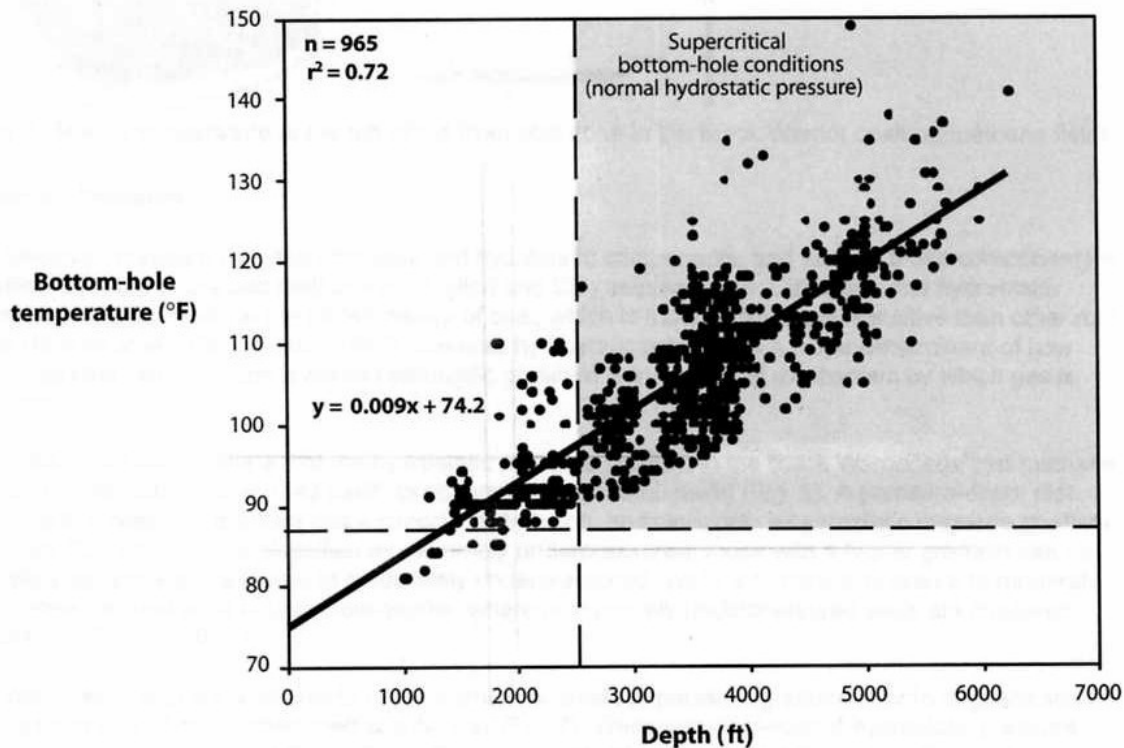
The first method simply consists of a direct examination of general temperature-depth data. Figure 3 plots temperatures recorded in the bottom of gas wells with respect to depth within the Pottsville formation throughout the Black Warrior Basin. Temperatures range from 80° to over 140°F for depths of 1000 to 6000 feet.

Figure 3. Temperature-depth plot for coalbed methane wells in the Black Warrior Basin (Pashin and McIntyre, 2003).

Although there is a significant degree of variation in the data ($r^2=0.72$), the temperature range for the approximate depth of the mining horizon (1700 ft) in the Jim Walter

Resources, Inc., No. 7 Mine is roughly 85°F to 95°F. The regression line intercept for a depth of 1700 feet indicates a temperature of 90°F. It should be noted that temperatures recorded in gas wells are typically considered minimum estimates: corrected borehole temperatures tend to be slightly higher than recorded temperatures (Jack Pashin, pers. comm.).

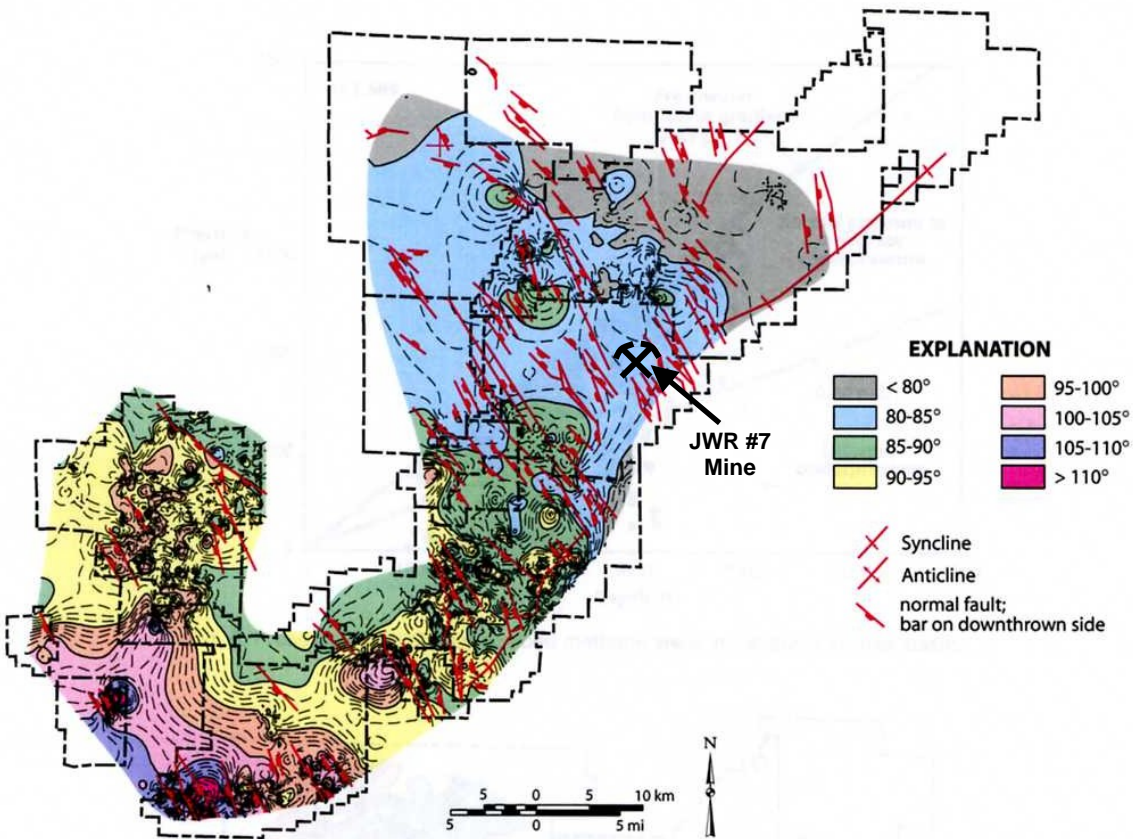
Another way to assess rock temperature in the Mary Lee coal zone is to consider the local geothermal gradient and temperature data from the Pratt coal zone, which is located roughly 900 feet above the Mary Lee zone. A temperature map of the Pratt coal zone (Figure 4), based on extensive gas exploration indicates that in the vicinity of the No. 7 Mine, estimated borehole temperatures at the top of the zone range from 80°F to 85°F. Corrected bore temperatures would be higher.

Figure 4. Temperature contour map for the top of the Pratt coal zone based on temperatures measured at the bottom of gas wells. Modified from Pashin and McIntyre (2003).

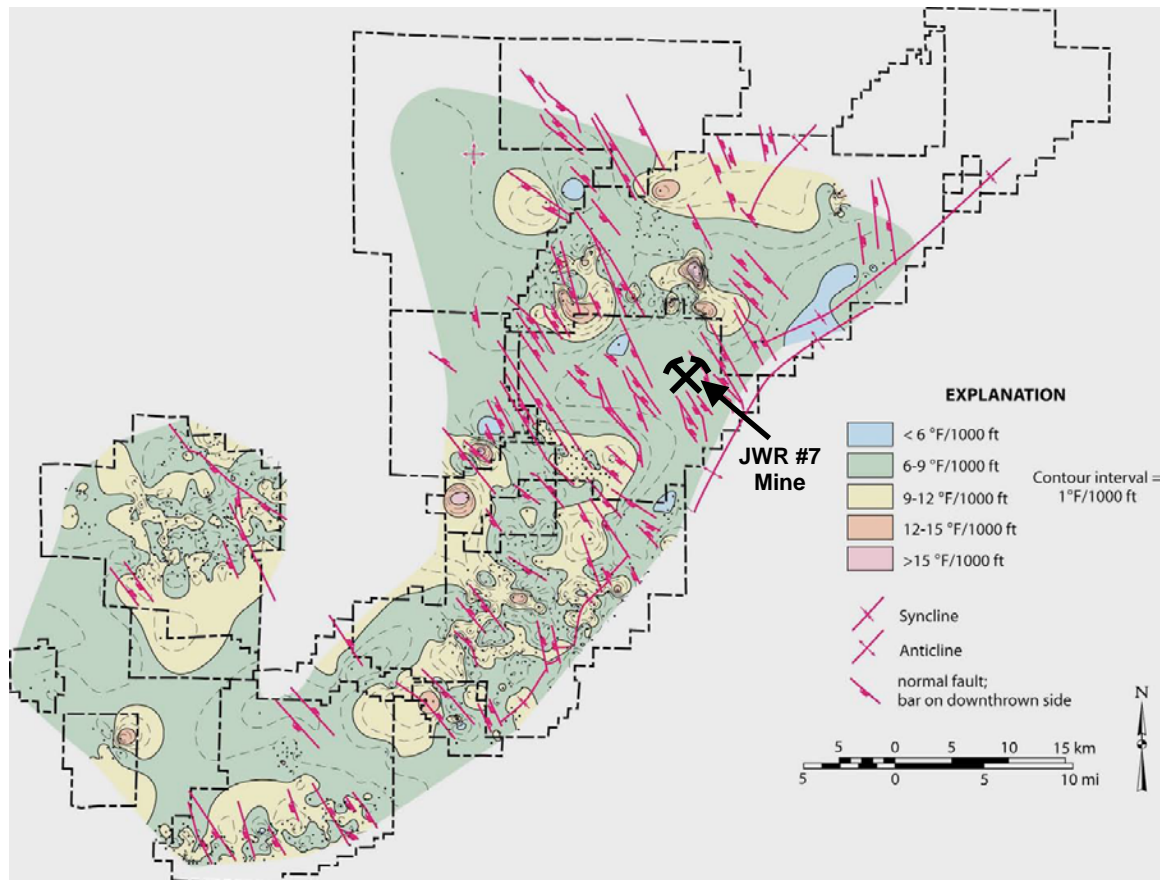
The geothermal gradient (Figure 5) in the area of the mine is 6-9°F/1000 feet. Using the geothermal gradient to extrapolate Pratt coal zone temperatures to the No. 7 Mine, 900 feet below, yields a temperature range of 85.4°F to 94.1°F. Again, temperatures would be expected to be higher after correction of the estimated borehole temperatures used.

Figure 5. Geothermal gradient map for the southeast portion of the Black Warrior basin. Modified from Pashin and McIntyre, 2003.

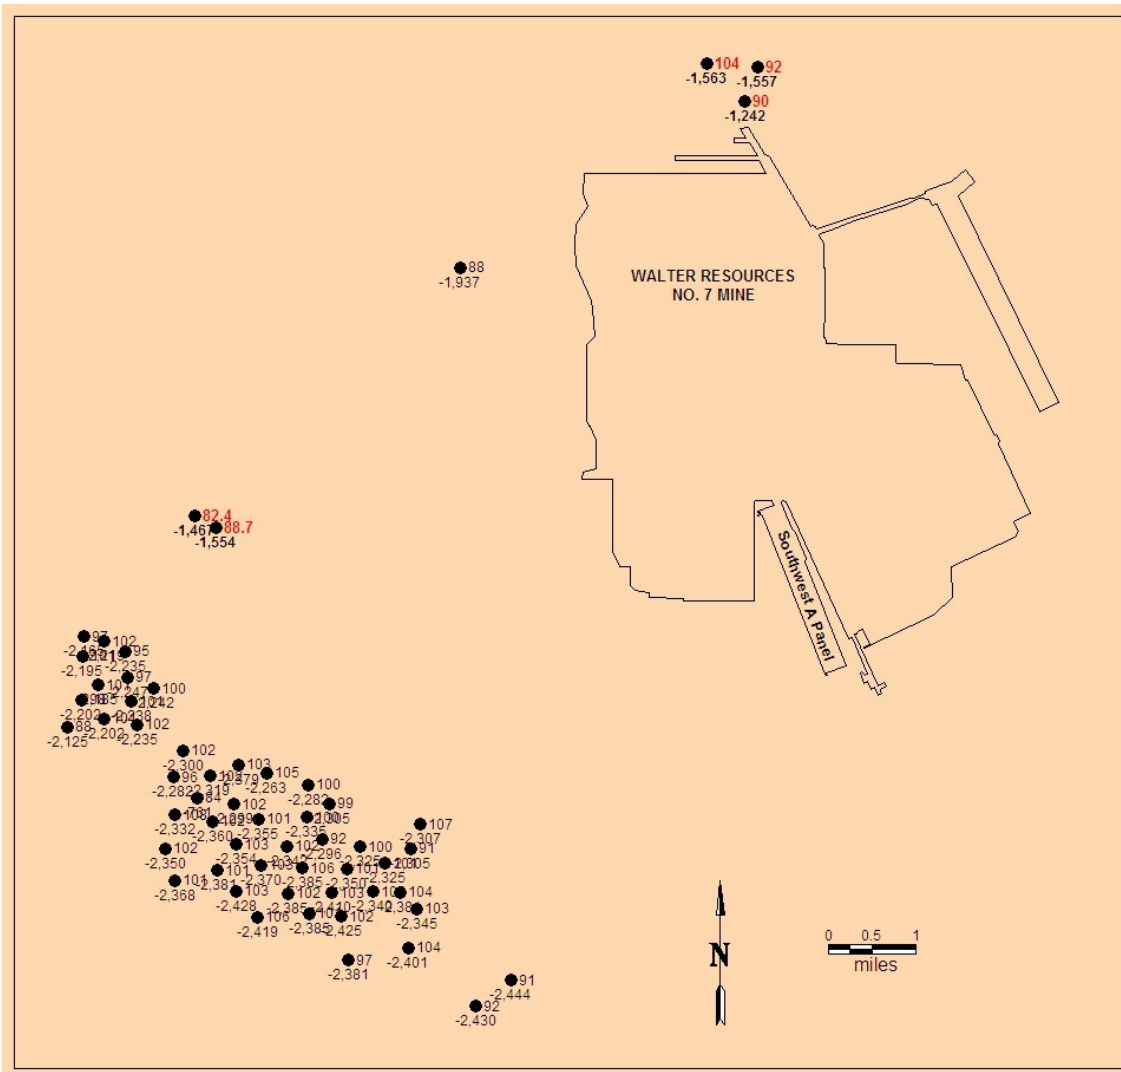
A third method involves the examination of a few specific bore hole temperature measurements from gas wells in the vicinity, and at similar elevations, of the Southwest A Longwall Panel. Figure 6 shows the location of 57 boreholes, their bottom elevation, and estimated bottom temperature, derived from the Brookwood Borehole Temperature database maintained by the Geological survey of Alabama. The large cluster of gas wells located southwest of the mine was drilled significantly deeper than the mine horizon. However, five of the holes north and east of the No. 7 Mine (Shown in red on Figure 6.) were drilled to elevations between -1200 and -1700 feet, roughly equivalent to the Southwest A Longwall Panel (-1300 to -1600 ft). The temperature range for these holes is 82°F to 104°F with a mean of 91.4°F. Again, these temperatures would be minimum estimates. In-situ rock temperatures could be a few degrees higher. The range in temperatures is reflective of temperature variation in the rest of the wells, regardless of depth. There do not appear to be any discernible factors that control the variation of temperature in holes drilled in close proximity to each other. They often show a significant temperature difference. It is possible that some of the variance is due to differences in drilling fluid temperatures or the amount of time elapsed between drilling a hole and recording the temperature.

Figure 6. Gas well data from holes drilled near the Jim Walter Resources, Inc., No. 7 Mine. Black dots are hole locations. Temperatures (°F) are shown to the right of the hole location, and elevation (MSL) is shown below. Temperatures shown in red were recorded in holes drilled to approximately the same elevation as the Southwest A Longwall Panel.
