**UNITED STATES  
DEPARTMENT OF LABOR  
MINE SAFETY AND HEALTH ADMINISTRATION  
COAL MINE SAFETY AND HEALTH**

**REPORT OF INVESTIGATION  
Surface Coal Mine  
Fatal Machinery Accident  
March 6, 2009**

**Dolet Hills Lignite Company Mine  
Dolet Hills Lignite Company LLC  
Mansfield, De Soto County, Louisiana  
ID No. 16-01031**

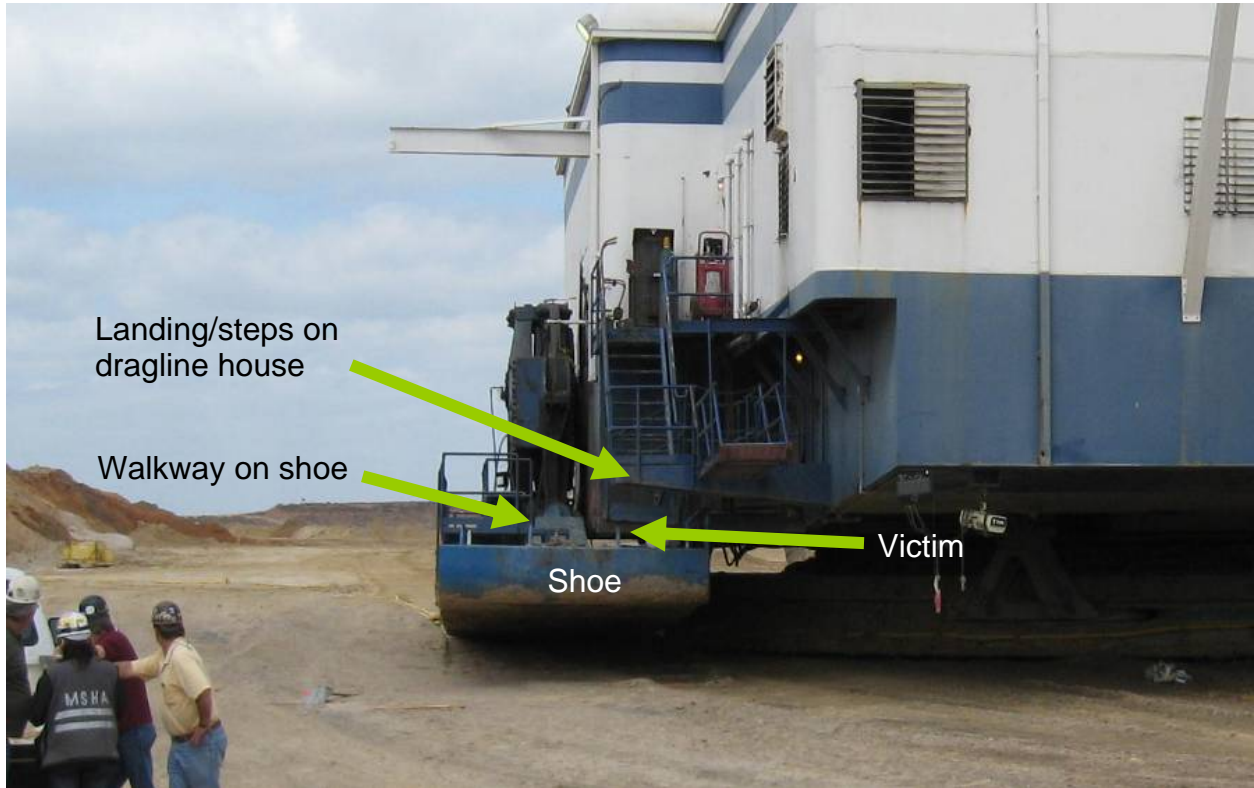
Freeman was found approximately 10 feet from the walkway on the left dragline shoe where he was last seen standing, apparently waiting to board the dragline house. He was found lying in a prone position on top of the shoe, between the inside edge of the shoe and the cam housing. The victim was located parallel to the inside edge of the shoe, facing forward and his feet nearer to the walkway where he was last seen. In this location, he was positioned between the cam housing on his left and the shoe guide located on the bottom of the house to his right. The cam housing and shoe guide prevented Freeman from rolling left or right to avoid being crushed by the dragline house. His hard hat was found on the top of the shoe, just to the side of his head, and was undamaged. He was wearing the electrical gloves that were normally used to

Measurements were taken between the top of the left walking shoe and the bottom of the dragline house at the location where Freeman was found to determine the clearance distance between the shoe and house during the walking procedure. The left shoe is located on the opposite side of the dragline from the operator's cab. Refer to Appendix B for the shoe location. With the walking shoe fully retracted in the minimum clearance position, the minimum distance from the shoe to the machine house was 7.25 inches. The clearance increased to 8.37 inches at the center of the area and 10.5 inches along the inside edge of the dragline shoe closest to the tub. With the walking shoe just touching the ground, measurements at these locations ranged between 34.25 and 35.75 inches. In the high cam position, where the maximum clearance occurred, the measurements ranged between 56 and 56.5 inches.

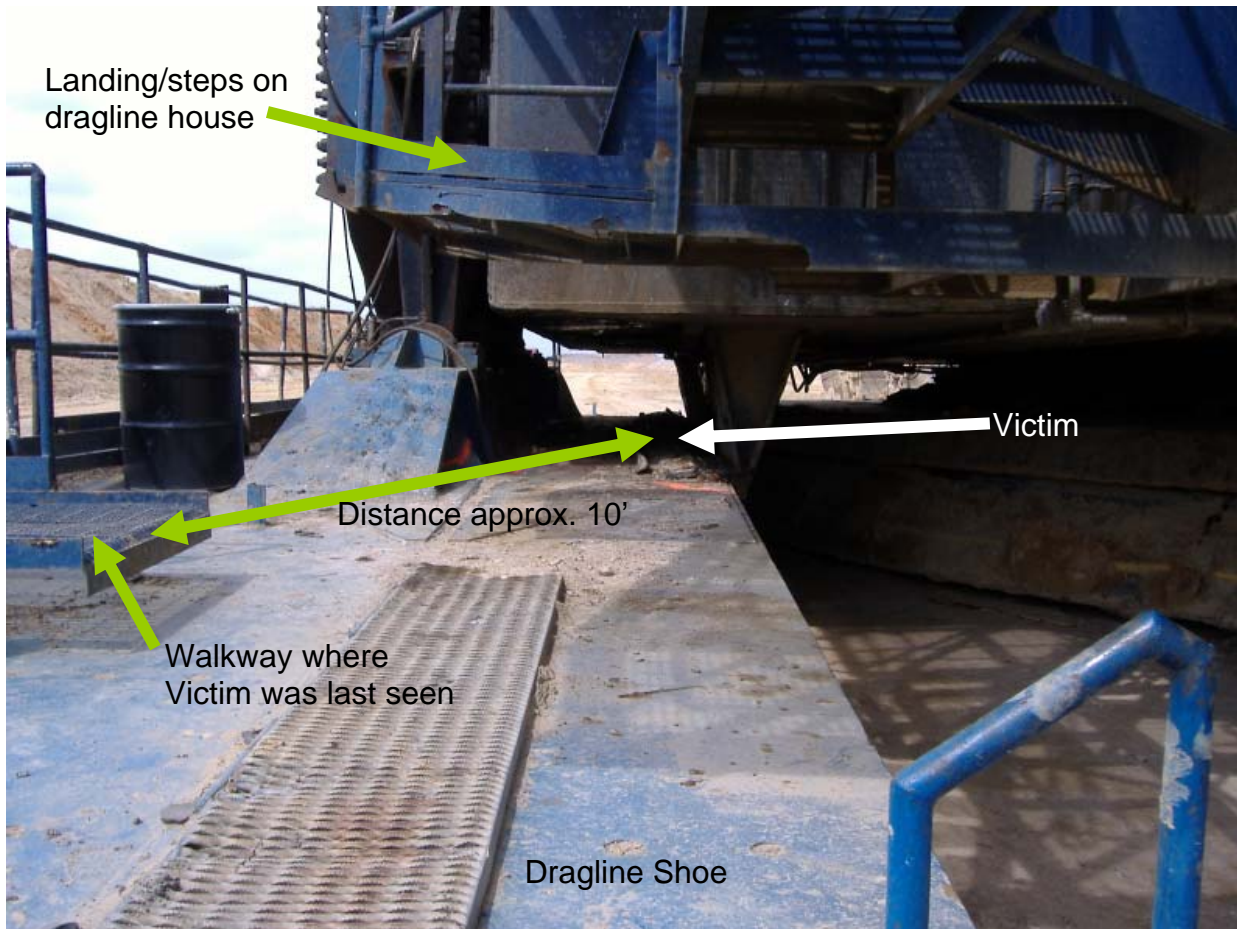
Freeman was last seen standing on the walkway on the left shoe, apparently waiting to board the dragline house after having added grease to the cam/slide mechanism on the shoe. To board the house, Freeman had to wait during the walking process for the walkway to line up with the landing/steps on the house. This occurred once during each step as the shoe rotated on the cam assembly. When aligned, the walkway on the shoe and the landing on the house presented an easy stepping situation from the shoe to the house. See Appendix D for a picture of the step required. Freeman was found approximately 10 feet away from the walkway where he was last seen waiting to board

the house. During the investigation, the walking shoe was observed to wobble and shake noticeably as the shoe rotated during the walking process.

Investigators observed a hand/finger mark on the left-side, middle handrail on the house landing/steps. The mark could have been made by Freeman as he placed his hand on the rail and it slid off in an attempt to board the house. A short vertical piece of angle iron was located on the dragline shoe a short distance from the end of the walkway where Freeman was last seen. See Appendix E for a view of this angle iron. The angle iron had a smudge on it that could have been made by a shoe impact. It is possible that Freeman attempted to board the dragline house before the walkway and landing lined up, lost his balance and grip and fell, striking the angle iron, and stumbled, landing between the shoe and the house where he was found.
