REPORT OF INVESTIGATION

Fall of Roof Accident
April 28, 2010

Dotiki Mine
Webster County Coal, LLC
Nebo, Hopkins County, Kentucky
ID No. 15-02132

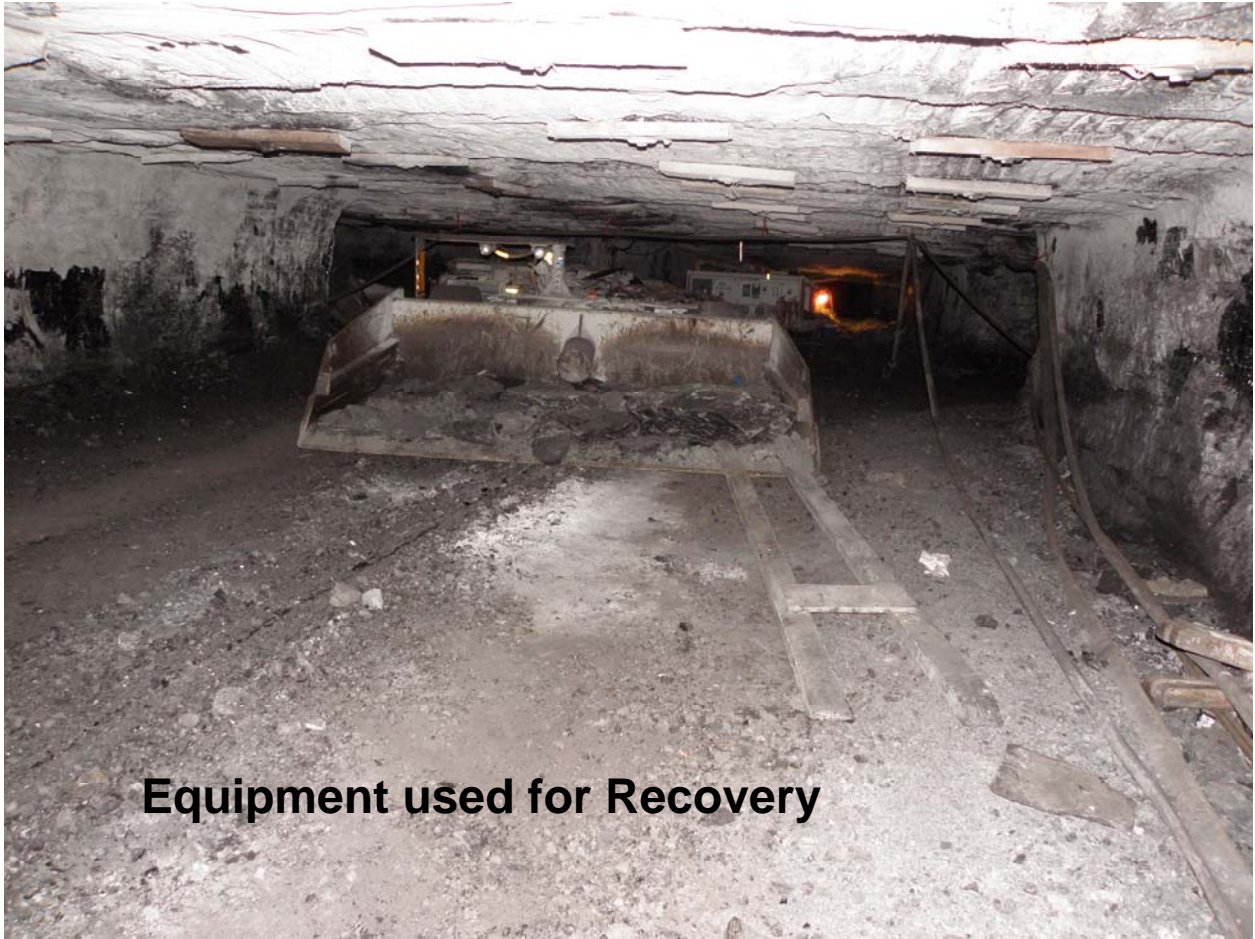
Exhibit 1

Equipment used for Recovery

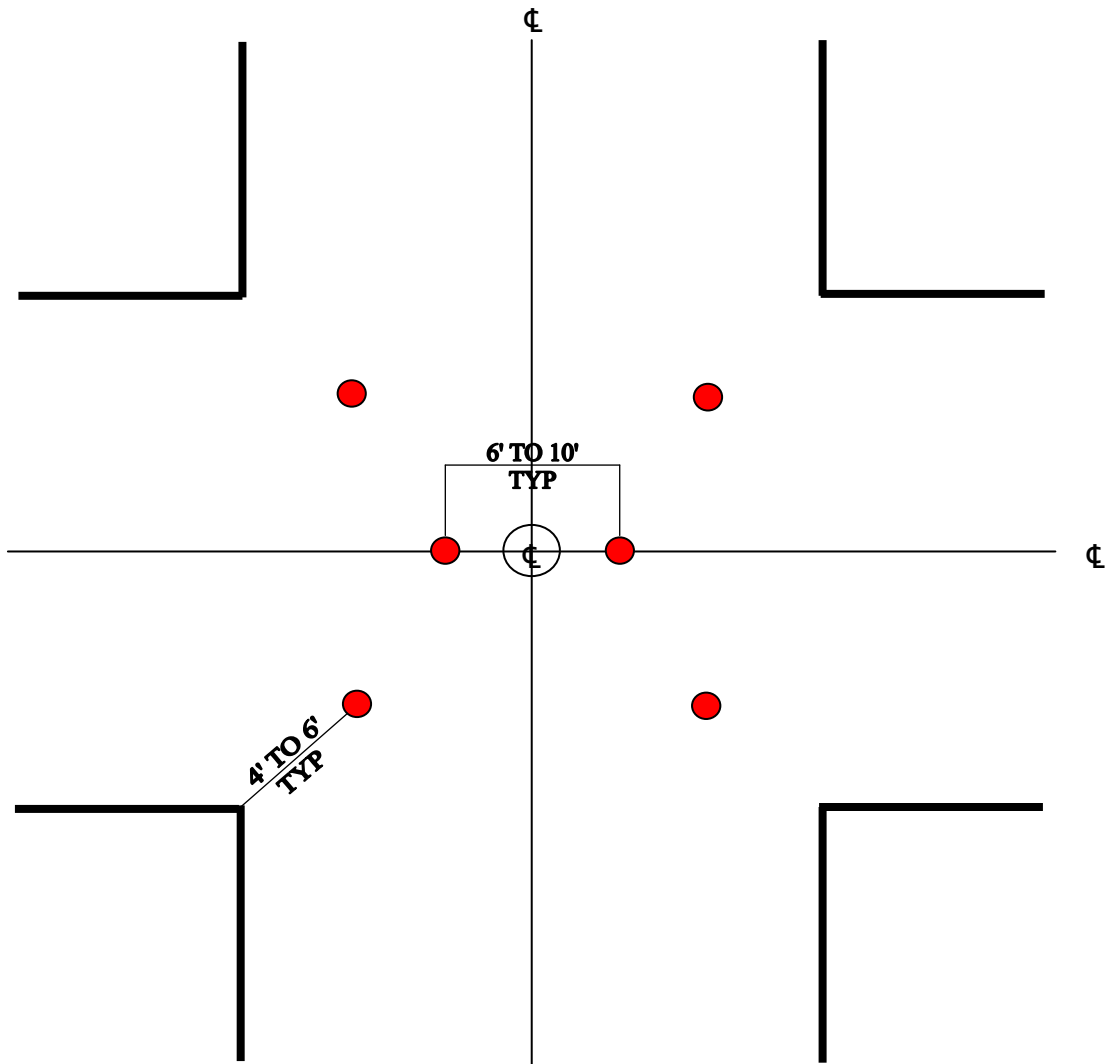
Exhibit 5

#9 AND #11 SEAM
SUPPLEMENTAL SUPPORT OPTIONS

PLAN E

8' MINIMUM VERTICAL CABLE BOLT
WITH 8" X 8" X 3/8" PLATE
HOLE DEPTH 8' MINIMUM
