REPORT OF INVESTIGATION

Powered Haulage Fatality
October 27, 2010

River View Mine
River View Coal LLC
Waverly, Union County, Kentucky
ID No. 15-19374

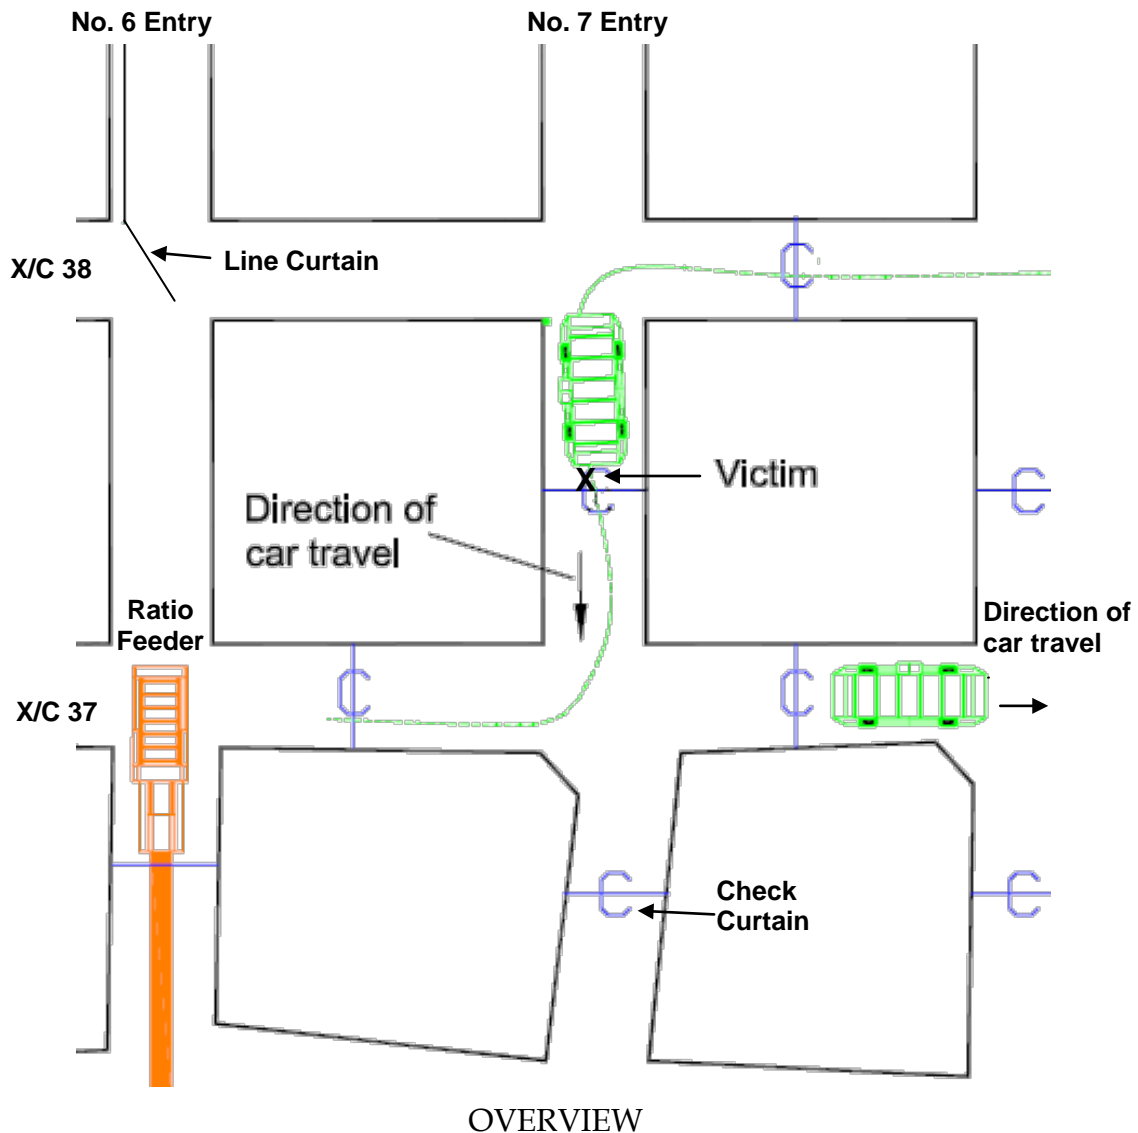
Accident Scene Sketch

On Wednesday, October 27, 2010, at approximately 7:50 a.m., 39-year old James J. Falk (victim), Continuous Mining Machine Helper, was killed when he was struck by a shuttle car being operated on the No. 6 Working Section, MMU# 014-0. Falk was last seen in the No. 7 Entry between crosscuts No. 37 and No. 38, on the inby side of the ventilation curtain, making repairs to the curtain. Justin Butts, Shuttle Car Operator, was hauling coal from the continuous mining machine to the ratio feeder, when he trammed out of the last open crosscut into the No. 7 entry and struck Falk, while the victim was repairing the curtain. Butts, unaware of the accident, was returning from the ratio feeder, when he discovered Falk in the No.7 entry, approximately twenty seven feet outby the check curtain. Falk was recovered by mine personnel and transported to the surface.
