**REPORT OF INVESTIGATION**

**Fatal Machinery Accident**

**October 17, 2011**

**Shoemaker Mine  
Consolidation Coal Company  
Dallas, Marshall County, West Virginia  
MSHA ID No. 46-01436**

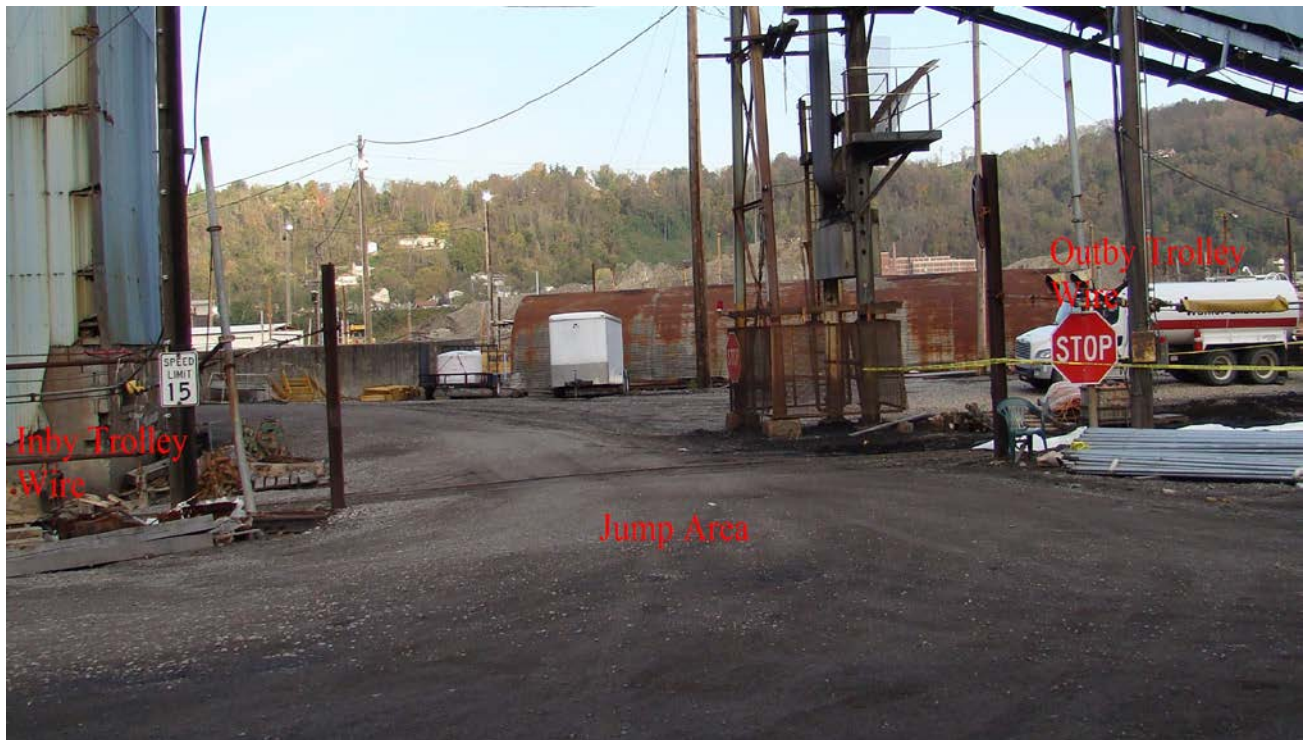
On October 17, 2011, Charles McIntire (Victim) was killed after being struck by a track-mounted ditch digging machine, powered by direct current (dc) electric trolley. McIntire exited the mine on the ditch digging machine and stopped at a break on the surface in the trolley wire. The accident location was referred to as the "Jump Area." McIntire dismounted the machine with the forward tram controls set for high-speed and did not set the park brake. He obtained a fused nip, located along the track at the outby end of the jump area, placing one end of the nip on the energized trolley wire. McIntire placed the other end of the nip on the machine's trolley pole, causing the machine to move forward suddenly, running over him.
