REPORT OF INVESTIGATION

Surface River Coal River Loading Facility

Drowning Accident

February 26, 2012

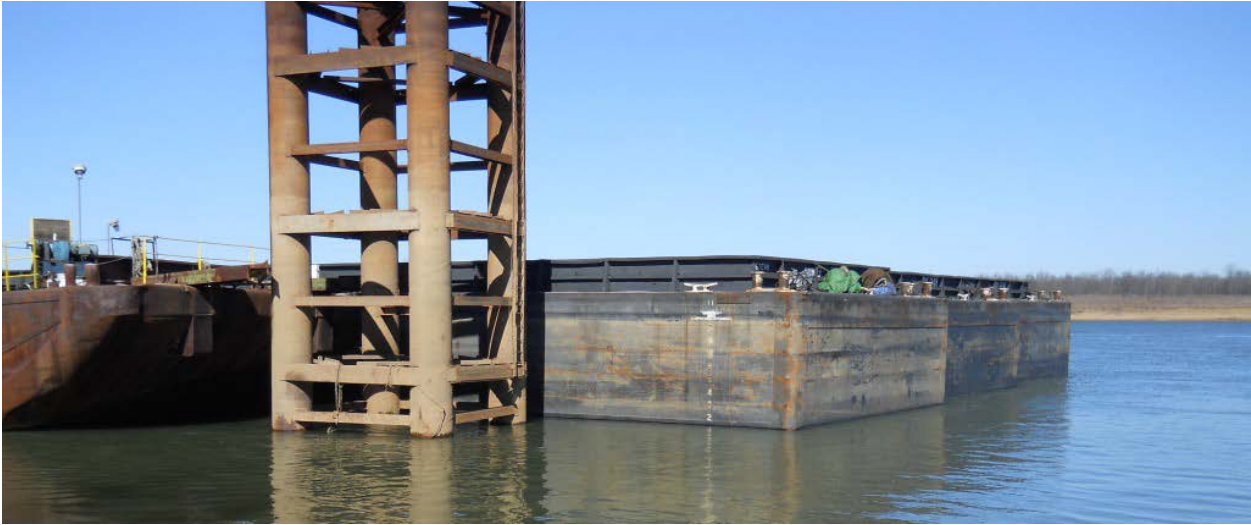
ACCIDENT SCENE

The work conditions on Barge # 1113 on February 26, 2012 were reported to be: no ice on the barge deck, some wet areas on the barge deck from previous washing, no loose coal or coal fines on the barge deck, and all hatches were closed and secured.

Exhibit 1 (found in Appendix B) shows the relatively narrow walkways (24") and several protrusions in the walkway. These include manholes and gunwales. When empty, the barge protrudes from the water approximately 11 feet. The barges are approximately 195 feet long and 35 feet wide. One end of the barge is vertical and the other end has a sloped end, which is called the rake. The rake is designed to help the barge move through the water. The victim was last observed on the rake end of the empty barge, where he was to take the draft reading. It cannot be determined specifically when or how the victim entered the water. According to the Coroner's Report, the victim died from drowning.
