REPORT OF INVESTIGATION

Surface of an Underground Coal Mine

Fatal Slip/Fall of Person Accident  
April 25, 2012

McCoy Elkhorn Coal Corp.  
KC #1 Mine  
Mousie, Knott County, Kentucky  
15-18747  
Accident Investigators

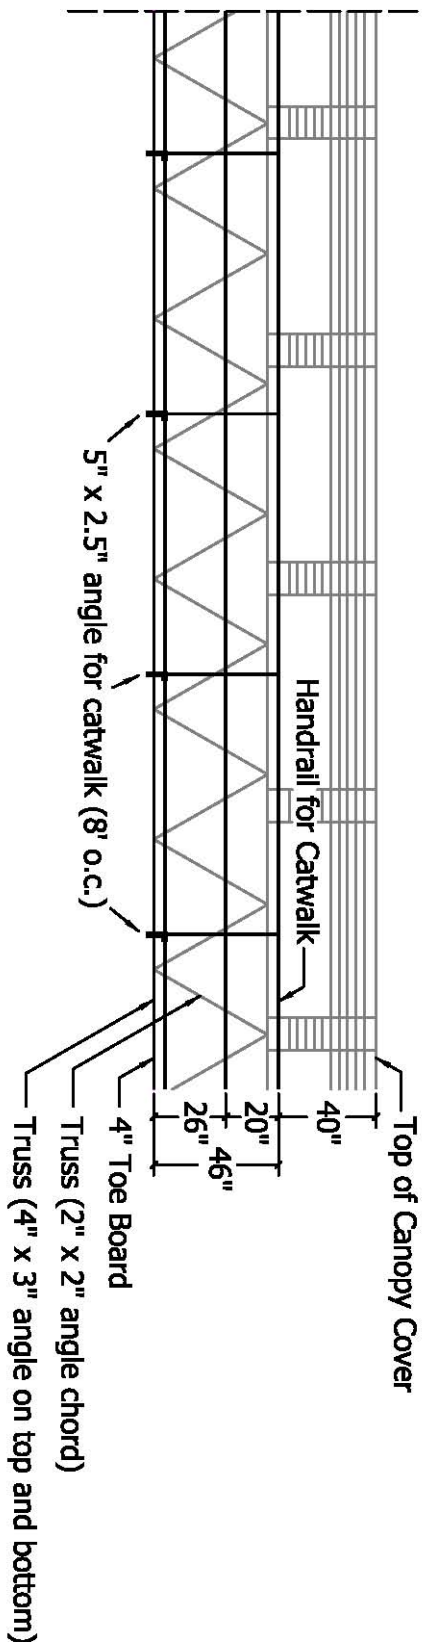
# CONVEYOR BELT STRUCTURE ENLARGEMENT

On Wednesday, April 25, 2012, at approximately 8:50 a.m., Delmer Miller (Victim), a 61-year-old Cutter/Welder contract employee for T&B Recycling & Transport (T&B) was in the process of dismantling the elevated conveyor structure from the surface area of a non-producing underground coal mine. When Miller completed the final torch cut from the elevated support beam that contained a counter-weight, the structure fell and contacted the walkway (catwalk) on which Miller was standing. The structure was located down slope 35 feet above the floor of the box cut. A section of the catwalk, approximately 25 feet in length, broke loose from the main structure and bent downward from the weight of the up slope structure that had been cut loose. The catwalk that Miller was standing on came to a sudden stop at 27 feet in height, causing Miller to lose his balance and fall.
