**REPORT OF INVESTIGATION**

**Surface Impoundment Facility**

**Dam Failure Accident (Drowning)**

**Nolan Run Slurry Impoundment  
Impoundment Site I.D. No. WV03-00161-00  
Robinson Run No. 95 Mine  
Consolidation Coal Company  
Near Lumberport, Harrison County, West Virginia  
Mine ID No. 46-01318**

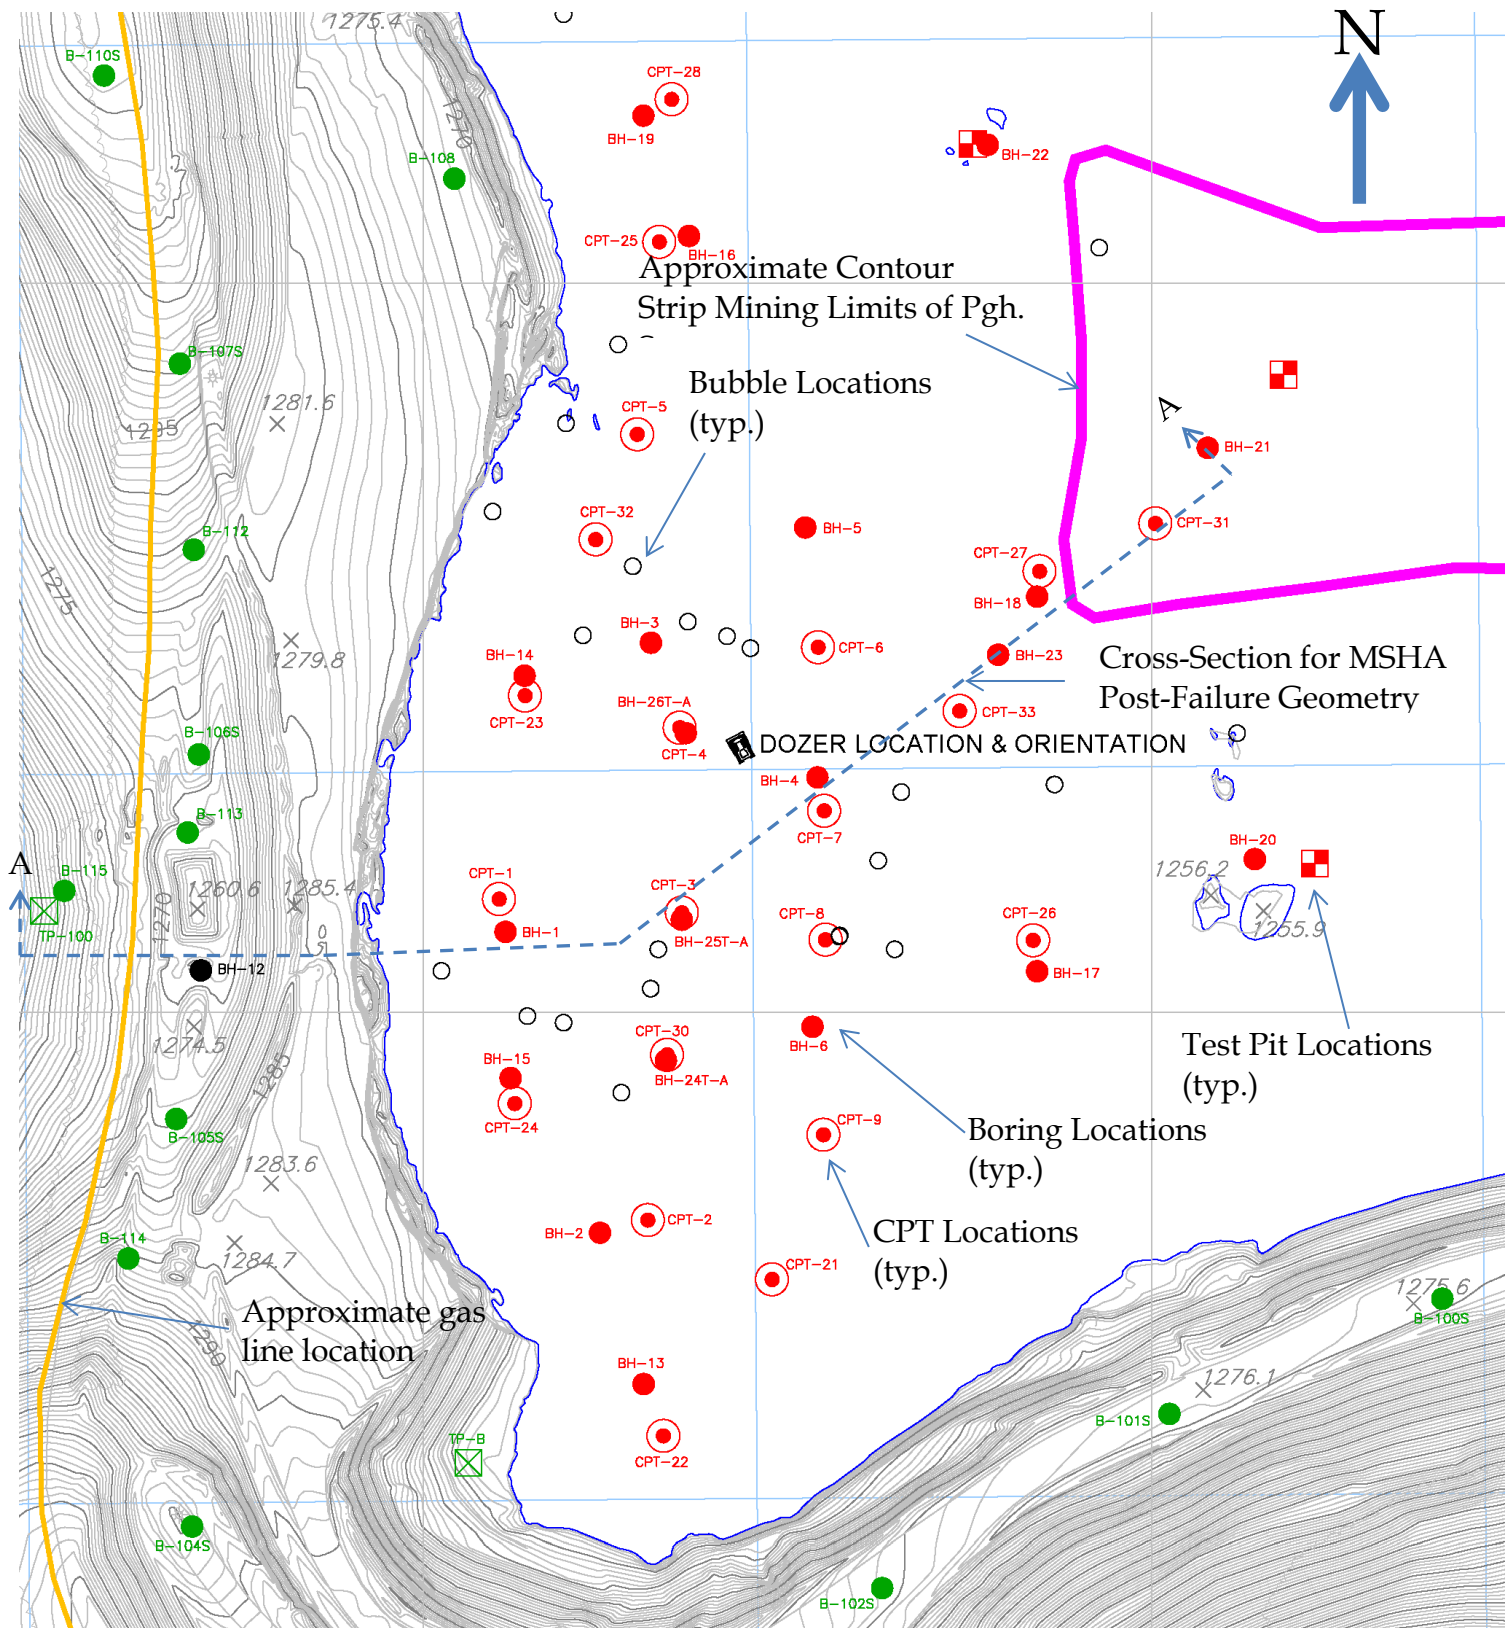
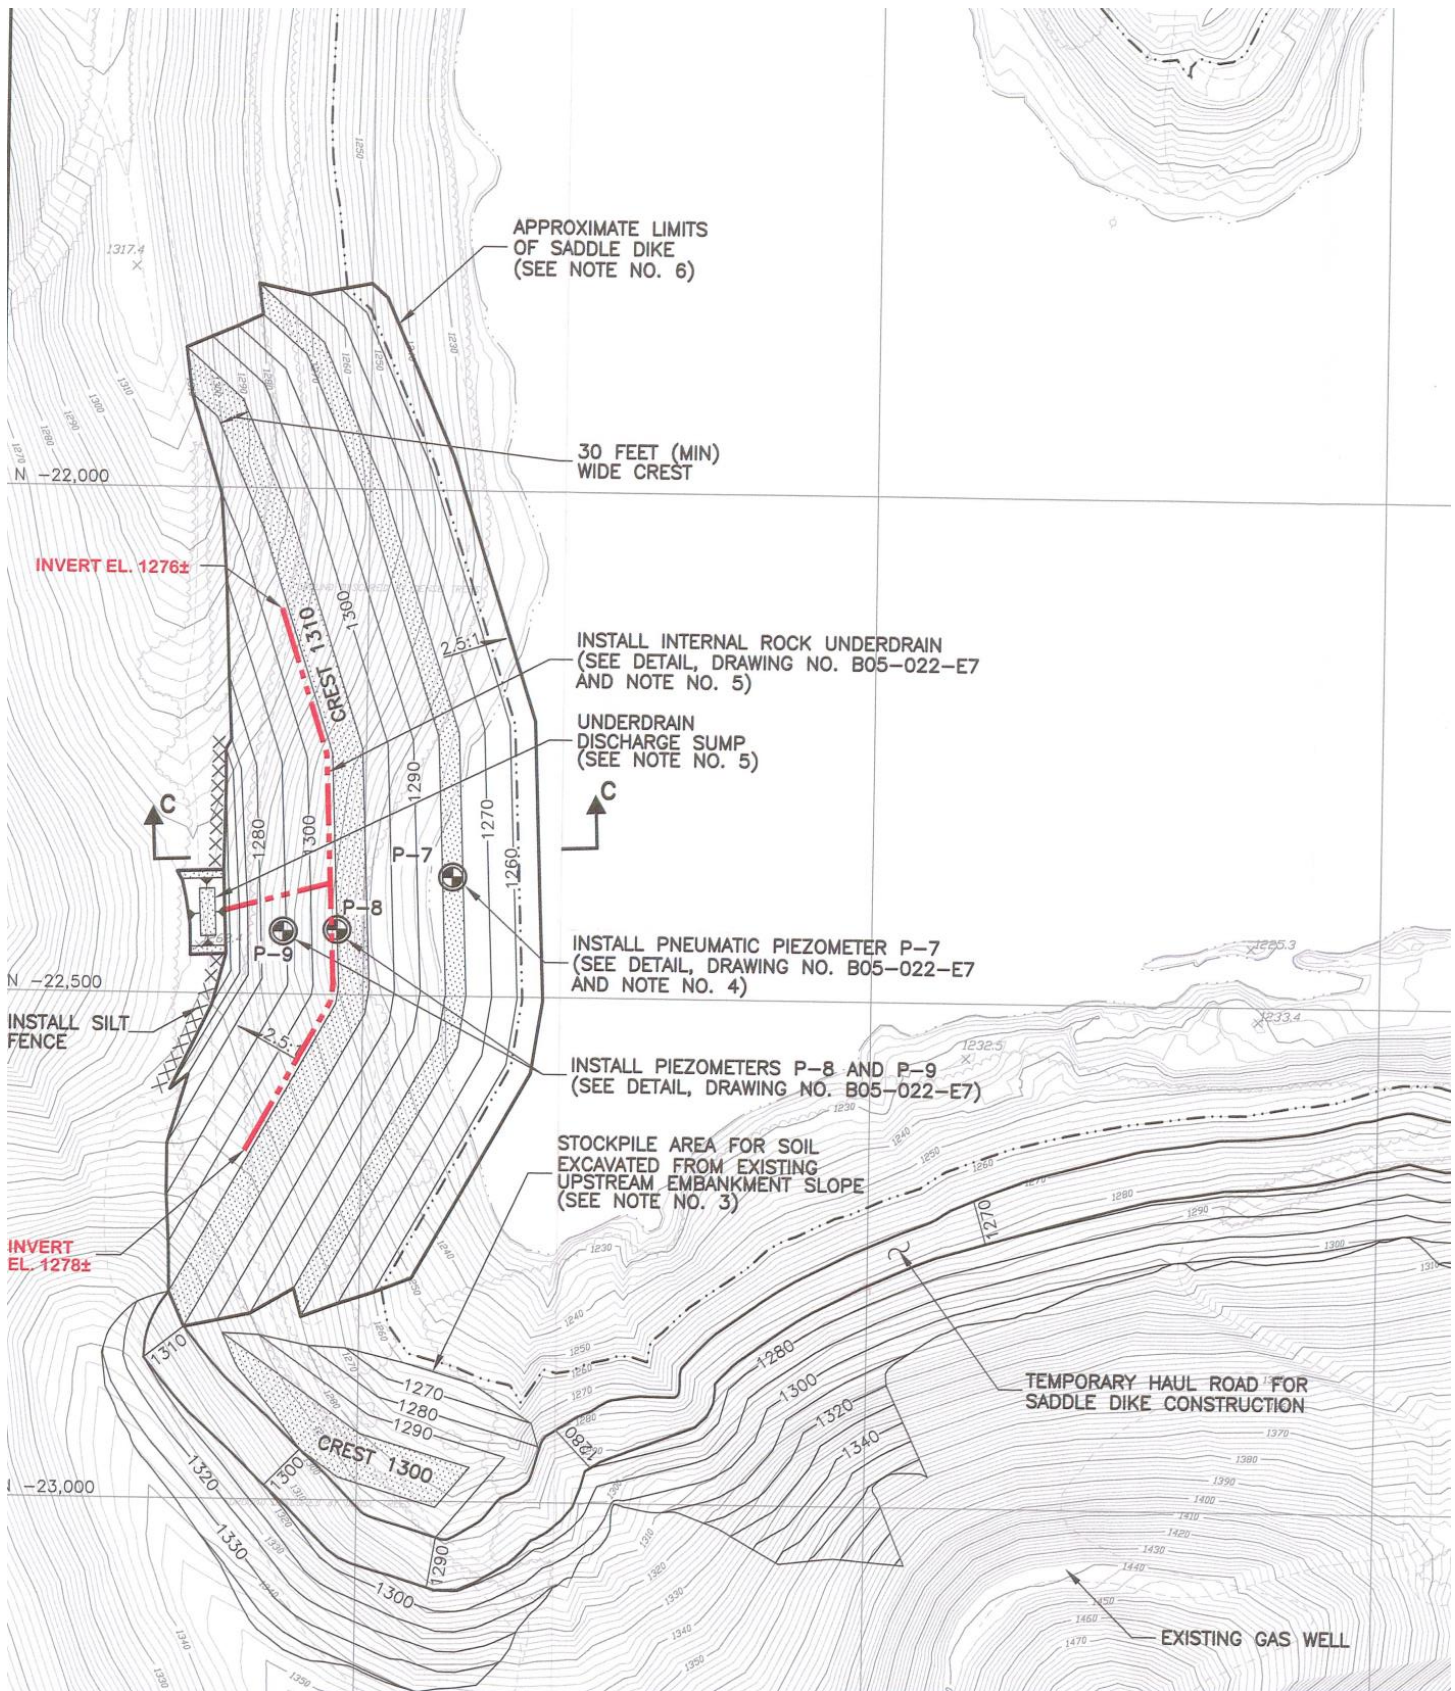
**Figure 2**  
**Boring Location Plan**  
 Portions of "Boring Location Map"  
 Drawing No. B12-594-E4  
 Revision Date: December 3, 2012

A subsurface exploration program was conducted by the operator as part of the accident investigation. The program included geophysical exploration, geotechnical drilling and sampling, in situ (in place) material testing, and laboratory testing (see a portion of the boring location map in Figure 2).

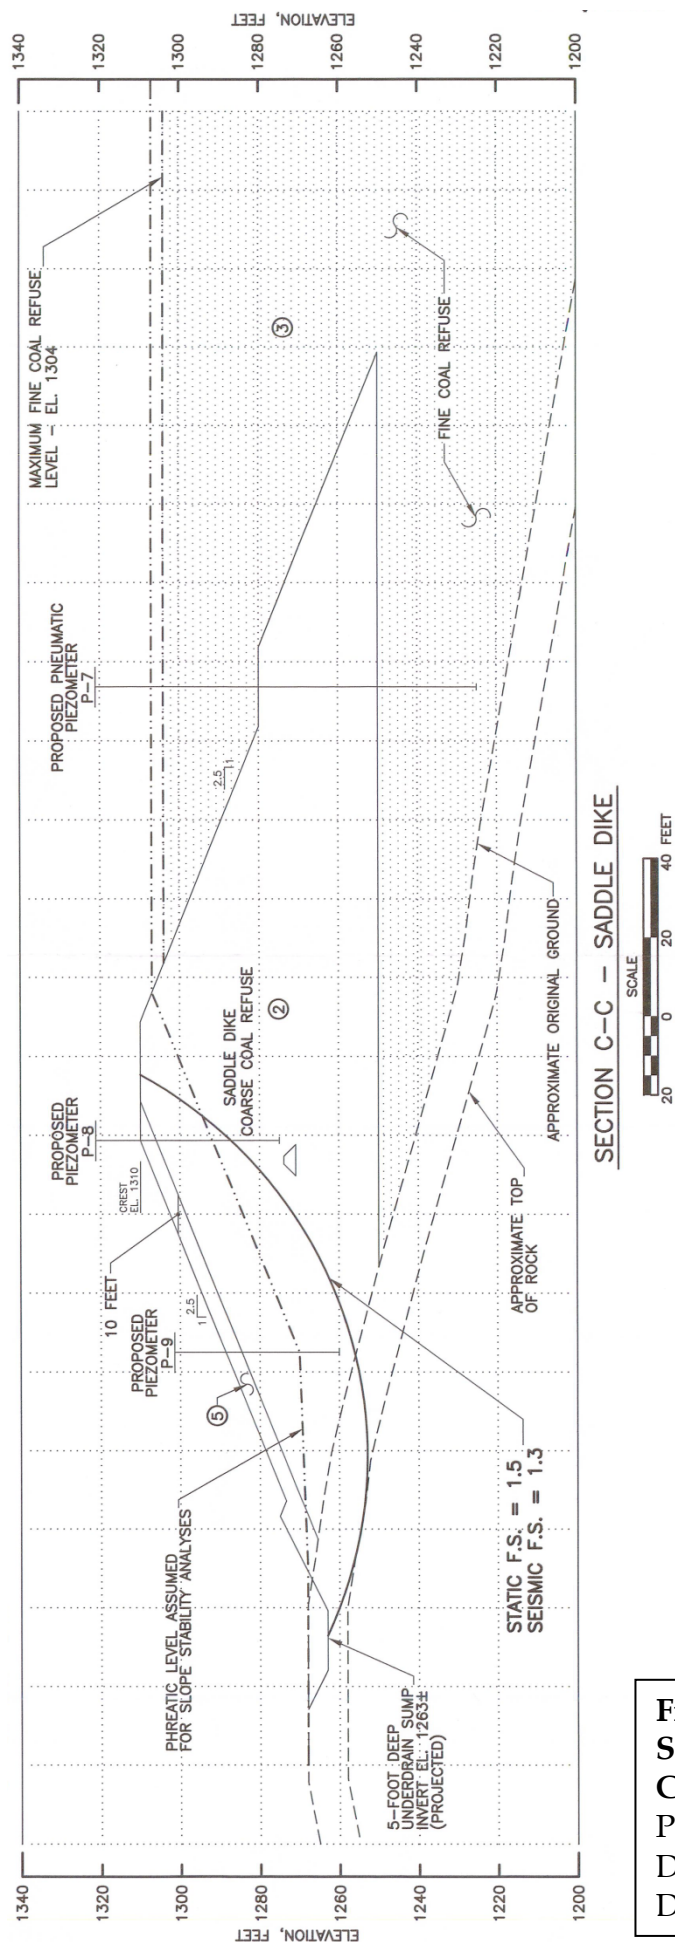
**Figure 3**  
**Saddle Dike Design: Plan View**  
 Portion of "Expansion Plan - Stage IV" Drawing No. B05-022-E2  
 Figure No. 3, Dated February 7, 2007

The Stage 4 plan included the construction of a Western Saddle Dike (Figures 3 and 4). The upstream construction method was also utilized to construct the Western Saddle Dike due to the elevation of the FCR and the narrow width of the ridgeline at the saddle location. The modified Stage 4 plan was approved by the District Manager on April 15, 2009, and construction of the Western Saddle Dike began in April 2012.

Pneumatic Piezometer P-7 was installed at the saddle dike on November 16, 2012, by Triad. The location of this piezometer is shown on Figures 3 and 4. The purpose of a pneumatic piezometer is to monitor the pressure in the pores of fine-grained material, such as FCR, during embankment construction. Pneumatic piezometers respond much more quickly to pressure changes than standpipe piezometers, and are often used in upstream construction. Tolerable excess pore pressures predicted in the design can then be compared with the monitored pore pressures. During material placement on soft, saturated, fine-grained soils, the load is initially carried by the water. The CCR being pushed out onto FCR through upstream construction is similar to building an island on top of mud; the weight of the CCR drives the water from the pores of the underlying material. This consolidation of the underlying FCR and clay occurs at a slow rate due to the low permeability of the material.
