REPORT OF INVESTIGATION

Surface Coal Mine
Fatal Machinery Accident
July 31, 2013

Amerikohl Strips
Oneida Operation Pit 114
Amerikohl Mining Incorporated
Dubois, Jefferson County, Pennsylvania
MSHA ID 36-09654

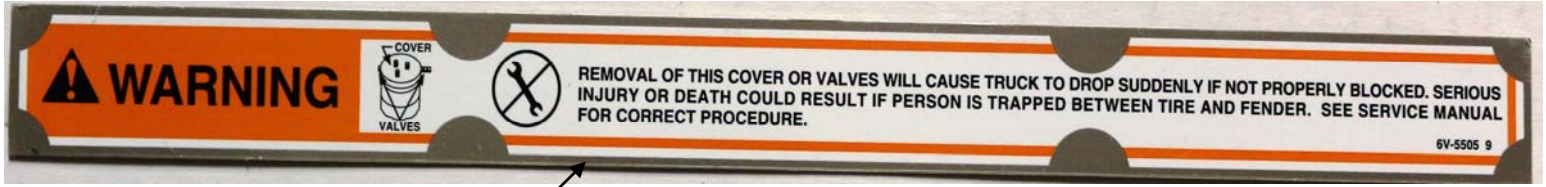
Appendix C - Photographs of Warning Label and Suspension Cylinder Cover Assembly

2. *Root Cause:* The victim did not receive task training with regard to the hazards associated with the cylinder cover assembly. The cover assembly can be mistaken as a guard on the cylinder head. The lack of structural rigidity and the open design of the cover could give the impression that the cover assembly was a guard for the bolts securing the cylinder head. In addition, the following procedure from the service manual could have been misunderstood or caused confusion: "Check for leakage at the O-rings that are located under the protective plates that are on the head. These protective plates cover some of the head bolts in order to prevent removal of the head while there is pressure in the suspension cylinder."

The accident occurred when the third and final bolt on the cylinder cover assembly was loosened on the truck's pressurized suspension cylinder cover assembly releasing the cylinder pressure. The right front suspension cylinder suddenly collapsed while the victim was working between the top of the right front tire and the bottom of the right front fender. In addition, the Cat truck frame was not blocked or secured against motion prior to the three cylinder cover assembly bolts being loosened. The victim was not trained adequately with regard to the hazards associated with the cylinder cover assembly.

O-Ring Surrounding Pressure Port

Cover Assembly

Corrective Action: All mechanics received task training on the hazards of the cover assembly.
