REPORT OF INVESTIGATION

Fatal Machinery Accident
December 8, 2015

MC#1 Mine
M-Class Mining, LLC
Macedonia, Franklin County, Illinois
I.D. No. 11-03189

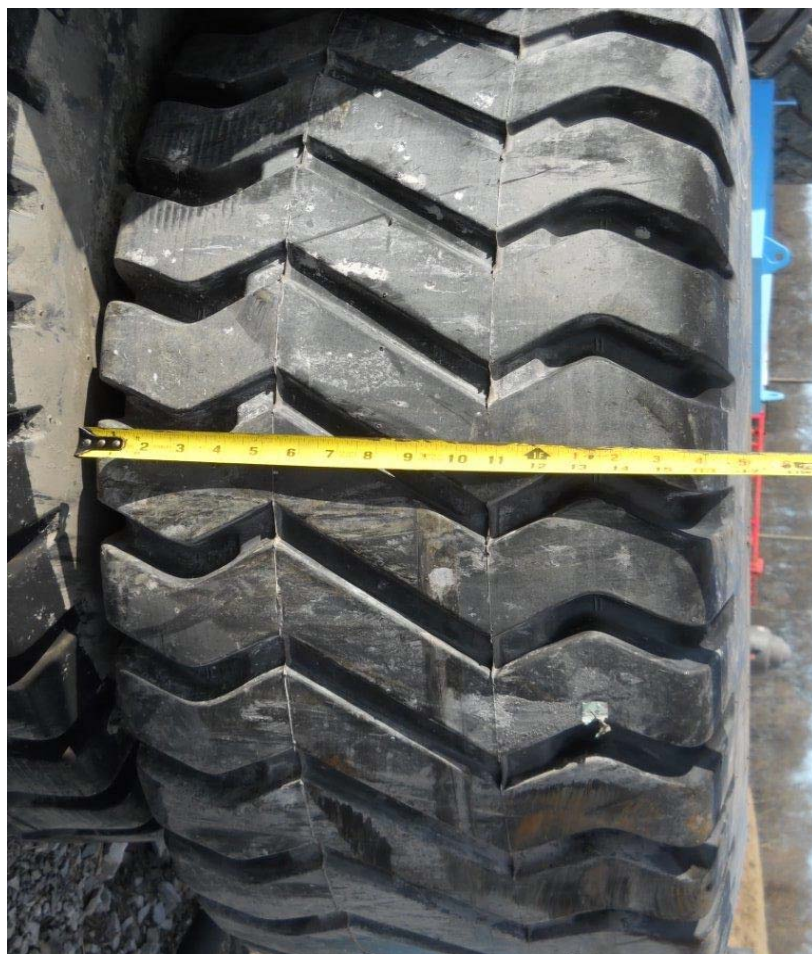
Photo 6: View of New Tire Showing Tread Characteristics

The tractor was using Yokohama Y-67 44X18-20 tires with IND-3 type tread on all four wheels. Visual inspections indicated that the tread conditions for all four of the tires were poor. On the rear tires, the middle section of the tread, between the side lugs, was worn smooth. Photo 4 in appendix D shows the smooth middle section approximately between the 4 inch and 12 inch marks on the tape measure. On the two front tires, the tires were essentially worn smooth across the entire width of the tires. Considerable portions of the side lugs were worn smooth on the two front tires (see Appendix D photo 5). These tread conditions can adversely impact a tire's general performance from a traction and steering standpoint when considering the roadway conditions observed within the accident slope. Photo 6 in appendix D shows a new tire tread for comparison.
