REPORT OF INVESTIGATION

Fatal Powered Haulage Accident  
January 4, 2016

Lower War Eagle  
Greenbrier Minerals, LLC  
Man, Wyoming County, WV  
ID No. 46-09319

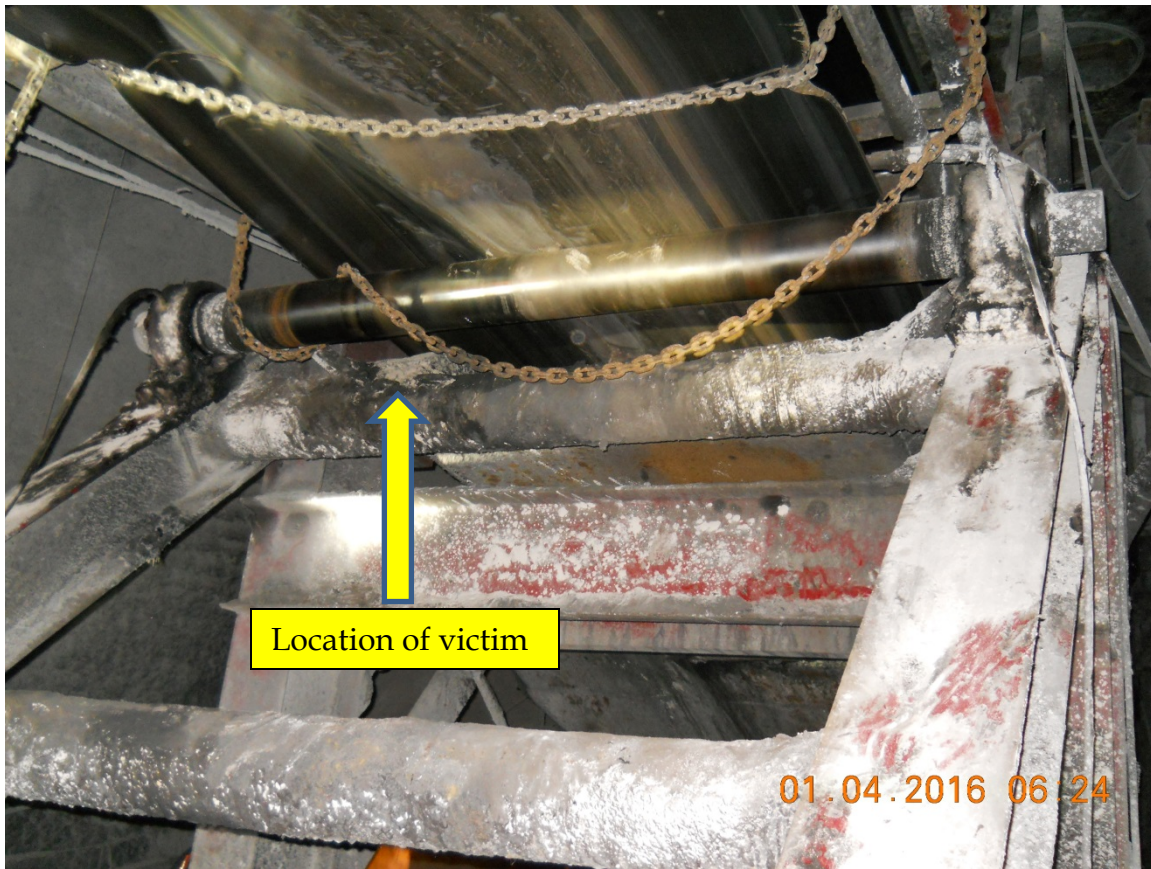
On January 4, 2016, at approximately 12:05 a.m., Peter D. Sprouse, a 53 year old miner received fatal injuries when he became entangled in the bottom hold-up roller and conveyor belt on the No. 1 belt head. The accident occurred because the No. 1 belt drive was not de-energized and blocked against motion while maintenance work was being performed by the victim to change out a bottom hold-up roller.
