REPORT OF INVESTIGATION

Fatal Machinery Accident
July 25, 2017

New St. Nicholas Breaker
Reading Anthracite Company
Pottsville, Schuylkill County, Pennsylvania
ID No. 36-01966

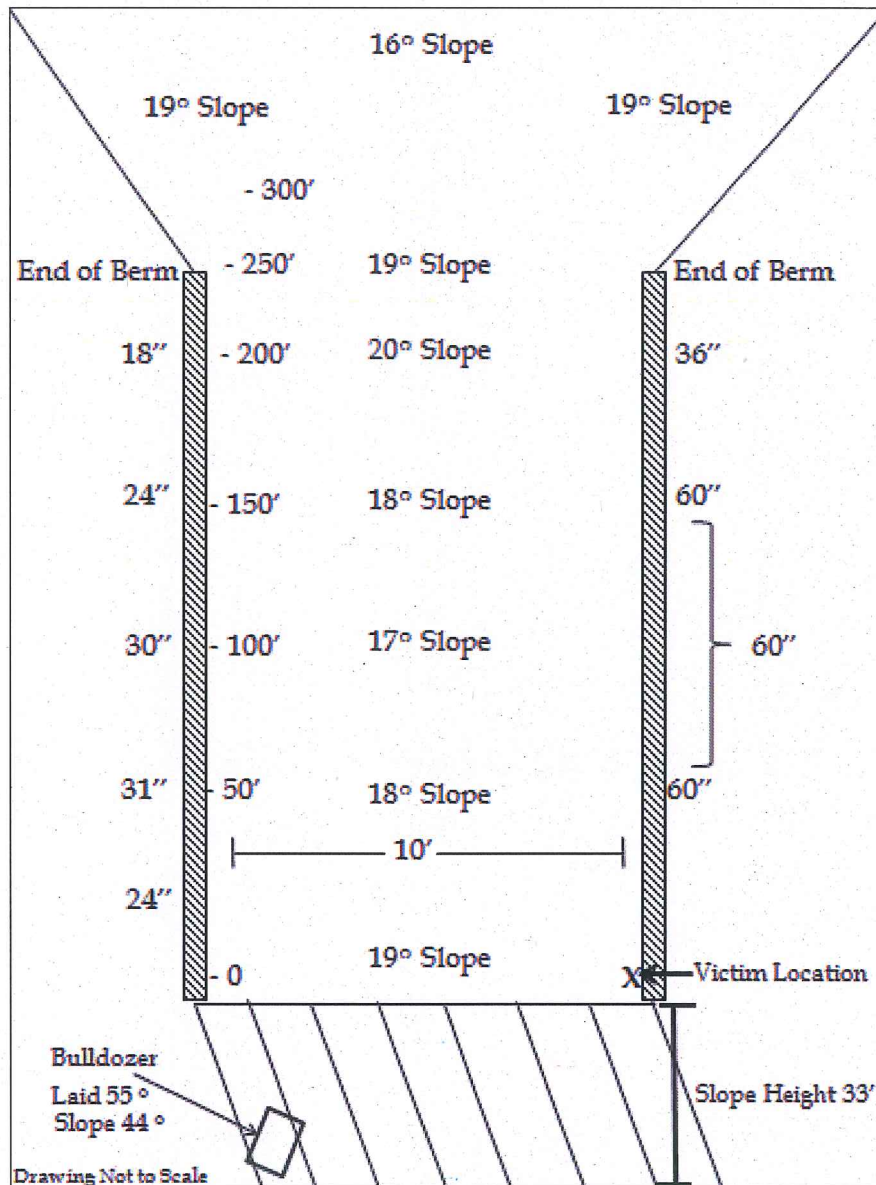
Appendix C Accident Location

Because the manufacturer's parking procedure was not followed, the bulldozer moved downhill after the victim exited the bulldozer. After the bulldozer hit the victim, it travelled over the edge of the refuse pile and went down a 44 degree slope. It traveled to the toe of the slope, and was found in the "laid" position (see Appendix C). Because the blade dug in deeper than the 44 degree slope, the machine was actually at a 55 degree slope when it was found by investigators.
