REPORT OF INVESTIGATION

Fatal Machinery Accident  
October 17, 2018

No. 1 Surface Mine  
Princess Polly Anna Coal, Inc.  
Rupert, Greenbrier County, West Virginia  
ID No. 46-09473

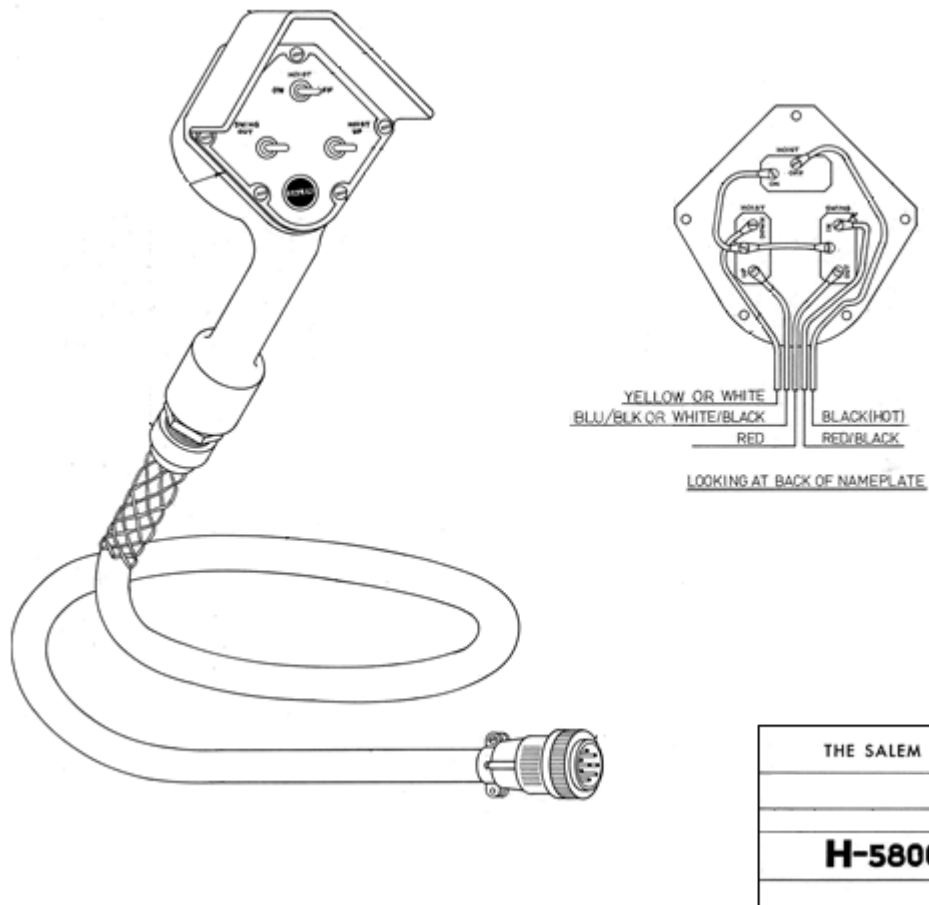
### Crane Boom Hand Held Control Drawing

1. The auger crane boom swings outward slowly without operator input;
2. The hydraulic relief pressure for the auger crane boom jack was set 2.74 times higher than manufacturer's recommended settings. This caused the crane swing to operate suddenly with a jerking motion;
3. The hydraulic relief pressure of the auger crane winch motor was set 1.38 times higher than the manufacturer's recommended setting. This caused the wire rope, hook, and load to jerk upward during lifting;
4. The relief pressure settings and valve bypassing associated with the hydraulic system caused the movements of the auger crane boom to be unexpected and uncontrolled.
