REPORT OF INVESTIGATION

Underground Coal Mine

Fall of Face, Rib, Pillar, or Highwall  
August 29, 2019

Enlow Fork Mine  
Consol Pennsylvania Coal Company LLC  
Prosperity, Washington County, Pennsylvania  
ID No. 36-07416

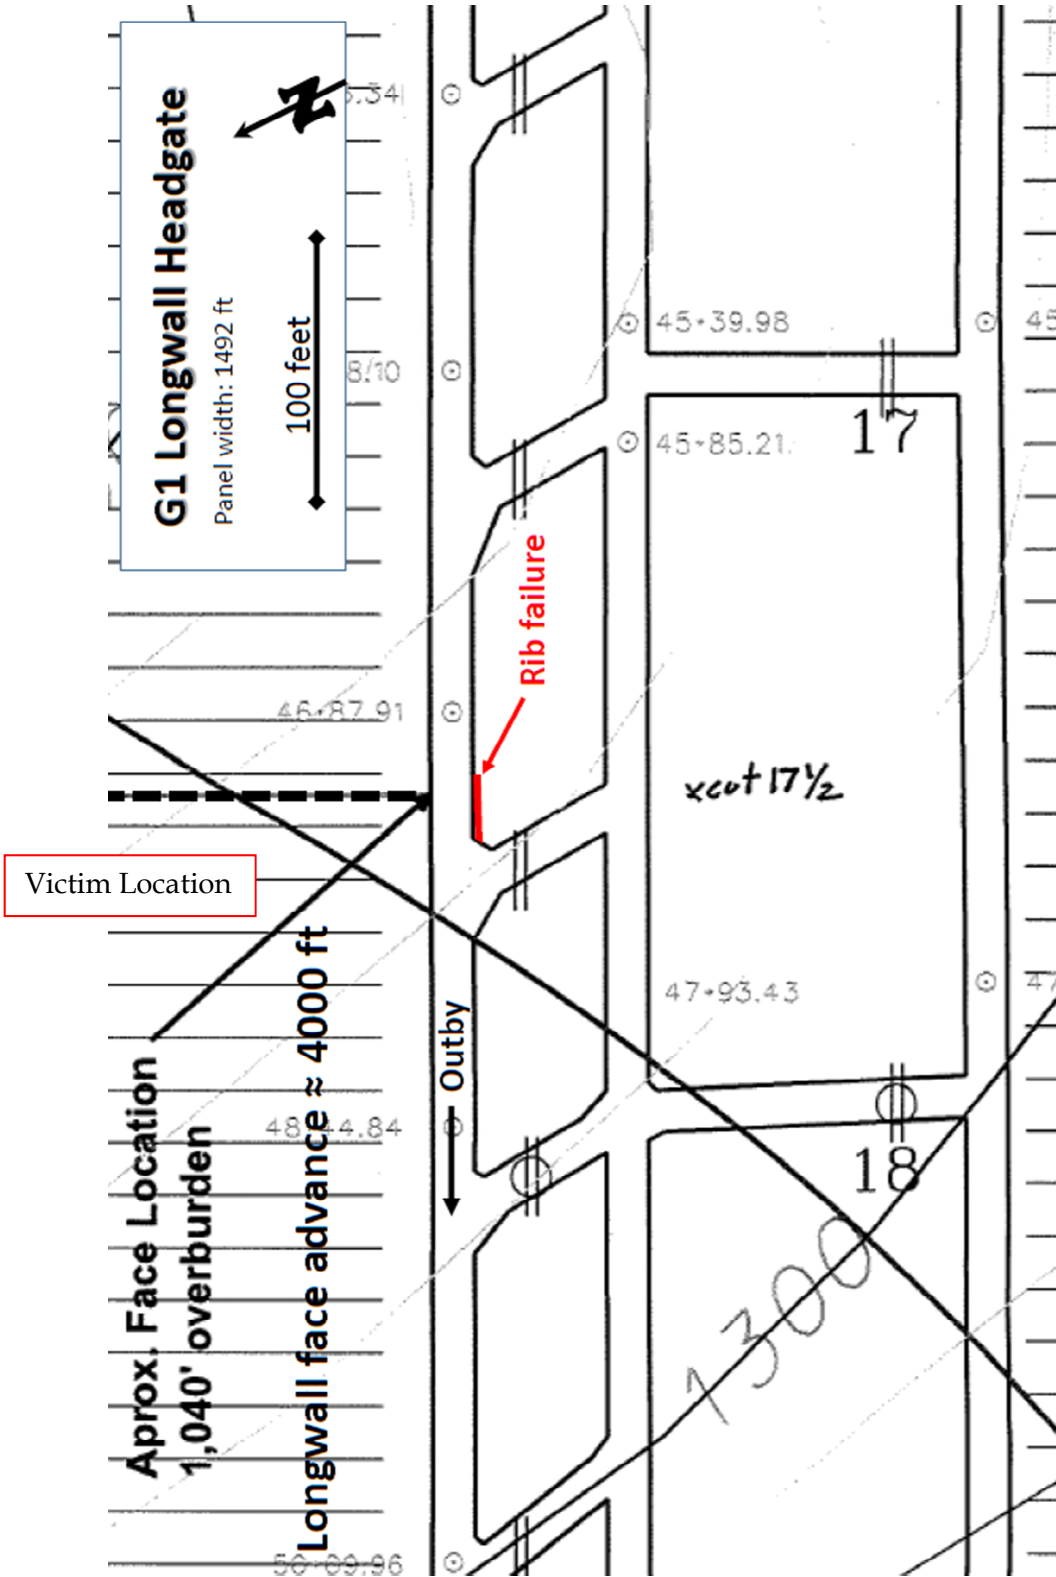
Appendix A  
Section Map  
(Not to Scale)

The accident occurred at the headgate of the G1 longwall panel on the south side of the No. 1 entry at crosscut 17½. Based on excavated debris, the victim was located adjacent to the stage loader approximately 14 feet inby the crosscut 17½ pillar corner. The rib failure extended 25 feet from the outby pillar corner at crosscut 17½ to a point 5 feet inby the longwall shield tips.
