REPORT OF INVESTIGATION

**Fatal Underground Mine Explosion
April 5, 2010**

**Upper Big Branch Mine-South, Performance Coal Company
Montcoal, Raleigh County, West Virginia, ID No. 46-08436**

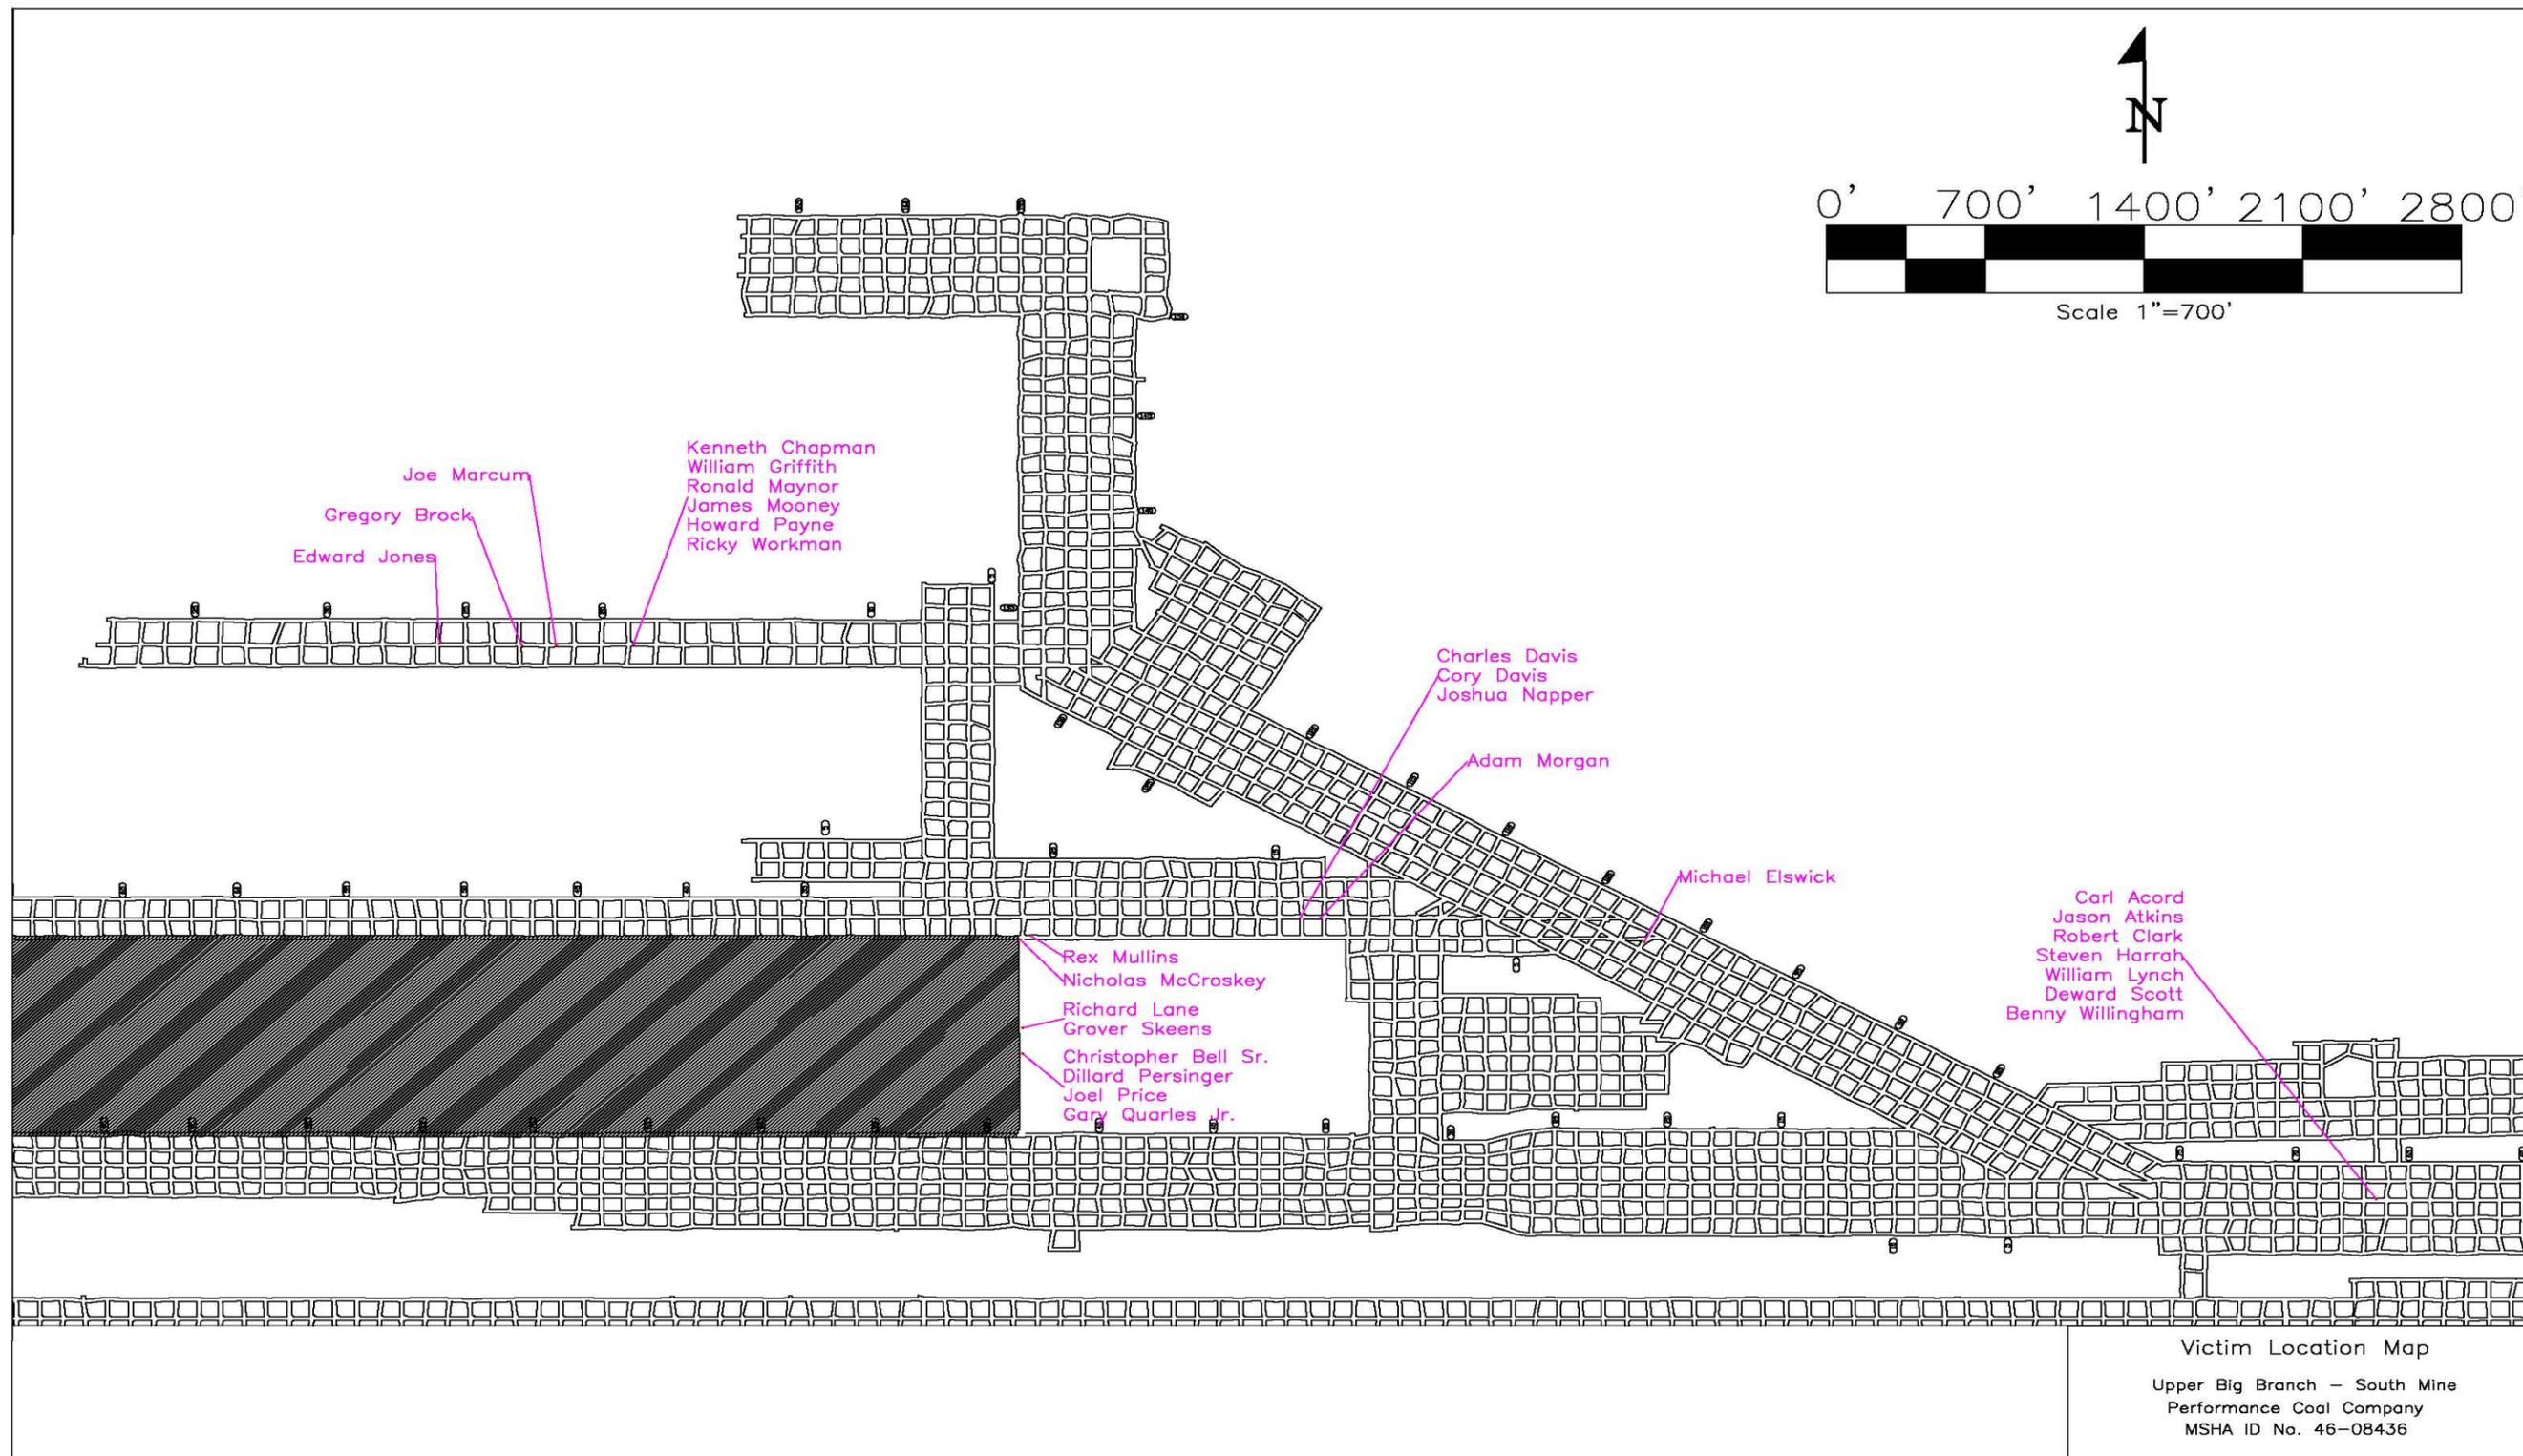
Figure 1: Victim Location Map

Victim locations are depicted in Figure 1.

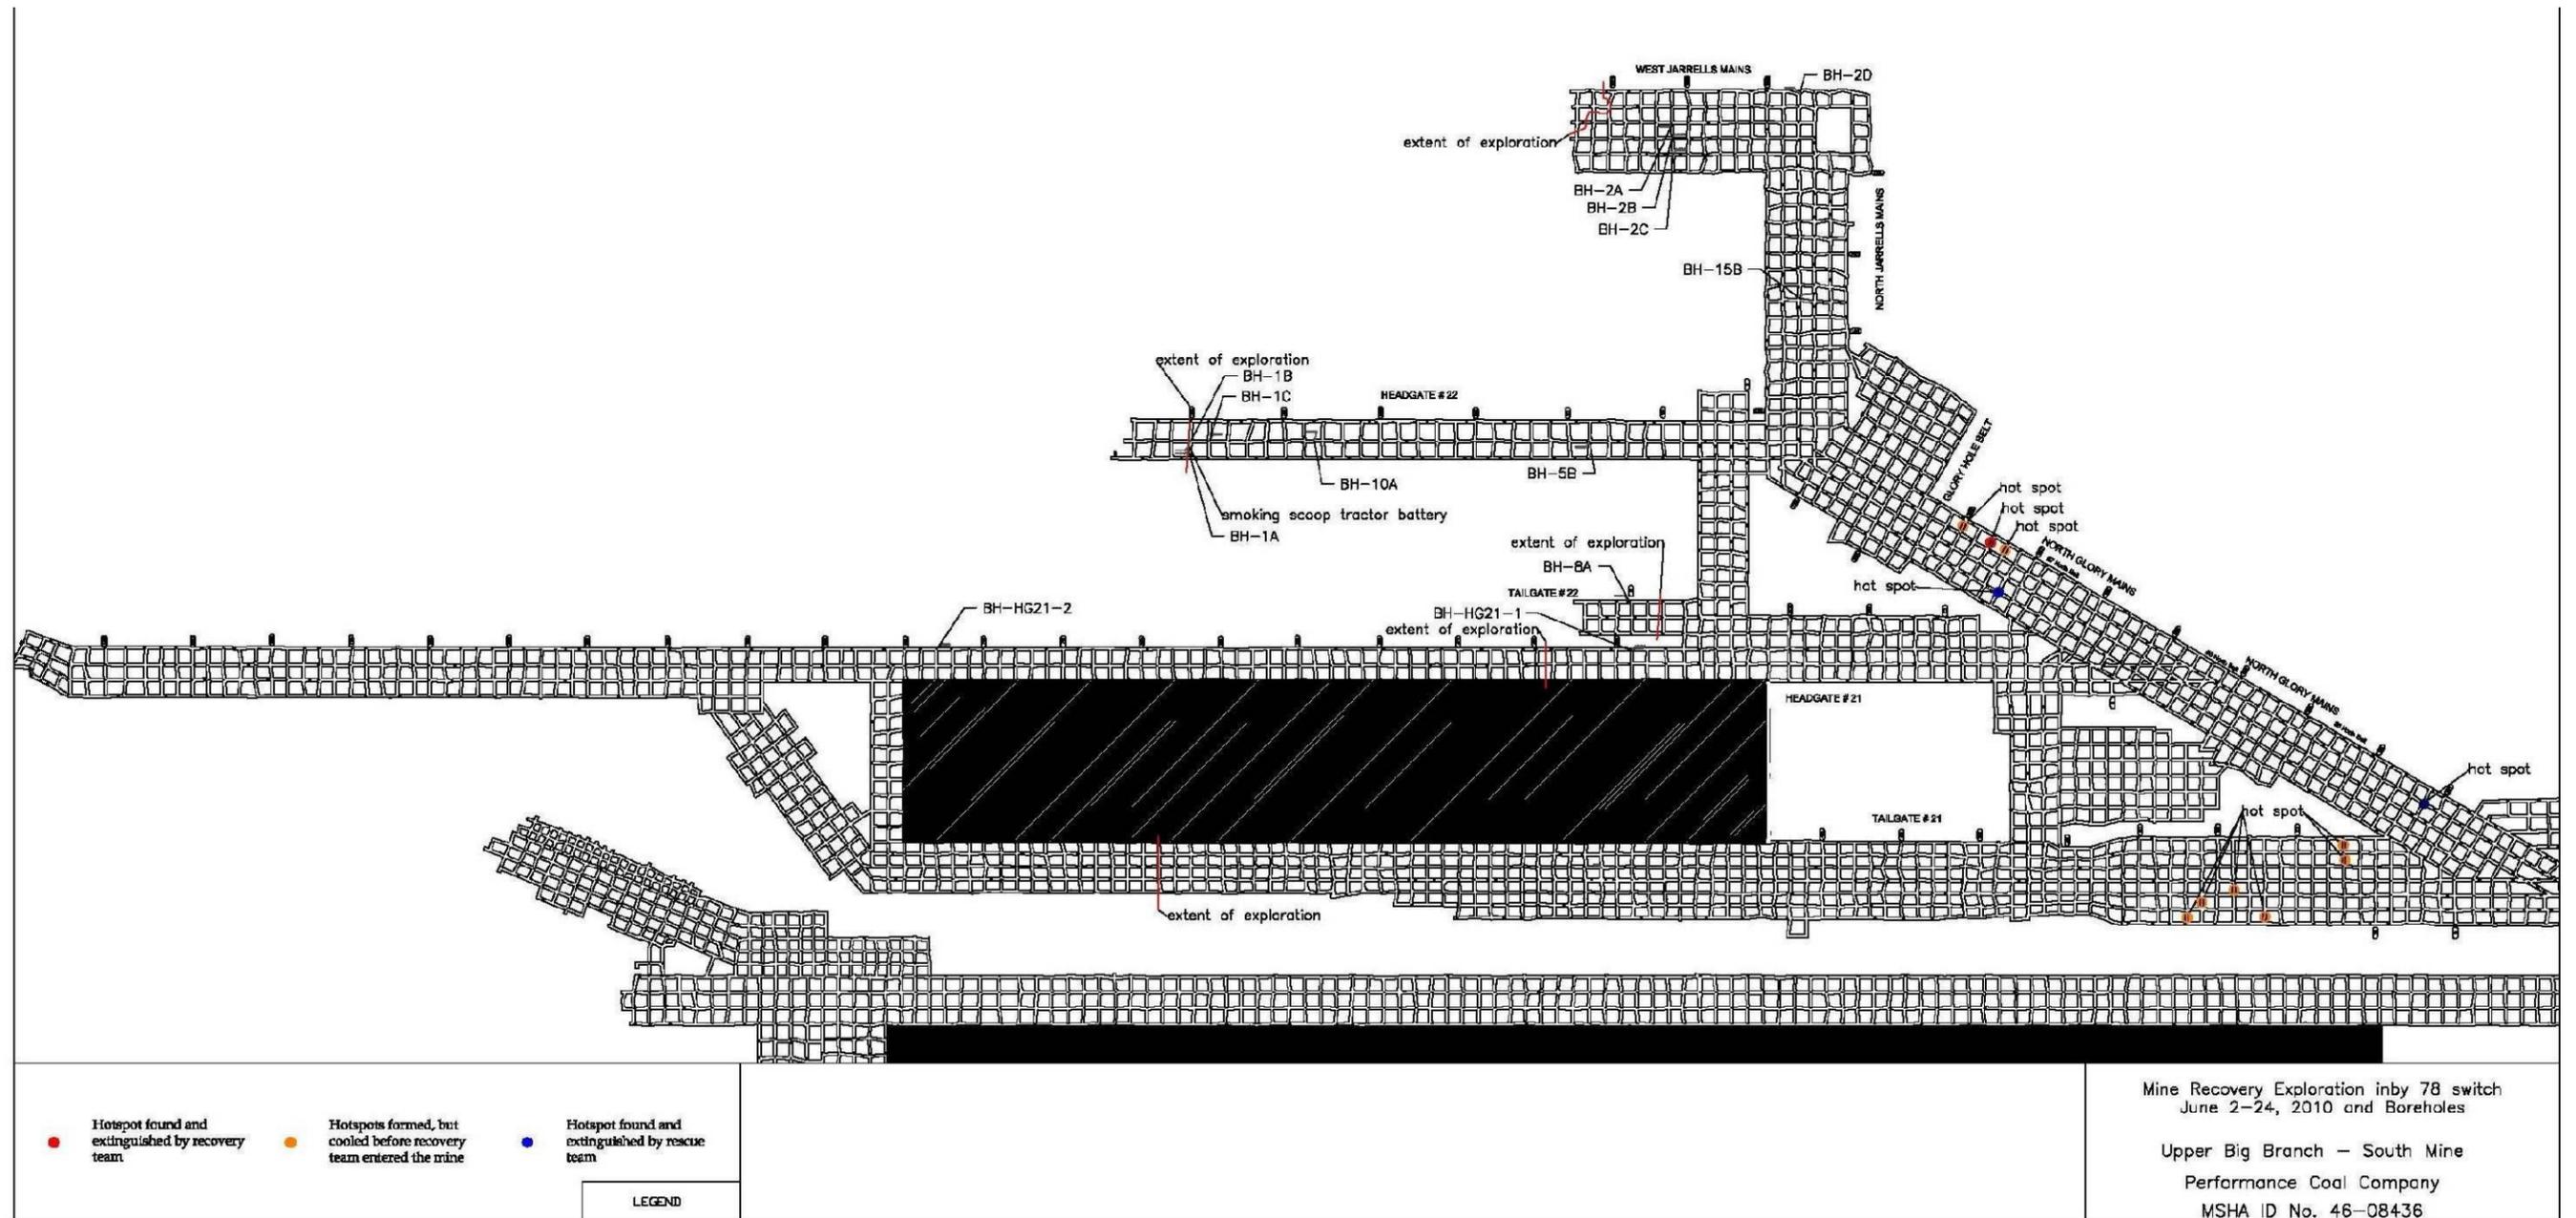
Figure 2. Map of borehole locations and “hot spots” encountered during recovery exploration

Several boreholes were drilled, some of which missed the intended mine entry, as shown on Figure 2. Other boreholes were stopped during drilling and never completed. See Appendix F for a description of each borehole drilled post accident at UBB.

Another re-entry plan was submitted by PCC on June 7 and MSHA modified the Section 103(k) Order to allow for additional exploration of the mine. This plan allowed for an orderly exploration progressing through the entire mine. A potentially hazardous elevated temperature area ("hot spot") was found on the mine floor/coal rib interface in crosscut 118, between the No. 4 and No. 5 entry in the North Glory Mains. This hot spot required water to be piped from the surface down borehole 15B so that rescue team members could apply water in sufficient quantities to eliminate the hot spot hazard. Also, two additional hot spots identified by mine rescue teams after the explosion were checked and found to be at ambient mine temperature. Eight other areas in the mine were previously identified as having had elevated temperatures but had subsequently cooled to ambient mine temperatures. Six of these areas were found in Tailgate 1 North between crosscuts 11 and 24.

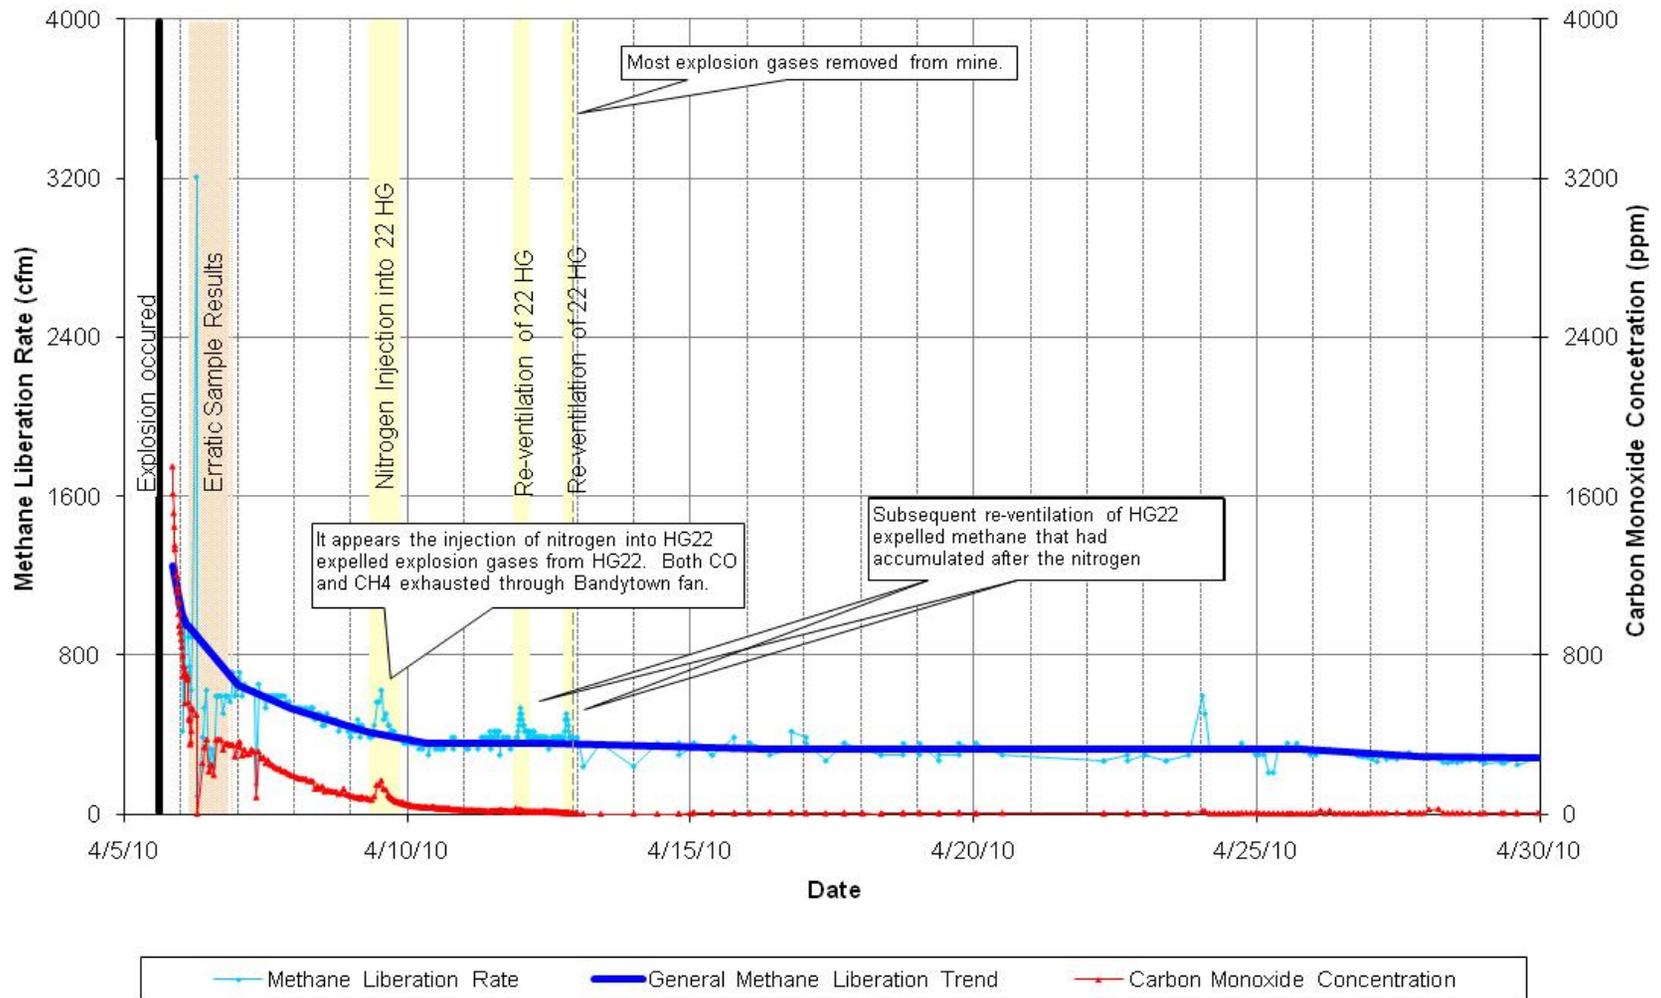
Figure 10: Methane Liberation Rate versus Carbon Monoxide Concentrations for Samples Collected from Bandytown fan from April 5 – 30, 2010

Beginning at 8:30 p.m. on April 5, 2010, air samples were collected regularly at the Bandytown fan for analysis using a gas chromatograph, which is not susceptible to the cross-sensitivity of gases. Figure 10 contains a graph depicting methane liberation rate versus carbon monoxide concentrations for samples collected from Bandytown fan from April 5 – 30, 2010. Sample results indicated that the total volume of methane that exited at the Bandytown fan at 8:30 p.m. was about 1,250 cfm. The methane liberation rate declined to 890 cfm by 5:00 a.m. on April 6, 2010.

A single sample, collected at 6:40 a.m. on April 6, 2010 and analyzed by the gas chromatograph, indicated an increase in methane, ethane and carbon dioxide while carbon monoxide, hydrogen, acetylene, and ethylene decreased slightly. Analysis of air samples collected after the explosion indicated normal declining trends. The apparent short-lived change in the concentrations of methane, ethane and carbon dioxide could not be explained conclusively.

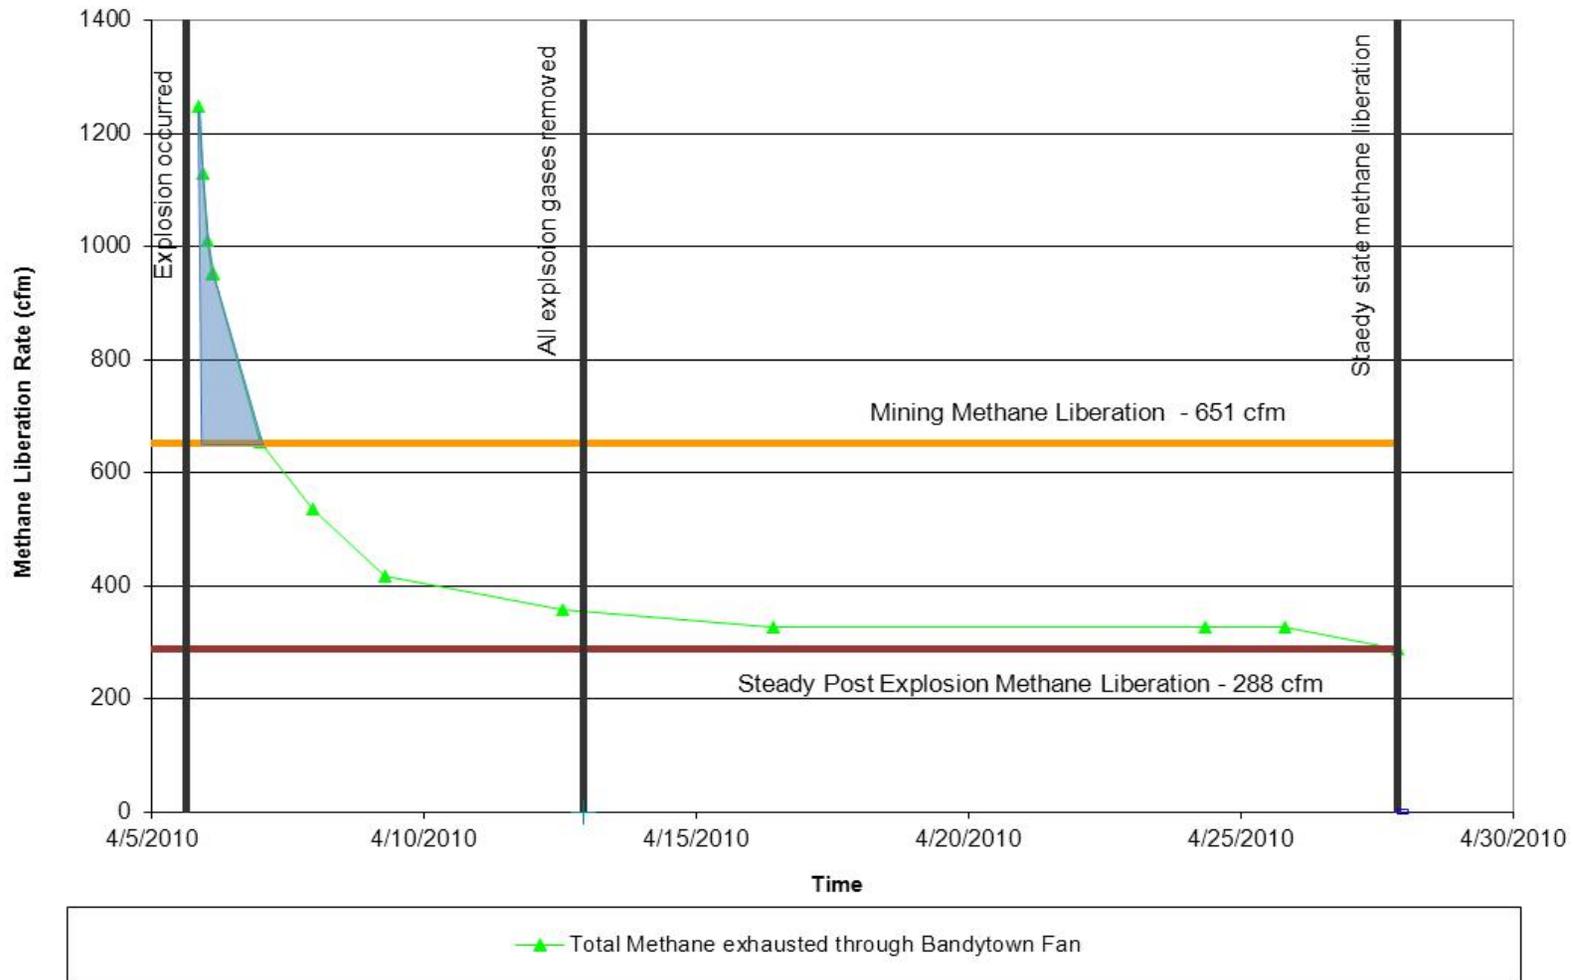
Figures 11 and 12 show graphical depictions of methane liberation rates from the Bandytown fan, based on information collected beginning 8:30 p.m. on April 5, 2010. The curve represents the total methane exhausted from the Bandytown fan from 8:30 p.m. on April 5, 2010 to April 30, 2010. The blue shaded area shown on Figure 11 represents the amount of methane exhausted as compared to the pre-explosion methane liberation. This represents the minimum amount of excess methane exiting Bandytown fan during the sampling period after the explosion. Figure 12 depicts the excess methane exhausted as compared to the post explosion steady-state methane liberation. This represents the maximum amount of methane exiting Bandytown fan during the sampling period after the explosion. Because the rate at which methane liberation from mining declines to the steady state non-mining rate is unknown, the actual amount of excess methane removed from the mine post-explosion would be between the two amounts shown on the graphs.

Figure 11. Graph of methane that was exhausted through the Bandytown fan for the period between April 5 and April 30, 2010. The area shaded in blue represents methane in excess of pre-explosion liberation levels.

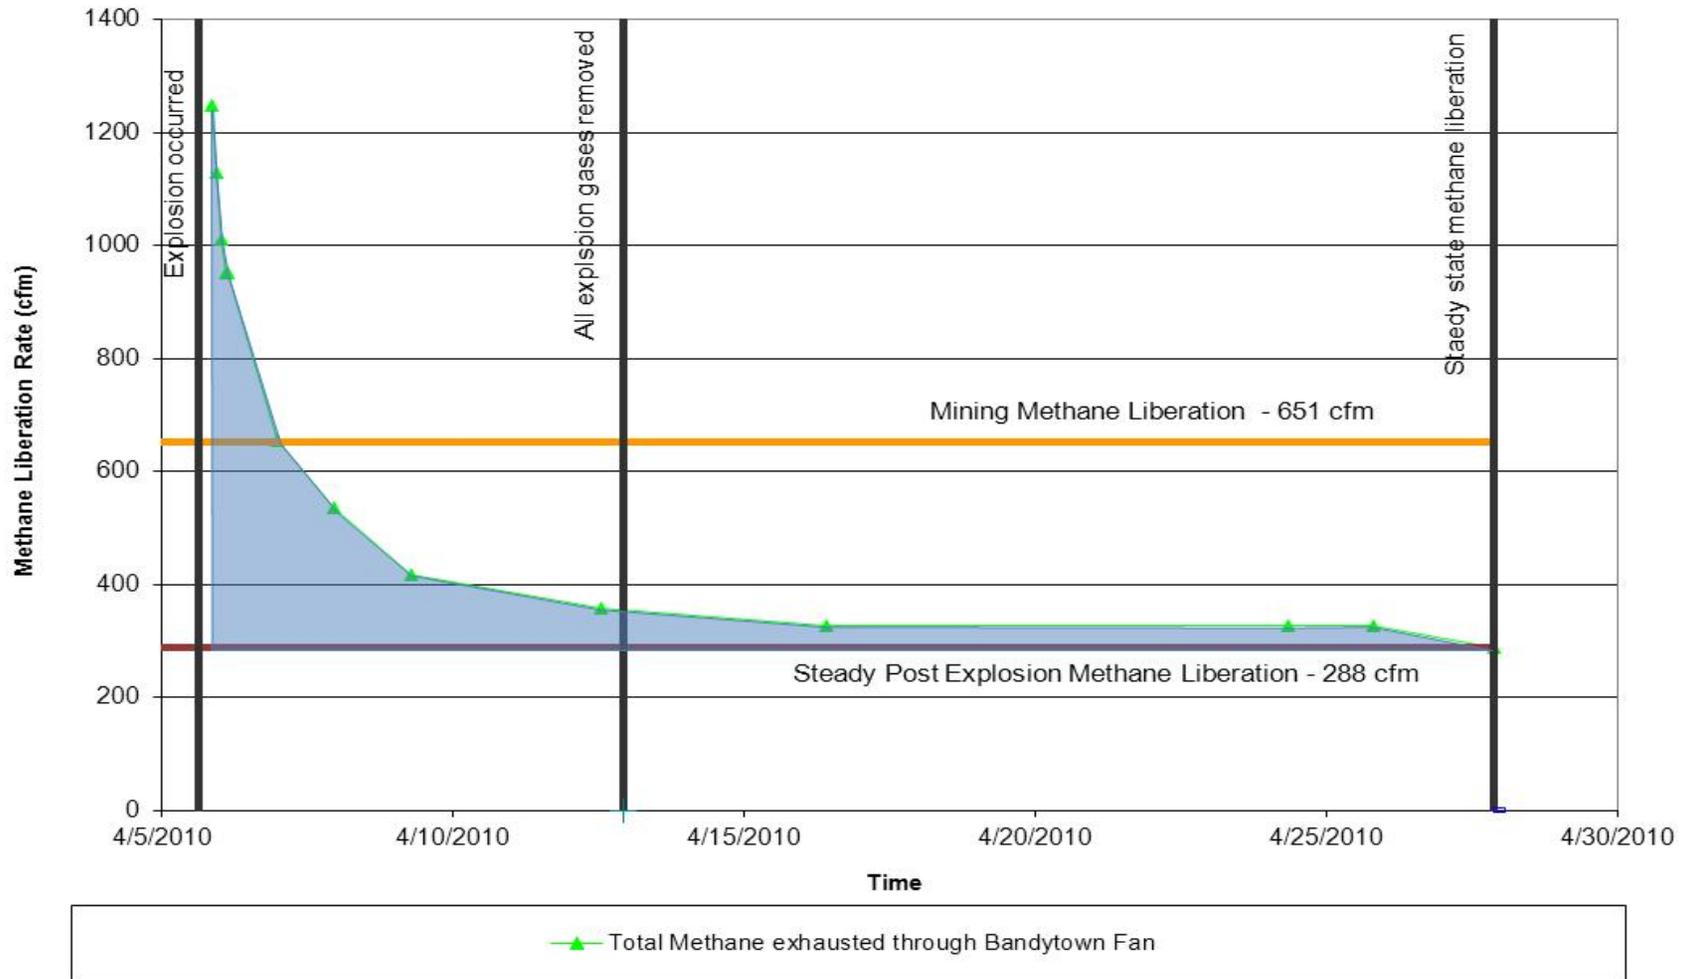
Figure 12. Graph of methane that was exhausted through the Bandytown fan for the period between April 5 and April 30, 2010. The area shaded in blue represents post-explosion methane versus steady state liberation levels.

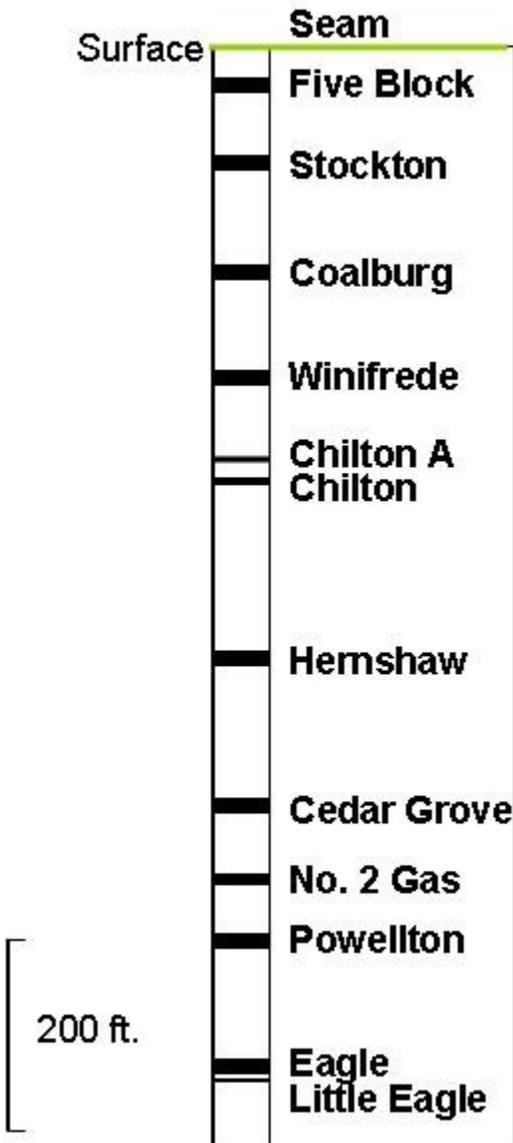
The face of the 1 North Panel is beneath approximately 1,075 feet of overburden at mid-face, with maximum overburden of 1,275 feet encountered near the start-up room at the back of the panel. Review of mine map overlays indicates that a remnant pillar configuration is present above the southern quarter of the current position of the longwall face, characterized by two rows of pillars flanked by gob represented by split pillars in the Powellton seam (determined to be the No. 2 Gas seam by the West Virginia Geologic and Economic Survey (WVGES)), 170 feet above. Three thick layers of massive sandstone, each 20-30 feet, are present between the Eagle and Powellton seams, although floor heave and roof potting in UBB can often be correlated to remnant pillars surrounded by gob in the overlying Powellton seam. Additionally, there are several other mined coal seams above; see Figure 14 below.

Figure 14. Stratigraphic column of coal seams present above the 1 North Panel longwall face. Note that WVGES names are offset, beginning with the Powellton.

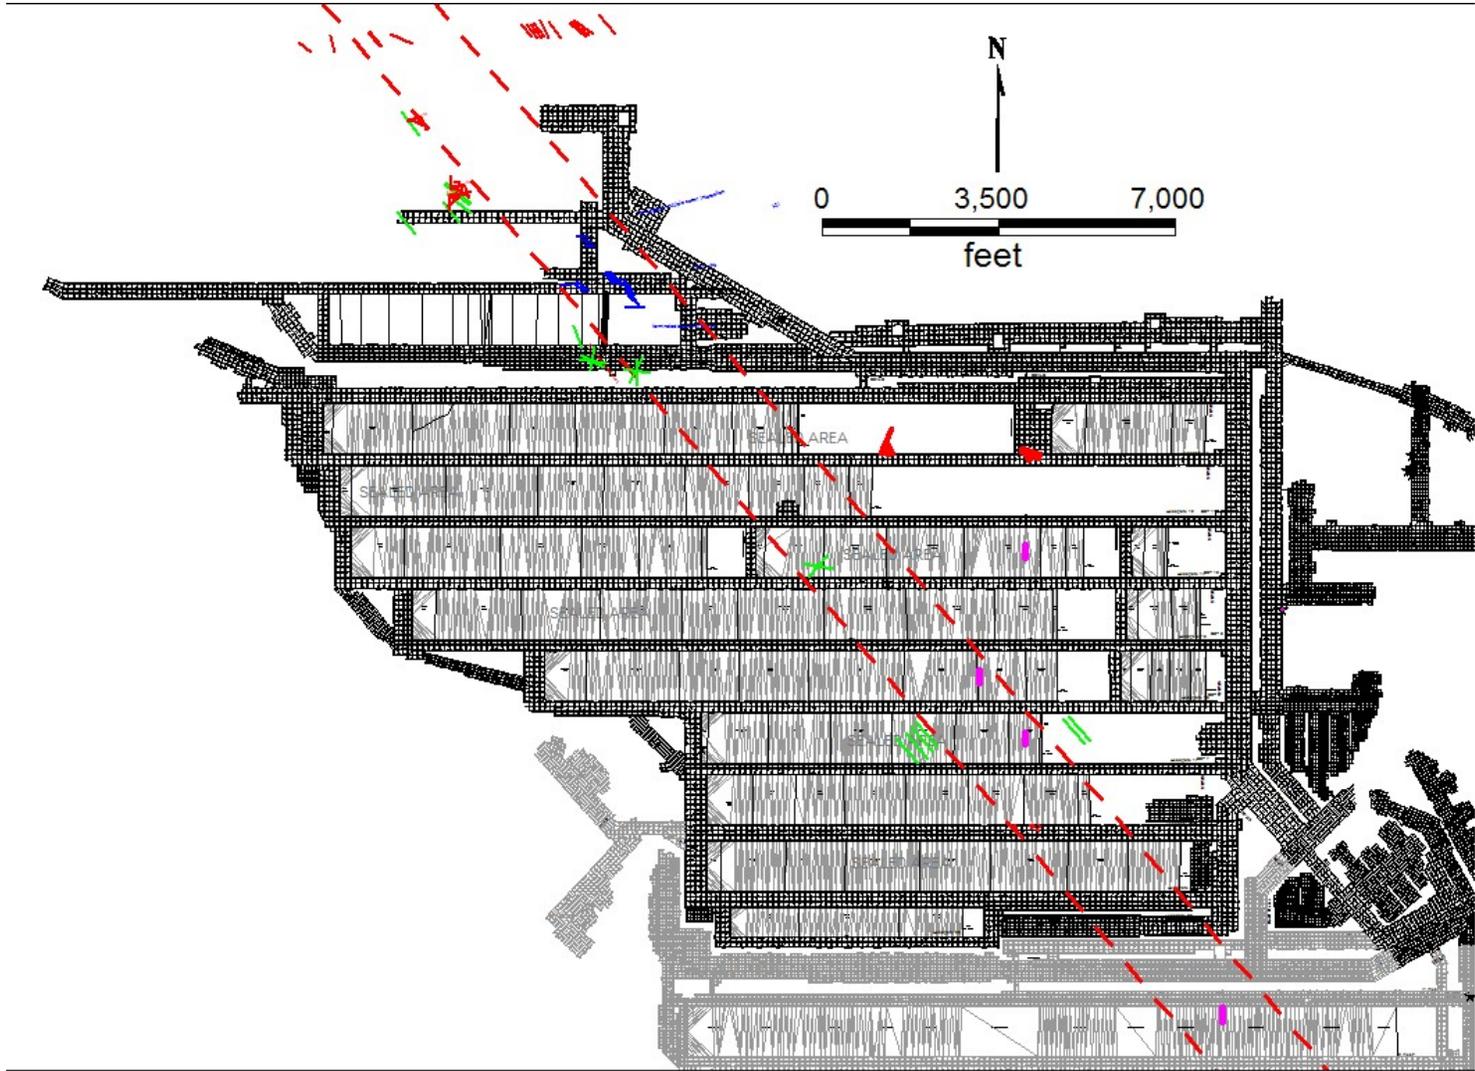
The investigation team concluded that a fault zone trends N 40° W across UBB, and dips 30° to the northeast (Figure 15). This is based on: 1) the locations of gas outbursts or explosions in 1997, 2003, and 2004, discussed above; 2) underground observations conducted at UBB in the 18 Headgate during the 2004 investigation; 3) extensive underground observations conducted between July 2010 and October 2010; 4) the face positions of Longwall Panels 11 and 12 when they were terminated; 5) observations of structural features in the overlying Powellton (Castle Mine) and Coalburg (Black Knight II Mine) seams; and 6) observations of structural features on the surface. To understand the conditions associated with the initial gas release, it is also critical to understand the interplay between the fault zone, the depth of overburden, and the redistribution of stress caused by longwall mining.

Figure 15. Upper Big Branch Mine with projected fault zone, and locations of joints (green, blue), slickensides (red), and floor burst locations (purple) used to constrain the location and trend of the fault zone.

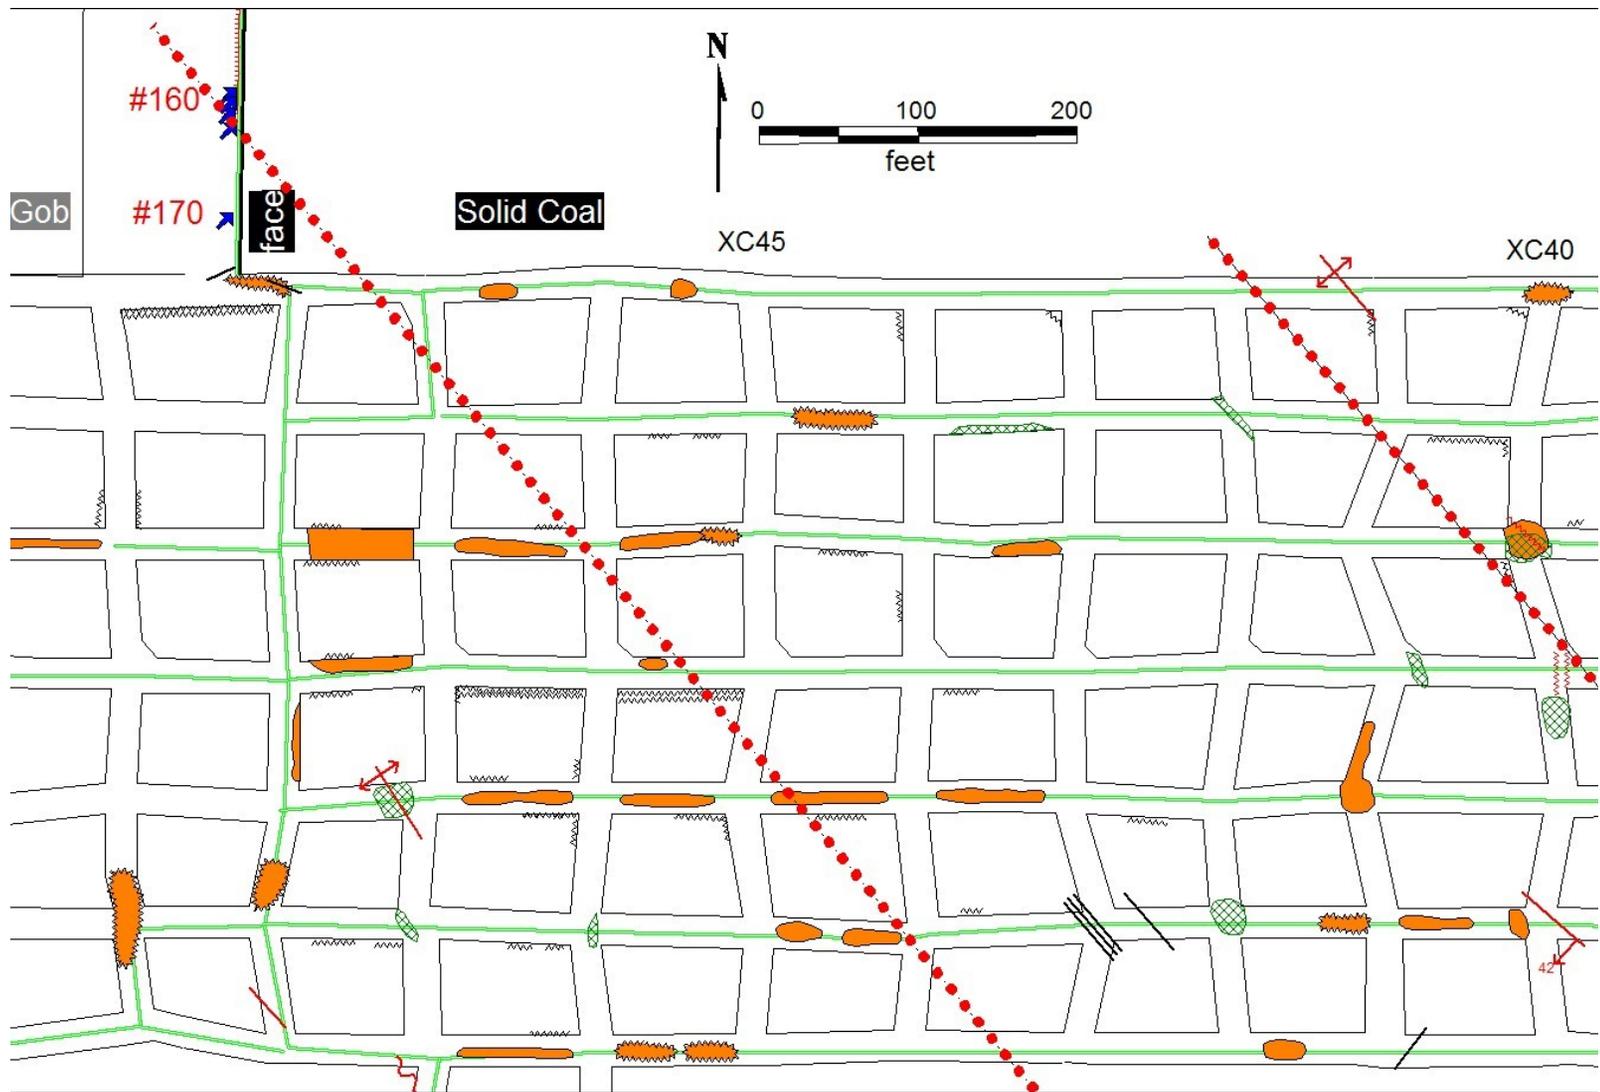
jointing, which also strike N 40° W, are present in thick sandstone layers that overlie the coal seams. The zone also localizes linear pot-outs in the roof and zones of floor heave (Figure 16).

Figure 16. Detailed mapping in Tailgate 1 North, showing trend of floor heave (orange), joints (heavy black lines), pot-outs (green hatch), rib sloughing (jagged lines), and slickensides (red lines) projecting into the longwall shield 160-171 gas feeder zone. Heavy red, dashed lines indicate individual fault zone projections. Blue arrow symbols represent floor feeders inby longwall face.

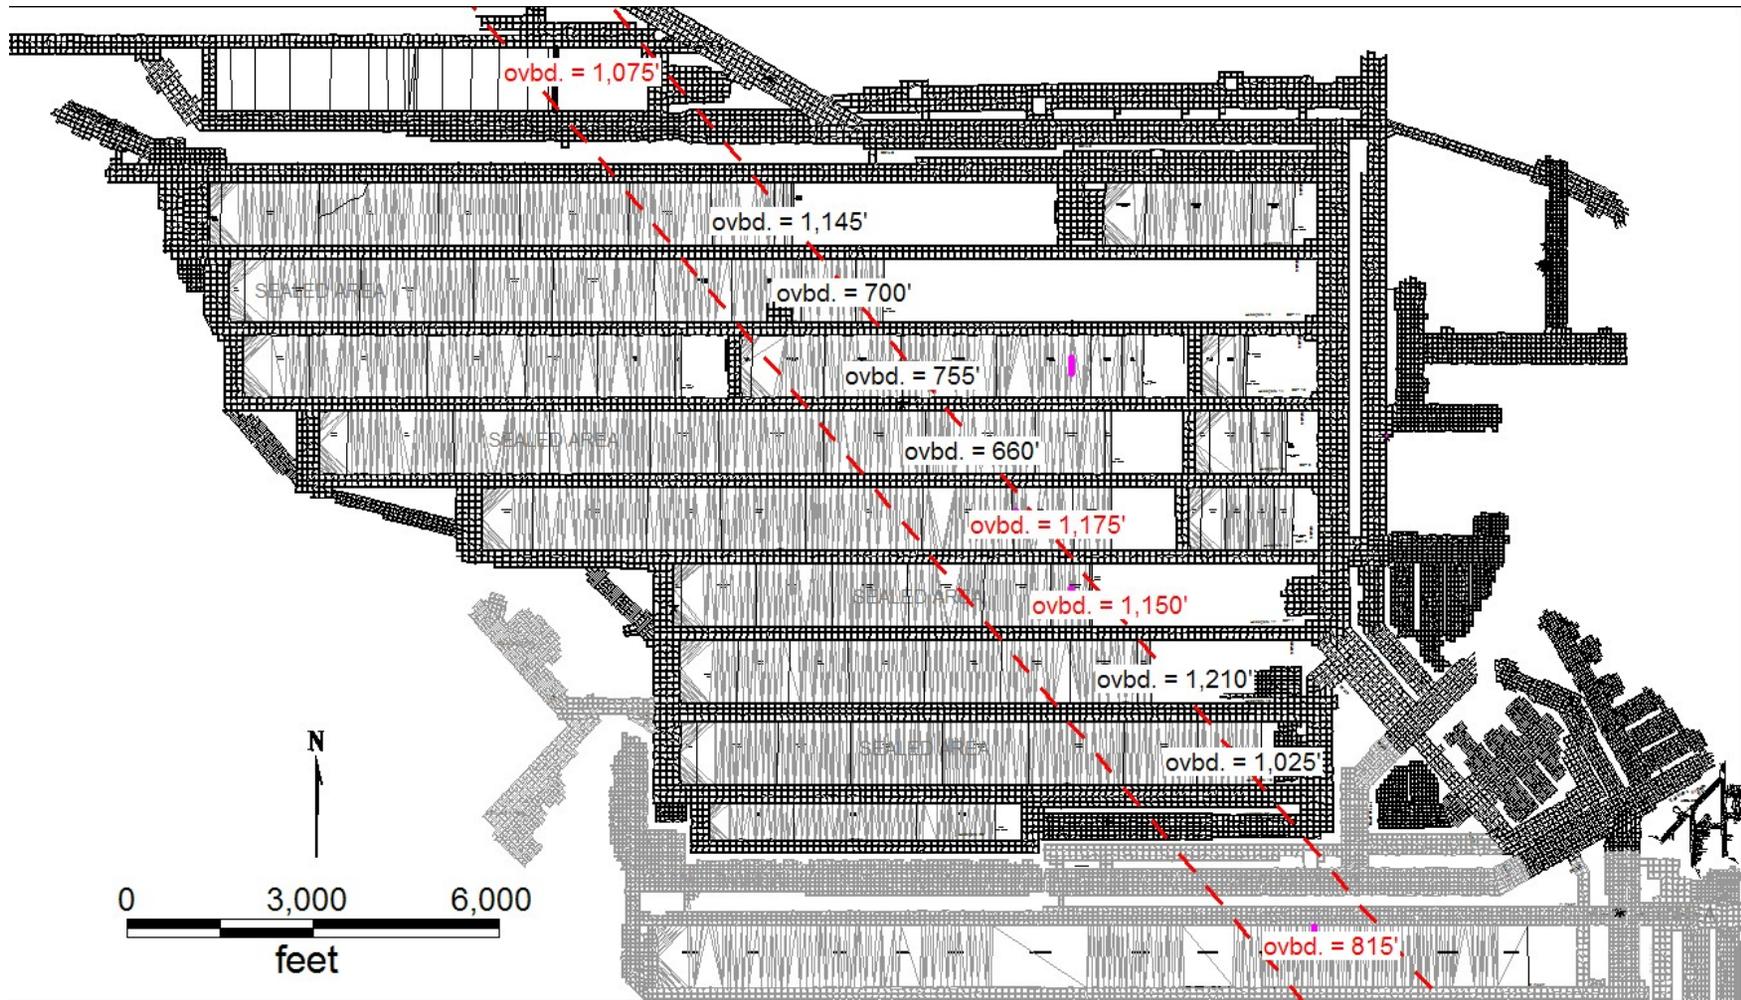
Another factor (discussed further below) in the release of methane appears to be the overburden present above the fault zone. While other panels mined through the fault zone without experiencing a methane outburst, those panels encountered overburden depths much less than 1,000 feet within the fault zone. The panels that experienced methane outbursts encountered overburden values of over 1,150 feet. It appears that several longwall panels, including Longwall Panels 11, 12, and 18 and Longwall Panels 16 and 17, were terminated in the vicinity where the projection of the fault zone intersected the 2,000-foot topographic contour. This corresponds to between 1,125 and 1,200 feet of overburden, depending on seam elevation (Figure 17).

Figure 17. Panels in which outbursts or explosions occurred are highlighted in red and lie along projected fault zone. Several panels were terminated upon intersecting the fault zone. Panels that encountered overburden of only 660-755 feet appear to have crossed the fault zone without incident, suggesting a critical overburden depth of 1,150 feet related to stress.

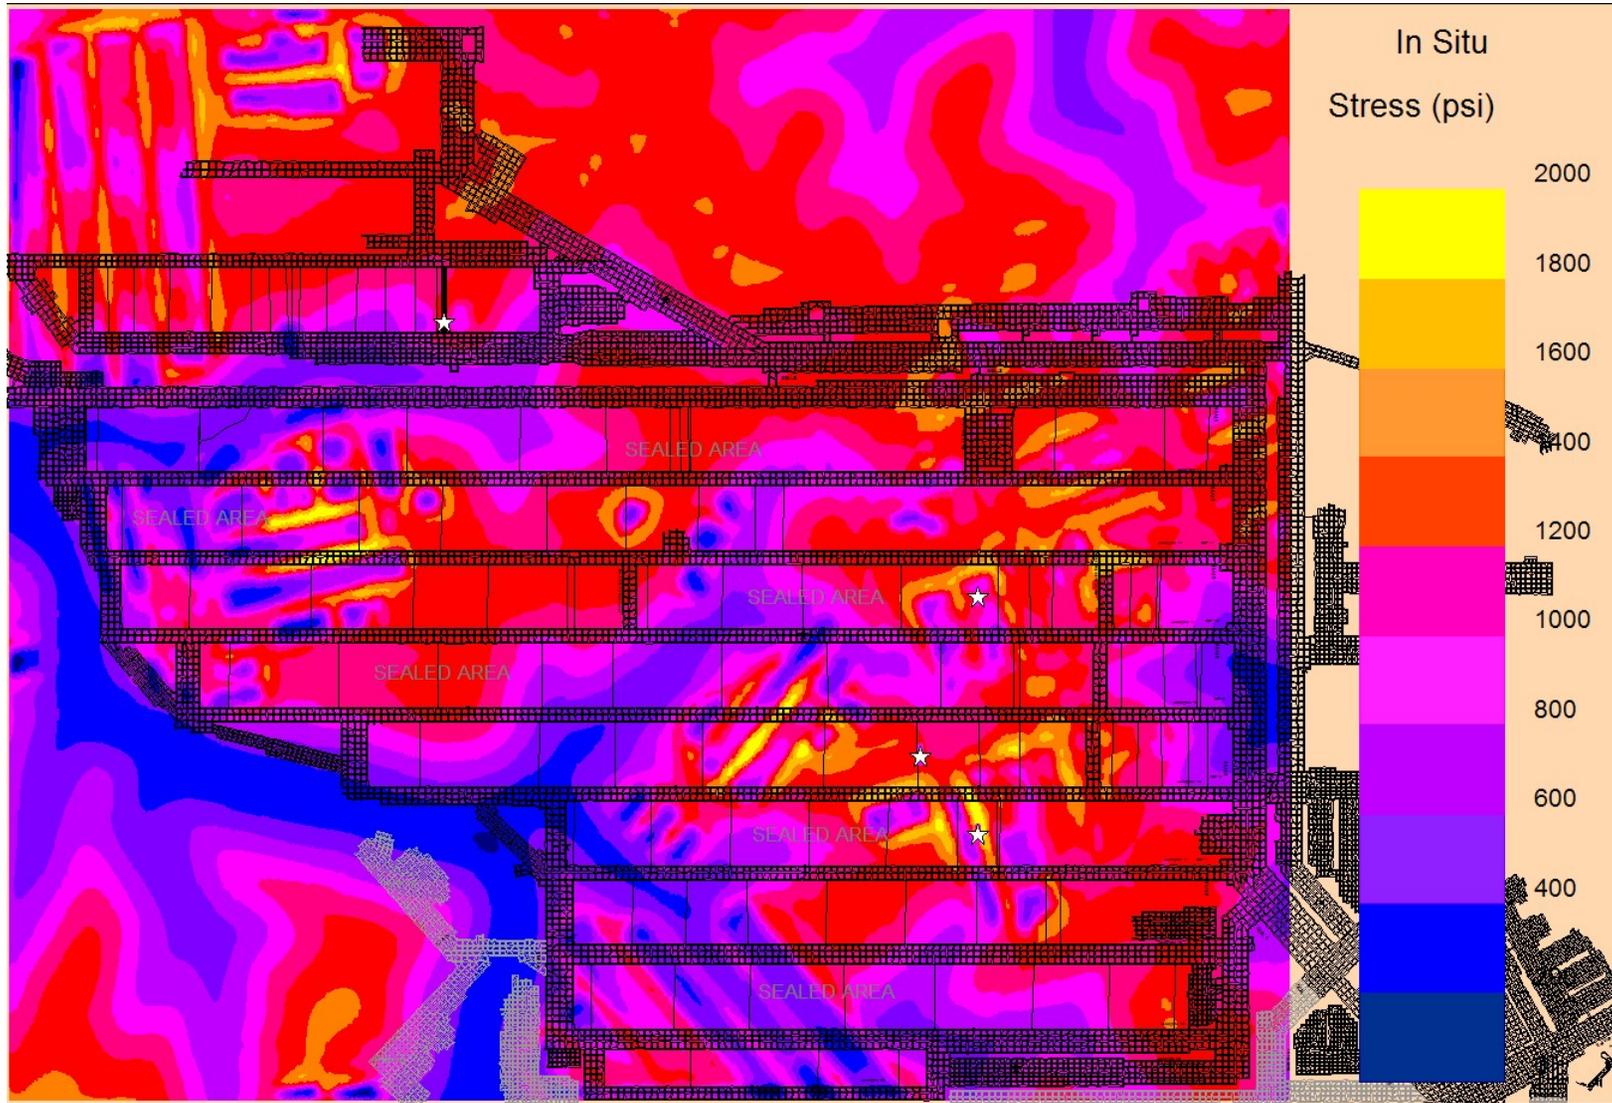
Dr. Heasley's model was used to assess the in-situ (in place) stress on the Eagle seam prior to mining to identify any high-stress areas and to assess any correlation between high stress areas and floor gas outbursts. Figure 18 represents a map of in-situ stress on the Eagle seam, including the vertical stress derived from the weight of overlying rock combined with stress associated with multiple seam interaction with the overlying Powellton seam mining. Although there appears to be a loose correlation between in-situ stress exceeding 1,200 pounds per square inch (psi) and the locations of the 2003 and 2004 gas feeder events, they are not associated with the highest stress values of 1,800 psi or greater.

At the time of the April 5 explosion, the longwall face was beneath a narrow swath of greater-than-1,200 psi stress associated with two rows of remnant pillars flanked by gob or thin, split pillars. Therefore, the documented outburst locations do not correspond to the highest stresses (>1,800 psi), and therefore, do not appear to be entirely stress-driven.

Figure 18. Map of in-situ stress on the Eagle seam, incorporating stress attributable to overburden and multiple seam interactions with the Powellton seam. White stars indicate locations of gas outbursts, with heavy black line on 1 North Panel (label), representing April 5, 2010 face position. Bright yellow patches represent >1,800 psi, with subsequent colors spaced at 200 psi intervals.
